GW - 362

LETTER OF VIOLATION OCTOBER 19, 2009

Re: **Riverside Transportation, GW-362**
1006 E. Hwy 128, Jal N.M.
NW/4 NW/4 of Section 20, Township 25 South, Range 37 East

OCD Inspection: Riverside Transportation, Jal GW - 362

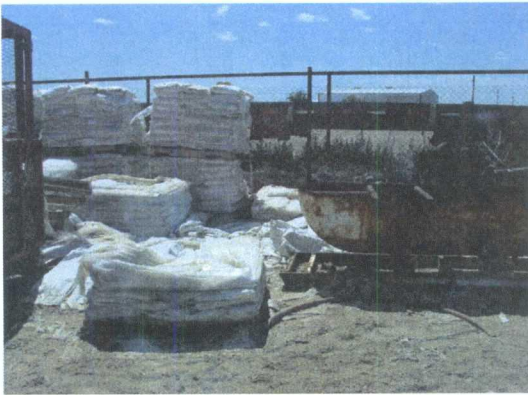
1. **Photo 1:** KCL bags are not located on an impermeable pad with curbing. The bags have lost integrity and have dispersed on to the ground. Owner/operator shall refer to Condition 7 of their discharge permit for containment of such media.
Owner/Operator responded on December 5, 2008 to the pre-permit inspection conducted on December 19, 2006 to OCD indicating that "All granular KCL has been removed from property and is being used only as needed." Per the recent inspection there were signs of KCL bags in the same location as previously noted in the 2006 inspections.

Photo 1: Broken bags of KCL located on wooden pallets. KCL dispersed on ground.

Owner/operator shall **immediately** confine all KCL to a proper impermeable area and address the leaking trailer in Photo 15.

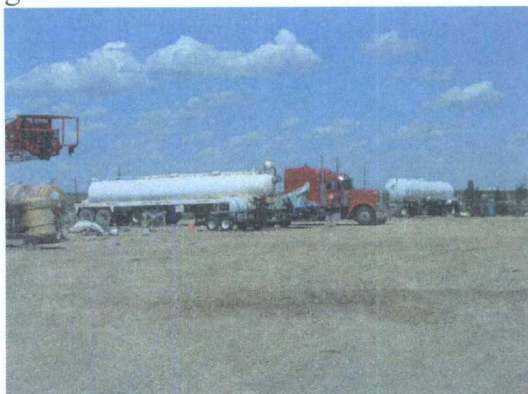
2. **Photo 2 – 17:** Several areas within the yard show soil staining/contamination. Contaminated soils shall be promptly addressed. Best Management practices will be implemented in order to prevent spills from reoccurring. Refer to Conditions 15 and 18 of your permit for details. Note OCD Rule 116 is now Part 29. Reference all current rules and regulations for clean up. **No discharges are allowed under the discharge permit; refer to Condition 18 of their permit for details.**

Photo 2: Staining in yard.

OCD request that the Owner/Operator modify its discharge plan application per Condition 19 to provide for investigation, remediation, abatement, and monitoring requirements for any vadose zone or water pollution. Please promptly submit the specified Condition 19 modification changes for OCD approval.

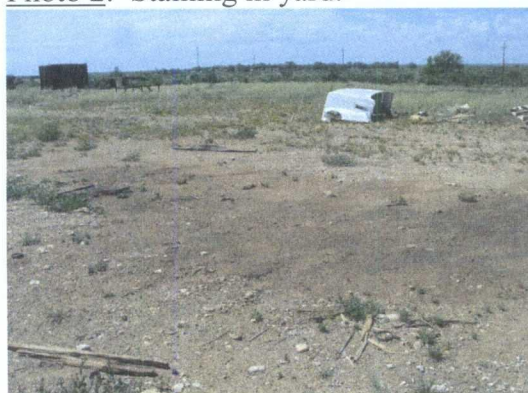
Photo 3: Staining in yard.

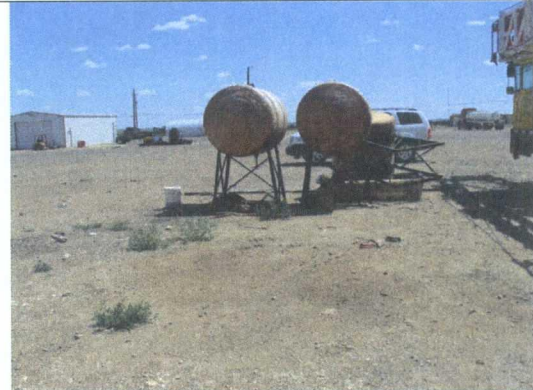
Photo 4: Staining in yard.

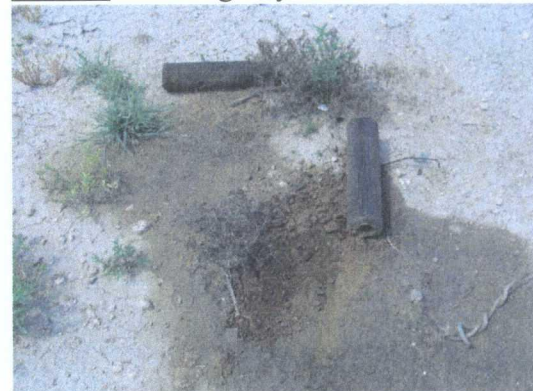
Photo 5: Used filters and soil staining.

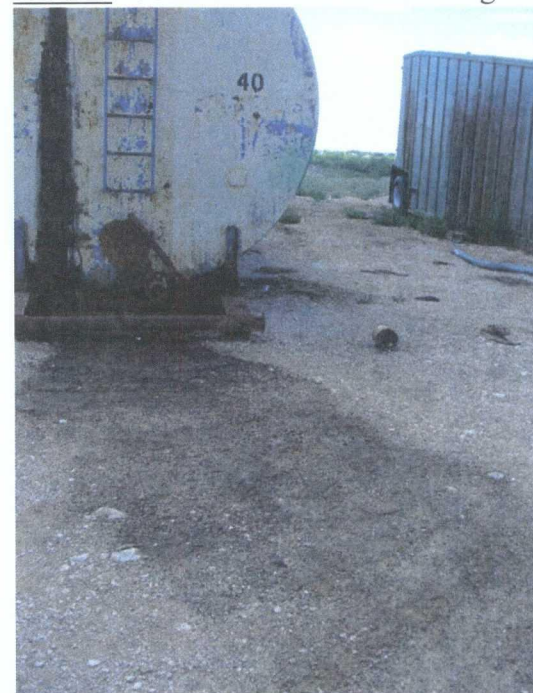
Photo 6: Staining from frac tank valve.

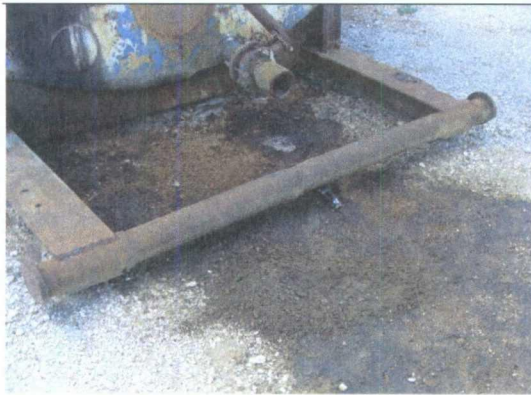
Photo 7: Close up of Photo 6.

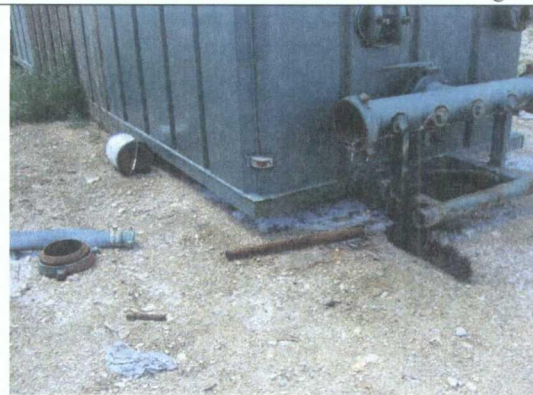
Photo 10: White residual staining near tank.

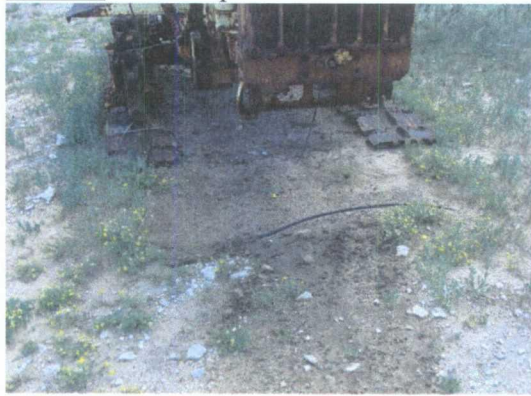
Photo 8: Staining near equipment.

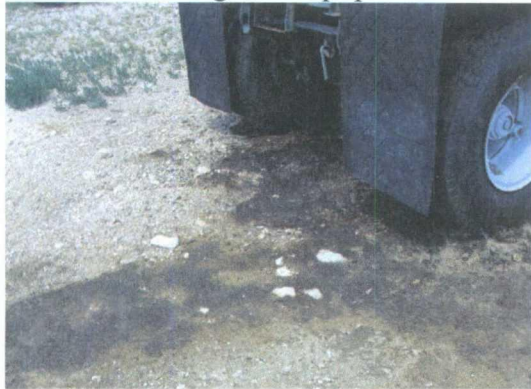
Photo 9: Staining near truck.

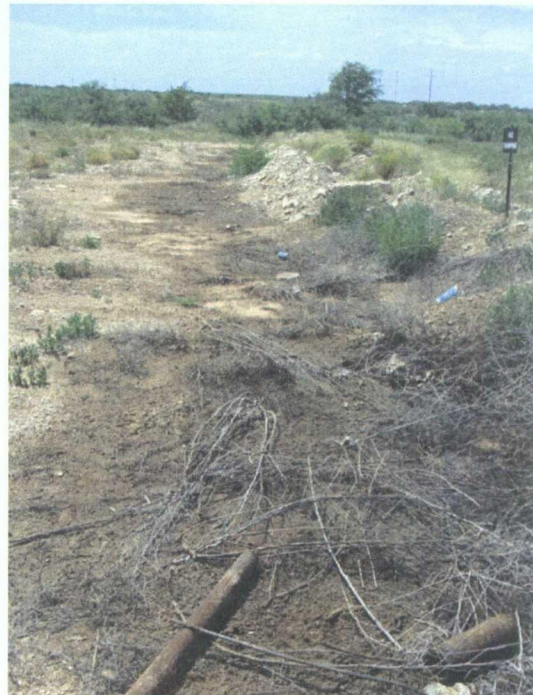
Photo 11: Used filters and hydrocarbon staining near back of yard.

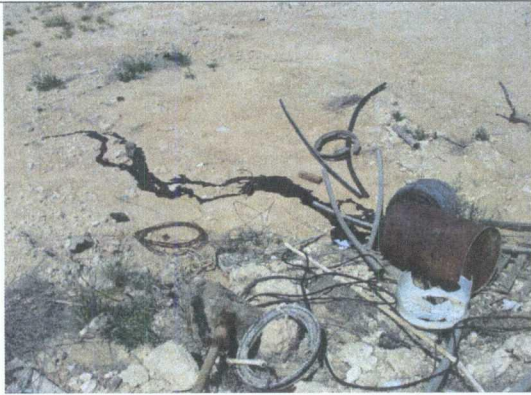
Photo 12: Contents of barrel being discharged in excavated area.

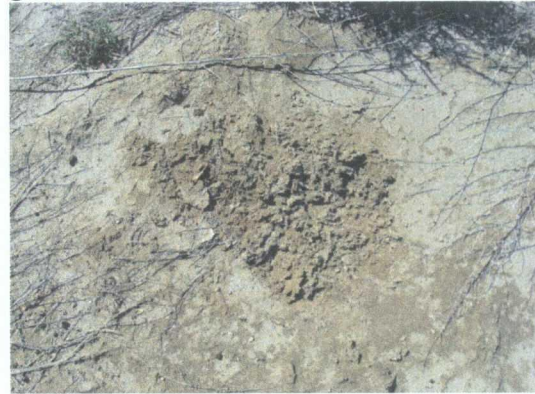
Photo 16: Dry drill cuttings located on ground.

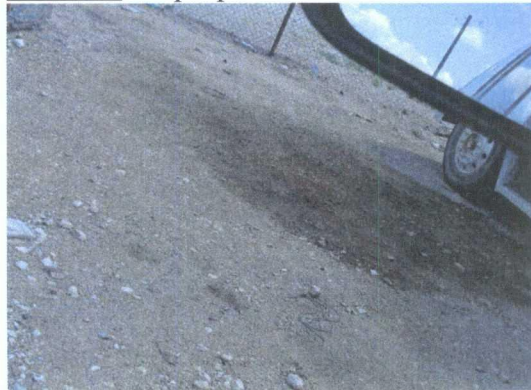
Photo 14: Soil staining.

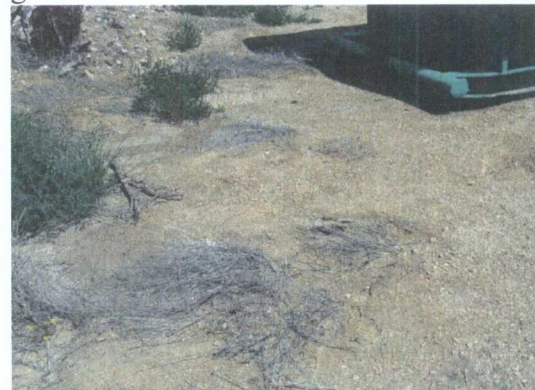
Photo 17: Overall view of photo 16.

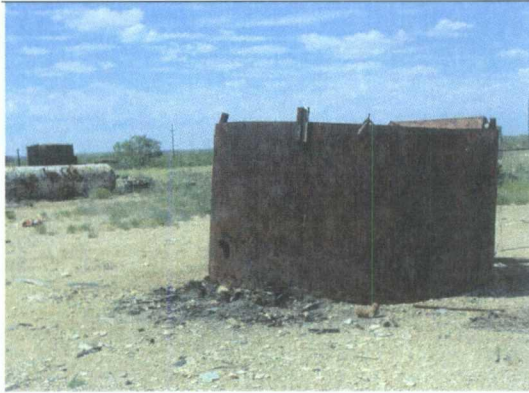
3. **Photo 18 & 19:** The Owner/Operator is reminded that waste shall not stay on site longer than 180 days without OCD approval. Refer to Condition 6.B. Note: OCD Rule 712 is now Part 35. Reference all current rules and regulations for proper waste disposal.
Owner/Operator responded to the OCD on December 2, 2008 indicating that all debris will be kept on a trailer within the yard. There was no sign of a trailer holding waste on site.

Photo 18: Stored solid waste.

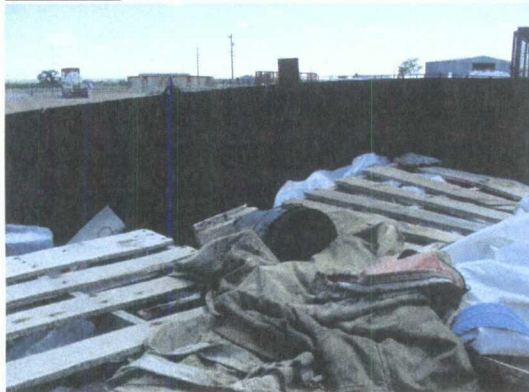
Photo 19: Solid waste in Photo 18.

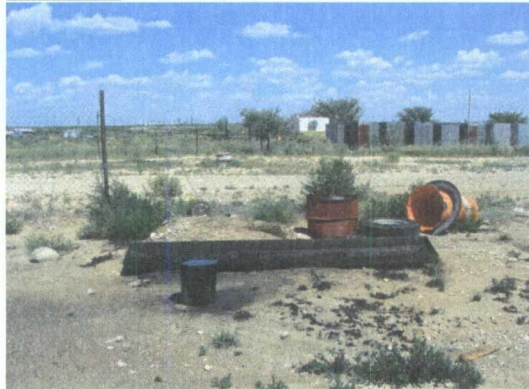
4. **Photo 20 & 24:** Proper maintenance of spill or catch containments needs to be addressed, refer to Condition 14 of permit for details. **No discharges are allowed under the discharge permit;** refer to Condition 18 of permit for details.

Photo 20: Bins full of fluids. Staining on ground.

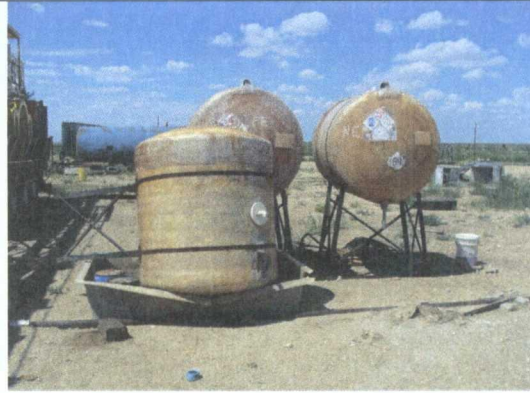
5. **Photo 21 – 25:** Tanks and barrels need to be properly stored on site. Reference Condition 7 & 9 of permit for details.
Owner/Operator responded to the OCD on December 5, 2008 indicating that it was addressing this issue by placing all empty tanks on a secondary containment. At the time of inspection in August, however, barrels were not properly located on secondary containment as required.

Photo 21: Improper location of saddle tanks.

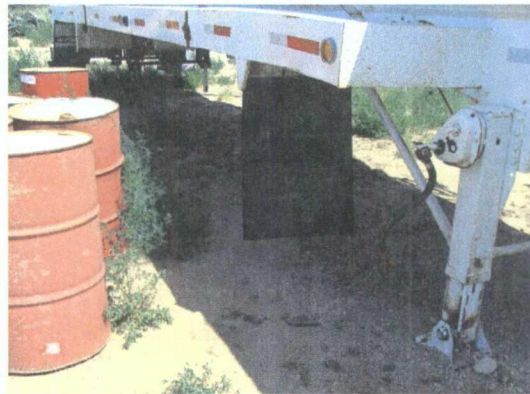
Photo 22: Improper placing of barrels.

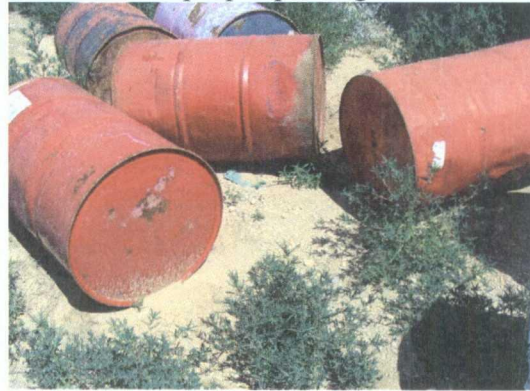
Photo 23: Improper storage of barrels.

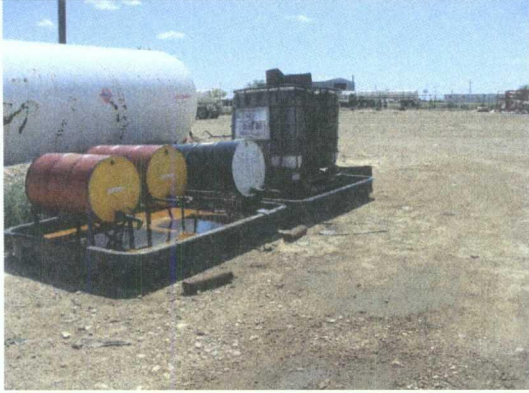
Photo 24: Secondary containments full of fluids. Staining on ground.

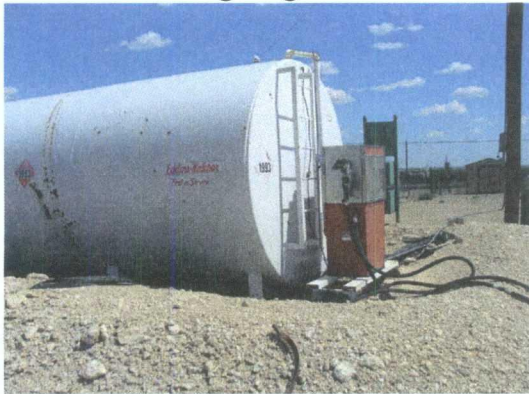
Photo 25: Improper lining of diesel tank.
