Annual GW Mon. REPORTS

Annual Report - OCD Case Number 1R0479

Rice Operating Company – Vacuum N-6-1 Junction Box, UL N Sec 6 T18S R35E

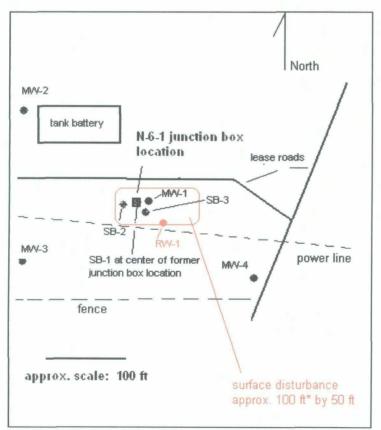
Figure 2 – Vac N-6-1 approx. monitor/recovery well locations.

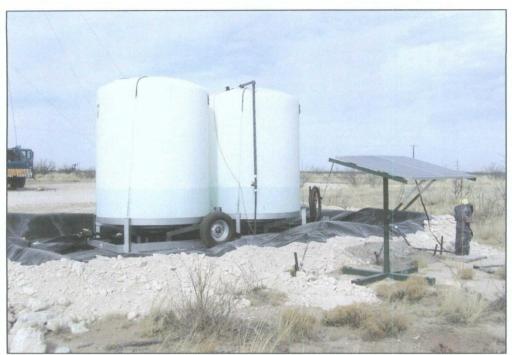
- Approximately 3,400 barrels of chloride affected groundwater were removed during 2009 from a near-source recovery well (RW-1, Figures 2 and 3). This water was subsequently used for Rice SWD line and well maintenance purposes.
- Groundwater chloride concentrations in a near-source well (MW-1) continued their decline from approximately 14,000 ppm to 12,000 ppm over this period (Figure 4).

Figure 3 – Vac N-6-1 solar-powered groundwater recovery system.

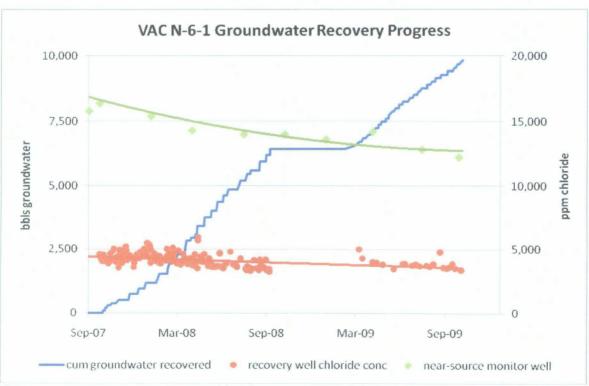
Figure 4 – Vac N-6-1 groundwater chloride concentrations (left axis) and cumulative groundwater recovery volumes (right axis).

We plan to continue this present course of action through 2010.
