WORKPLANS

March 10th, 2009

RE: **Investigation and Characterization Plan
Rice Operating Company – EME SWD System
EME N-18 Boot: UL N Sec 18 T 20S R 37E**

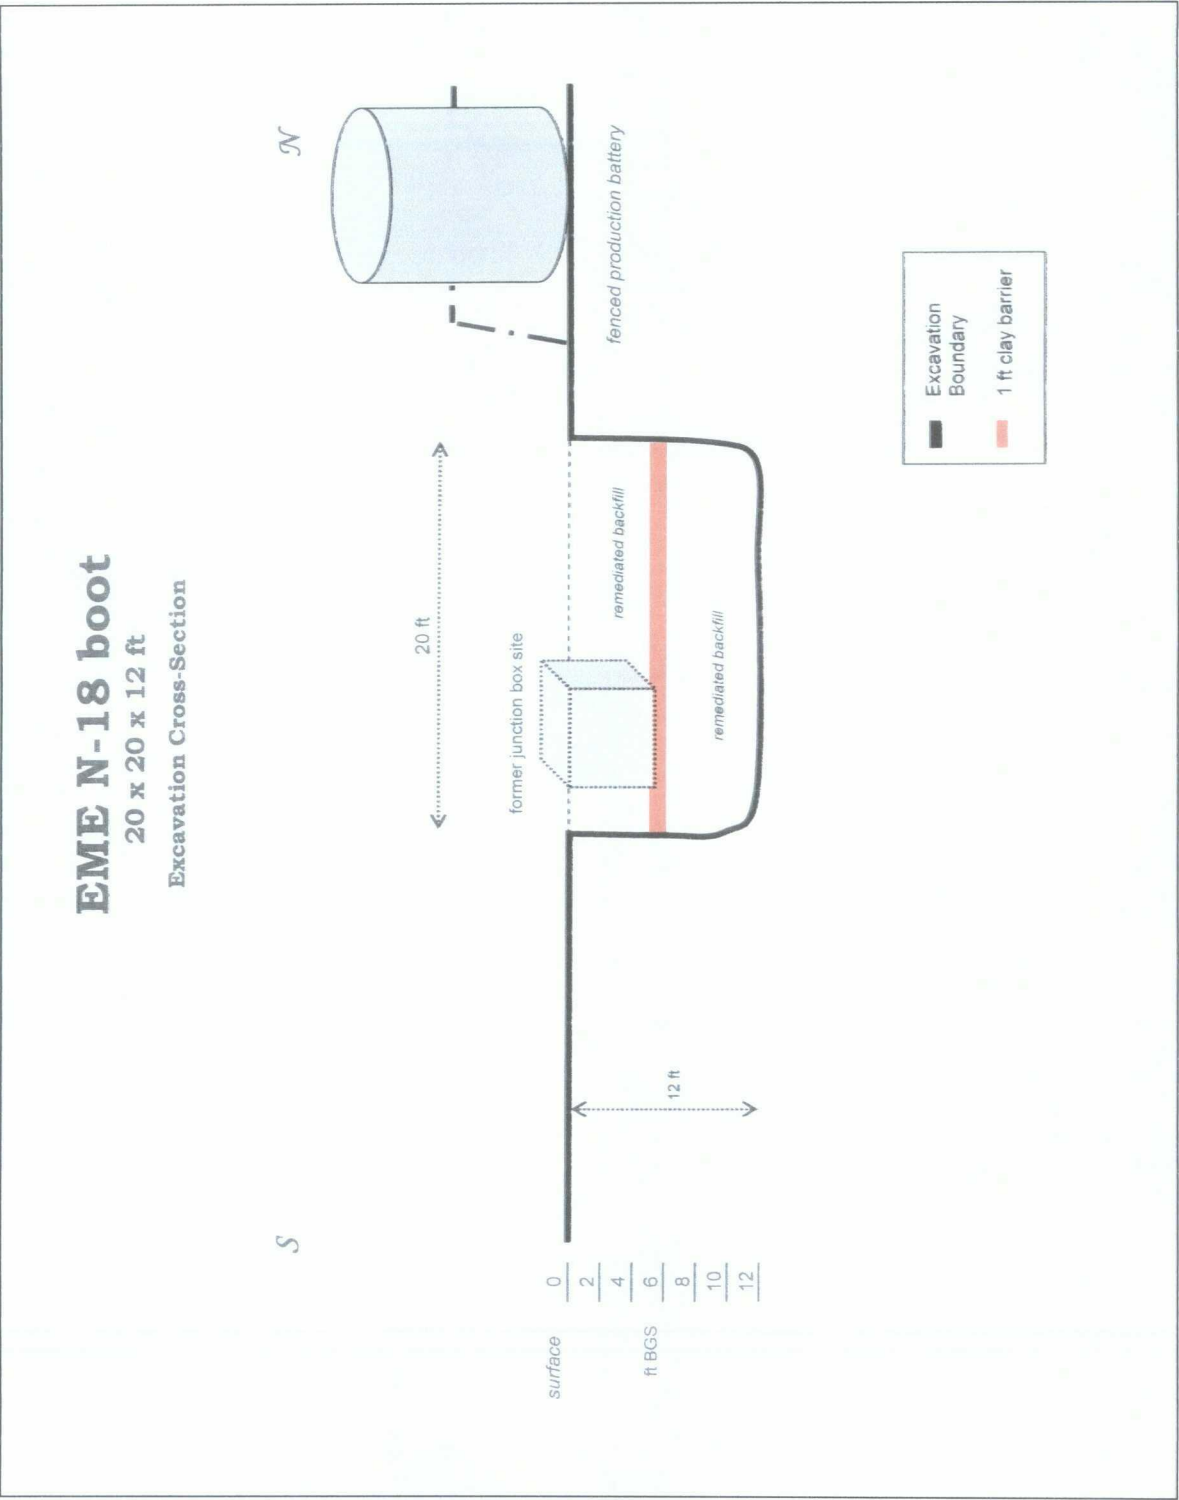
Figure 3 – Schematic diagram of installed clay barrier.

ROC removed a wooden junction box at this location in August of 2004 as part of its facility maintenance and upgrade program. (See Figure 2: Rice Junction Box Disclosure Report). As the original wood junction box was removed soils were sampled using a backhoe, creating a 20 by 10 by 12 ft deep excavation. The excavated soils were blended and then backfilled into the excavation to a depth of 6 ft bgs where a one foot thick compacted clay barrier was installed (Figure 3). The remaining excavated soil material was backfilled into the excavation above the clay barrier to the existing ground surface. The disturbed surface was then seeded with a native vegetation mix.

It should be noted that there is no longer a threat of continued, compounded impact at this site as the former junction box has been removed and a clay barrier installed to impede the downward migration of chlorides.

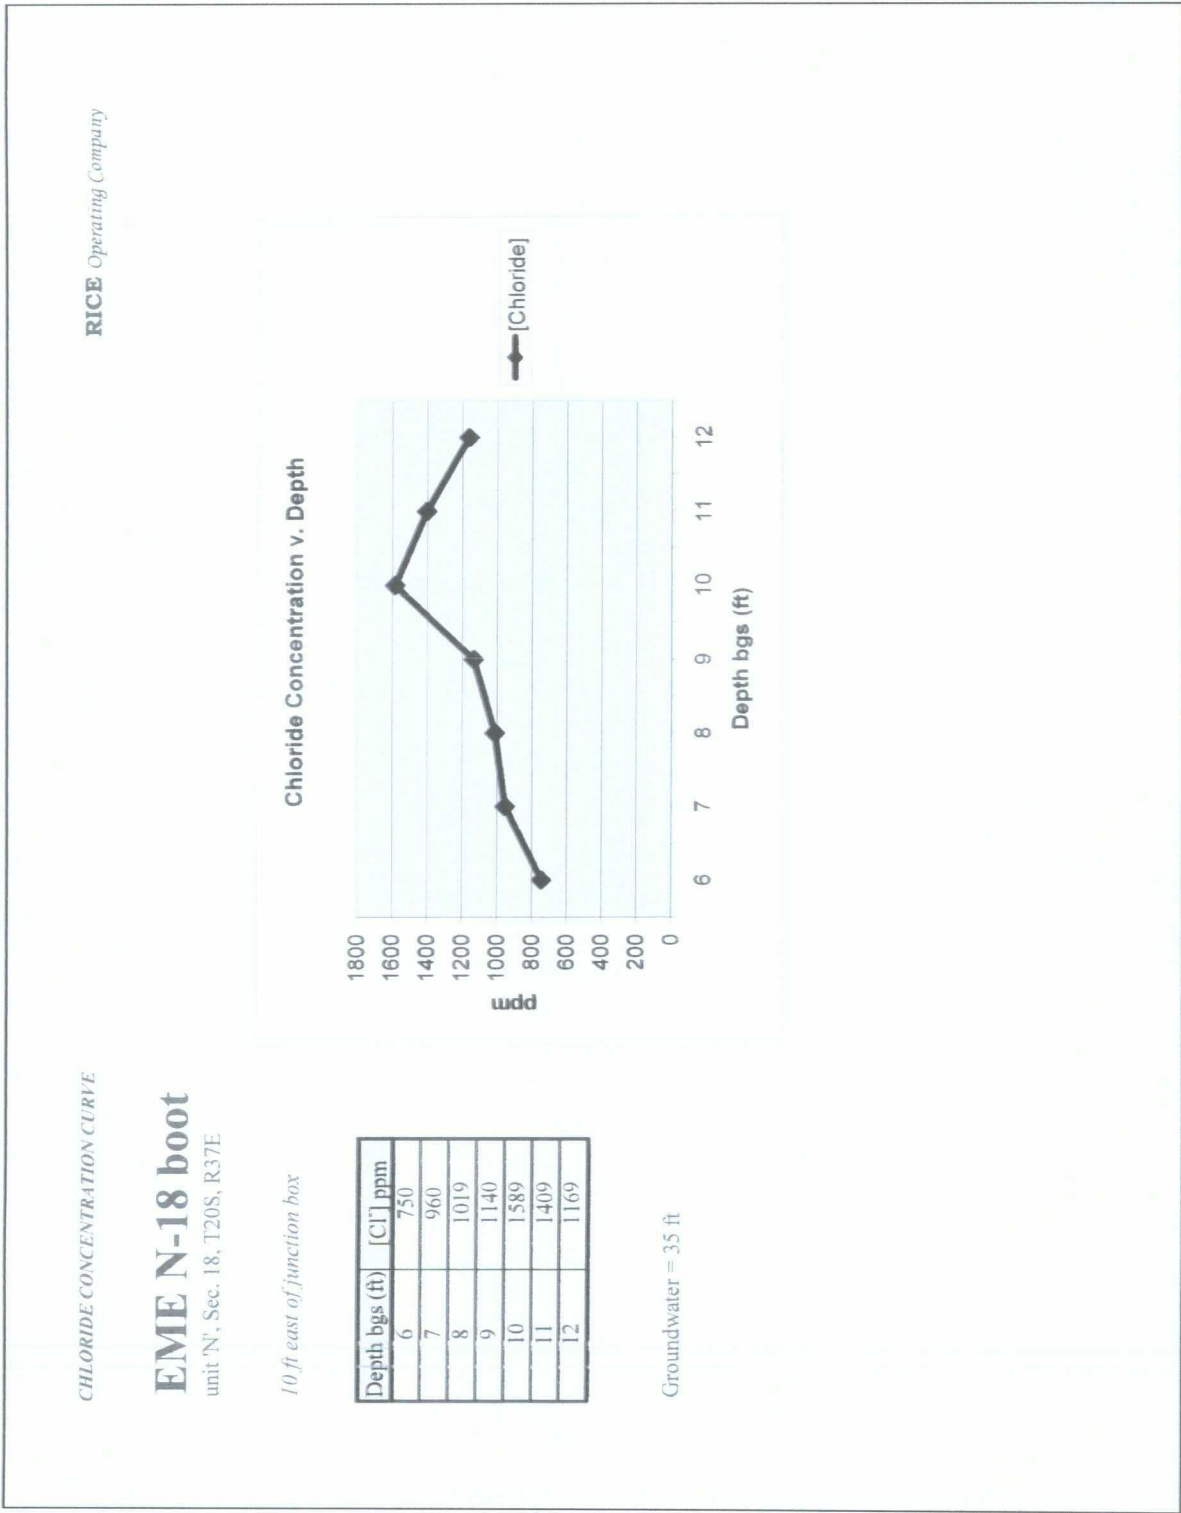
Chloride concentrations exceeded 1,000 ppm adjacent to the former junction box at 12 ft bgs (Figure 4). Insignificant concentrations (< 100 ppm) of gasoline (GRO) and diesel range organics (DRO) were encountered in the excavated soil and in the sidewalls and bottom of the excavation (Figure 5). Petroleum hydrocarbons were therefore ruled out as a potential constituent of concern. Photographs before, during and after junction box removal are given in Figures 6 through 10.

Figure 4 – Soil chloride concentrations adjacent to (10 east of) former junction box.

ROC proposes additional investigative work to determine if there is the potential for groundwater degradation from residual soil chlorides, which are the constituent of concern, as outlined below.

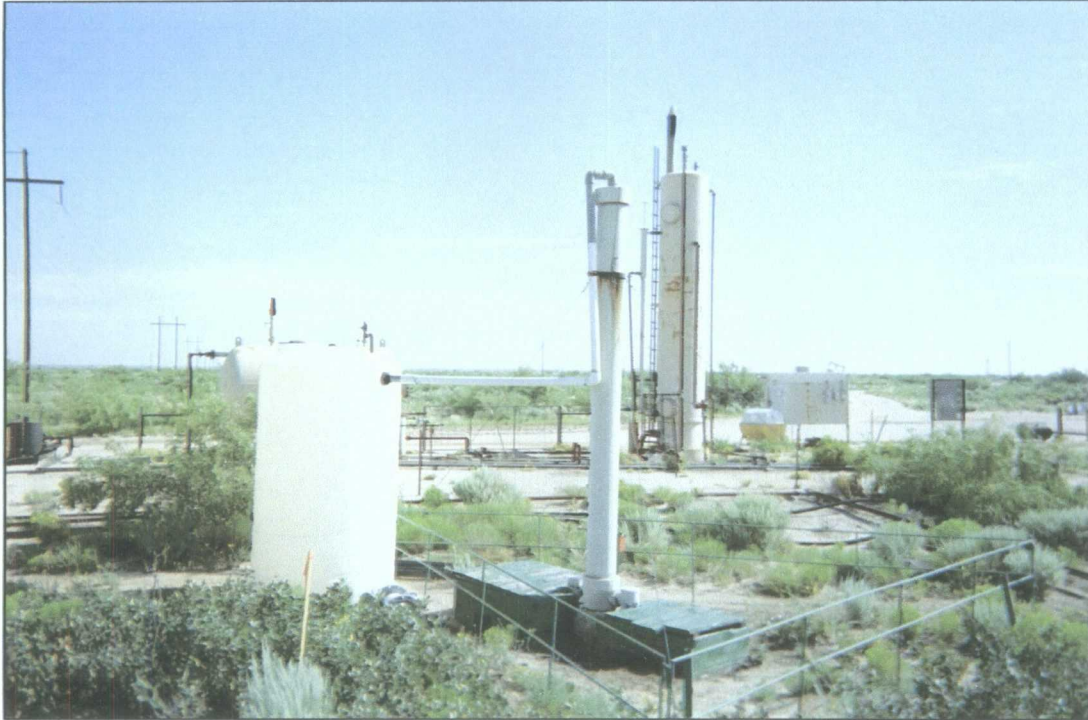
General Description of Remedial Action: This junction box contained a leak and was located directly south of an active production battery. The junction was eliminated and re-plumbed with a new poly pipeline. The box lumper was removed and the site was decontaminated using a backhoe while PPE screenings and chloride field tests were conducted at regular intervals. Chloride concentrations increased with depth to 12 ft RGS. PID readings were generally minimal and lab results revealed TPH concentrations well below NMOC guidelines. Chloride impact was concentrated in a small area directly to the east of the junction. This remedial action from the 20 ft x 22 ft x 12 ft deep excavation was decontaminated and then backfilled up to 12 ft RGS. A 6 ft x 1-ft-thick composite clay barrier was installed to inhibit further downward chloride migration. The remaining spoils were backfilled on top of the clay and contained to the surrounding surface. The disturbed surface was seeded with a blend of native vegetation on 10/16/2004 and an identification plate was placed on the surface to mark the junction site for future environmental considerations and the clay barrier below. NMOC has been notified of potential groundwater impacts at this site.

Figure 6 – Former junction box before removal.

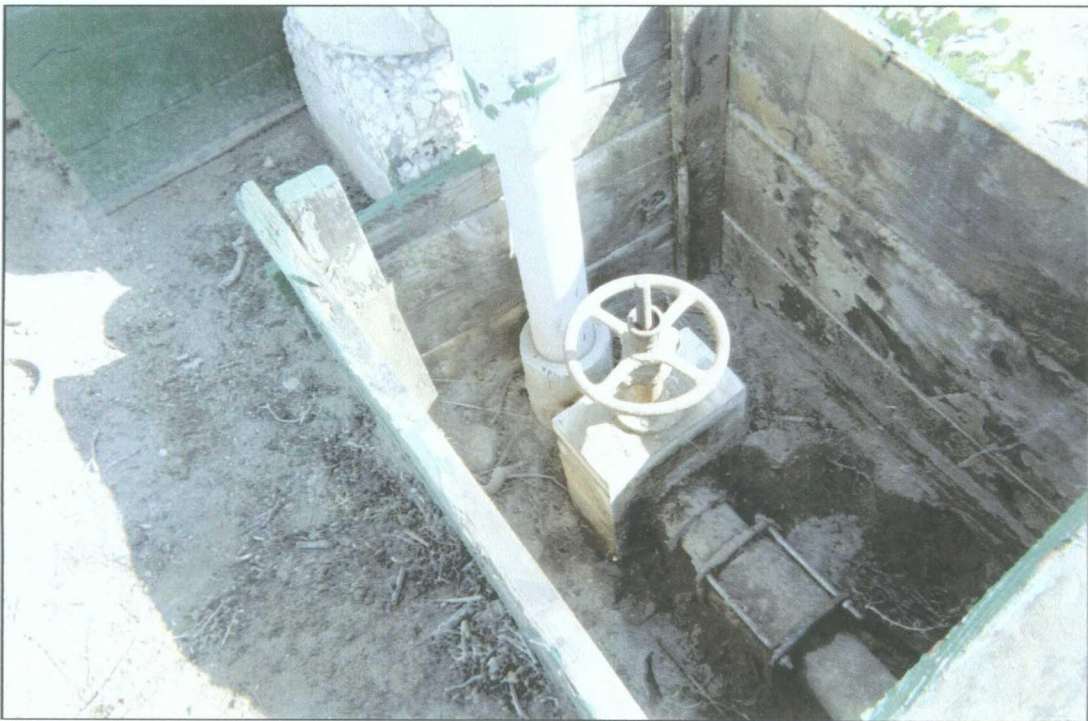
Figure 7 – Former junction box before removal, close-up view.

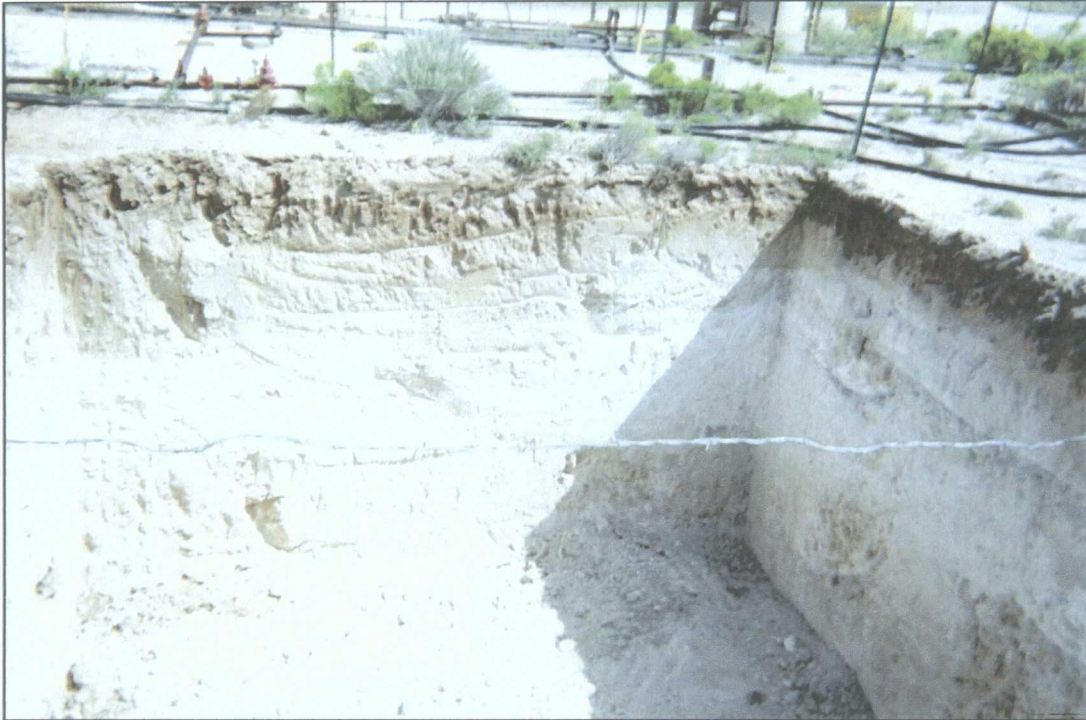
Figure 8 – Excavation following removal of former junction box.

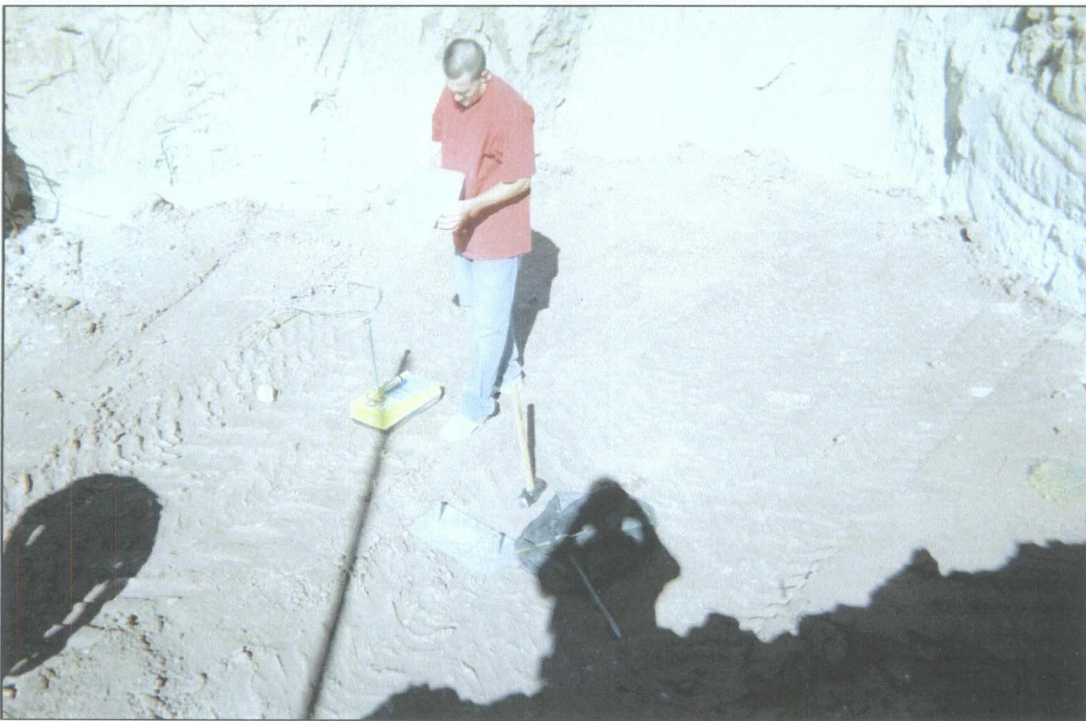
Figure 9 – Compaction testing of installed clay barrier.

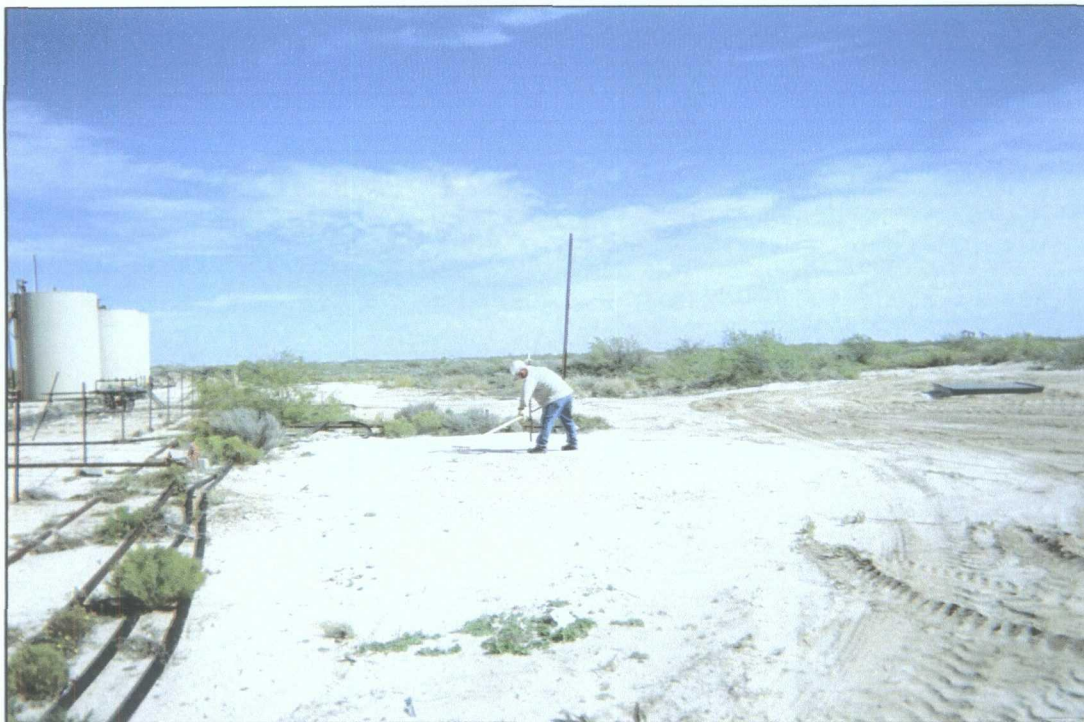
Figure 10 – Raking and seeding of reclaimed site.
