Release Notification and Corrective Action

Name of Company Occidental Permian Limited Partnership	Contact Steven M. Bishop	
Address 1017 West Stanolind Road, Hobbs, N.M. 88240	Telephone No. (575) 397-8251	
Facility Name South Hobbs Unit #209	Facility Type Production	
Surface Owner Mr. Dee A. Cochran	Mineral Owner	Lease No. API 30-025-29522

RE: Remediation Plan
South Hobbs Unit #209 3" Fiberglass Injection Line
UL 'C', Sec. 8, T-19-S, R-38-E

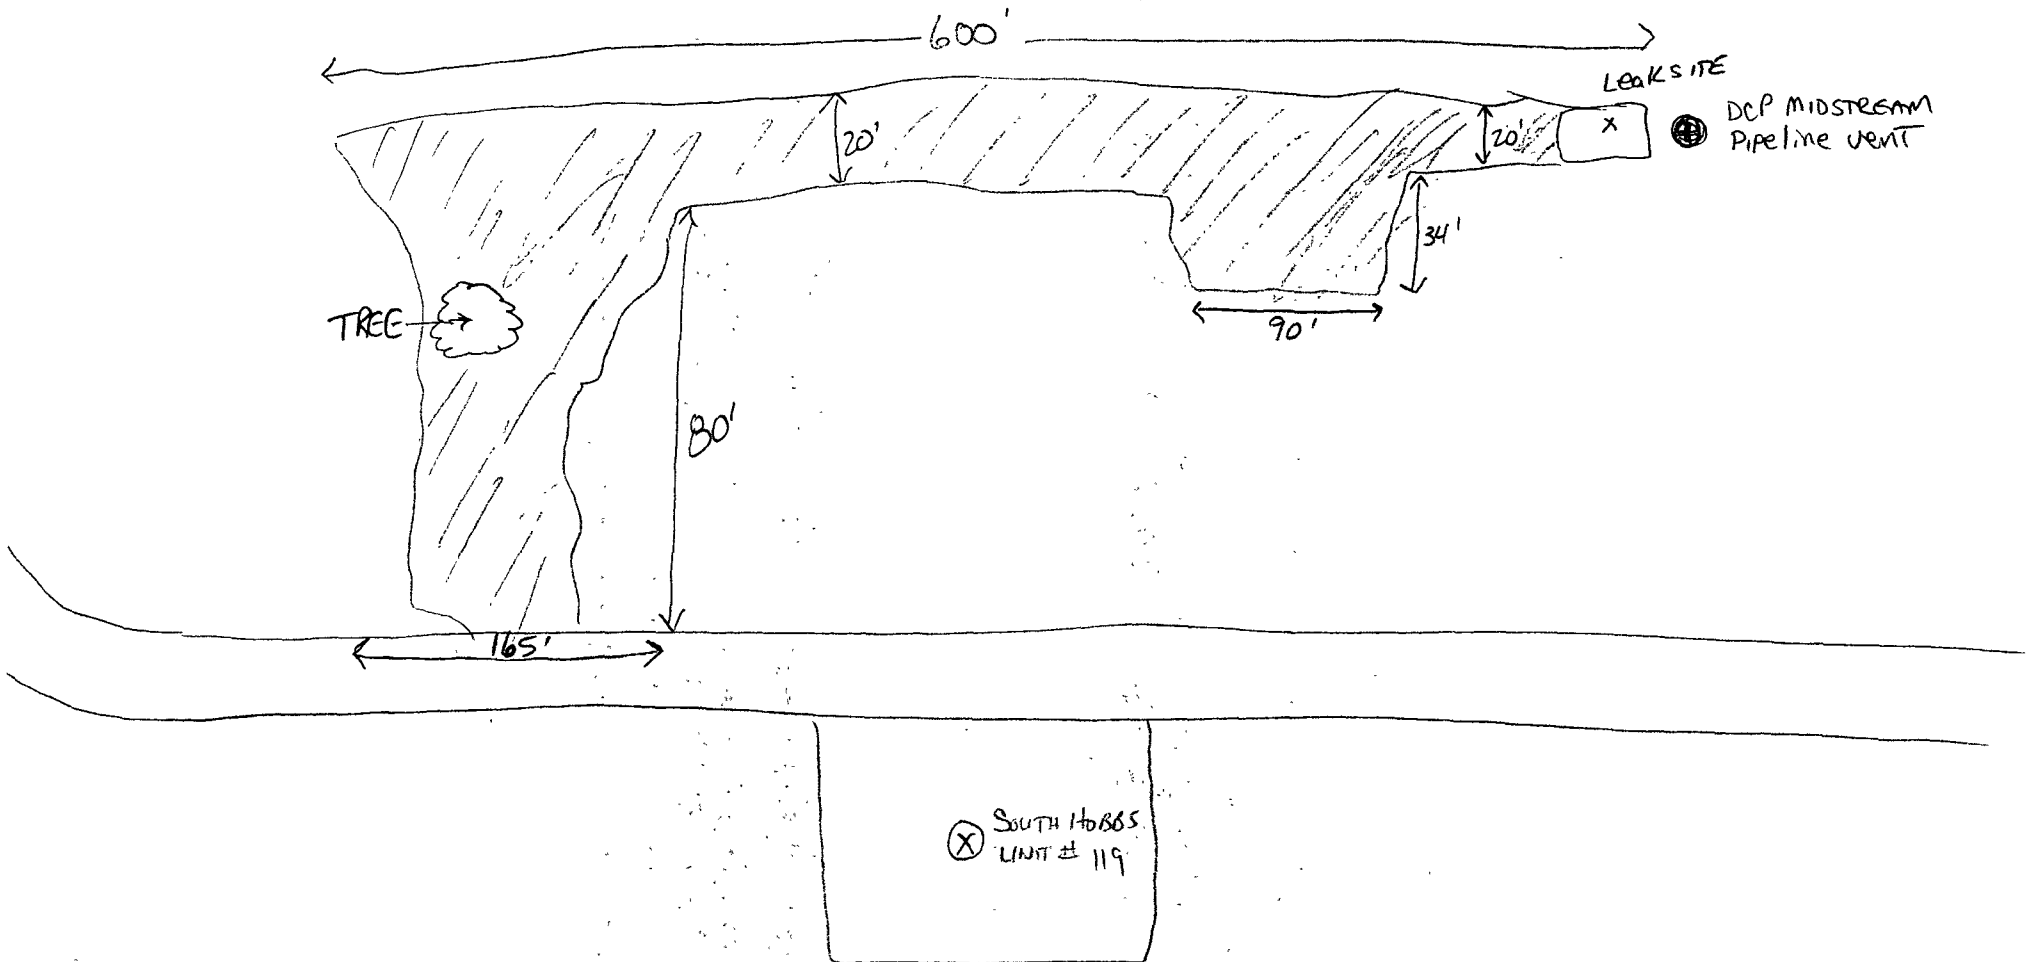
SPILL MAP

Describe Cause of Problem and Remedial Action Taken.* ☐ Landowner discovered a leak just north east of South Hobbs Unit Well #119. Landowner originally called DCP Midstream since it was by a DCP blow down. Oxy operators were called Monday 08/25/2008 evening to see if Oxy had lines close. Operators discovered the line went to South Hobbs Unit Well #209. Operators shut valves on injection header inside building #9 going to South Hobbs Unit Injection Well #209, and wellhead valves to contain leak. The well was not taking water at the time so leak occurred due to an automated valve at the header leaking. Valves were shut before and after the automated valve.

Describe Area Affected and Cleanup Action Taken.* ☐ Spilled fluid ran approximately 600' to the west of DCP blow down along a pipeline right of way. Fluid ran across grassy pasture and accumulated at the west end 600' away from the leak site. For the most part the area is 20' wide and 600' long but accumulated in a couple of areas. No fluid was recovered. Area will be remediated to NMOCD spill guidelines.

08/25/2008 SHU #209 INJ LINE LEAK. 3" FIBERGLASS

1. Piping will be excavated and repaired.
2. Affected area will be excavated and soil will be disposed of at Sundance Services, Parabo Faciltiy near Eunice, NM.
3. Soil samples will be gathered from affected area.
4. NMOCD guidelines will be used to insure the site is in compliance with guidelines.
5. Any soils removed will be replaced with clean fresh soils, where needed.
