Release Notification and Corrective Action

Big Kick #1 Tank Battery

Spill Remediation Report

Phoenix Environmental, LLC.

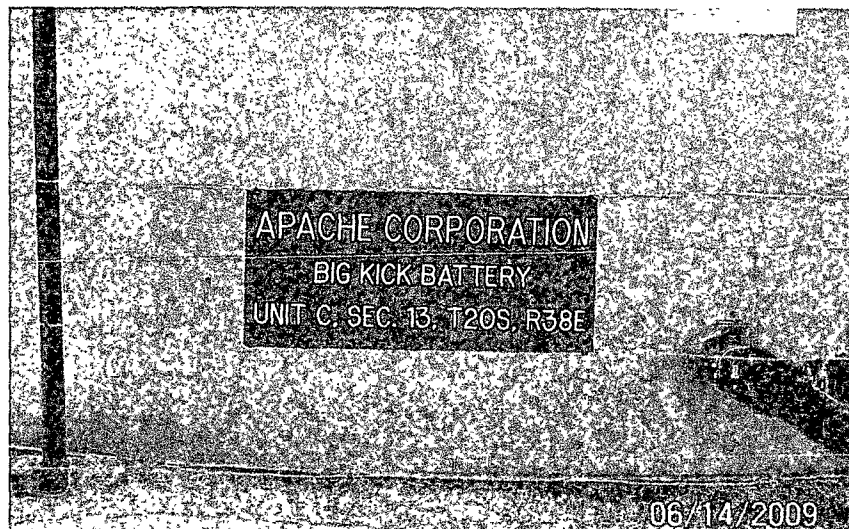
Photo #1 Beginning View of Spill Site

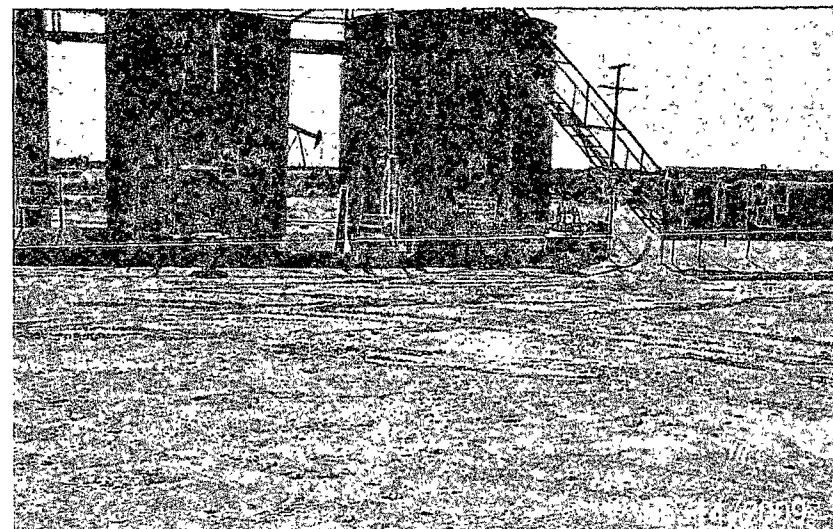
Photo #2 Beginning View of Spill Site

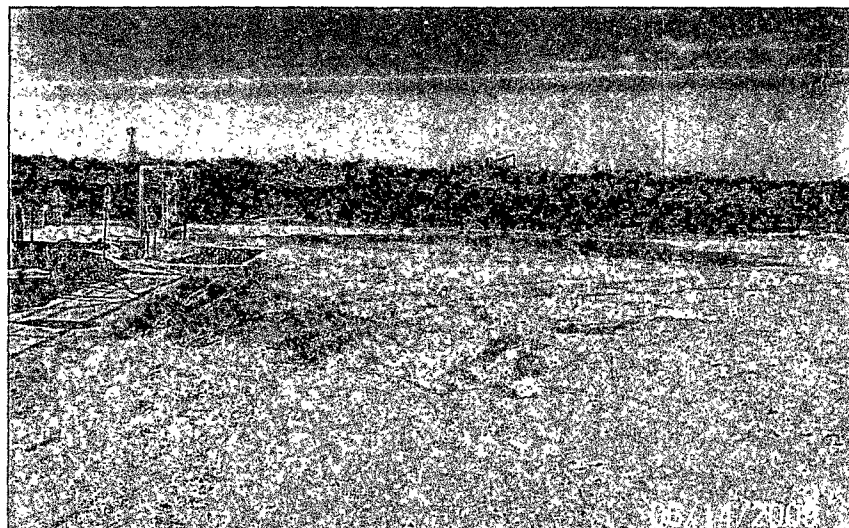
Photo #3 Beginning View of Spill Site

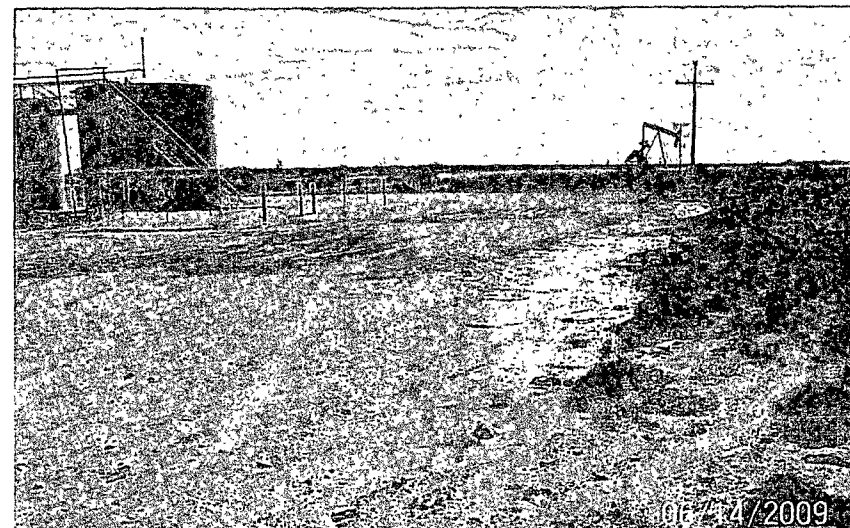
Photo #4 Beginning View of Spill Site

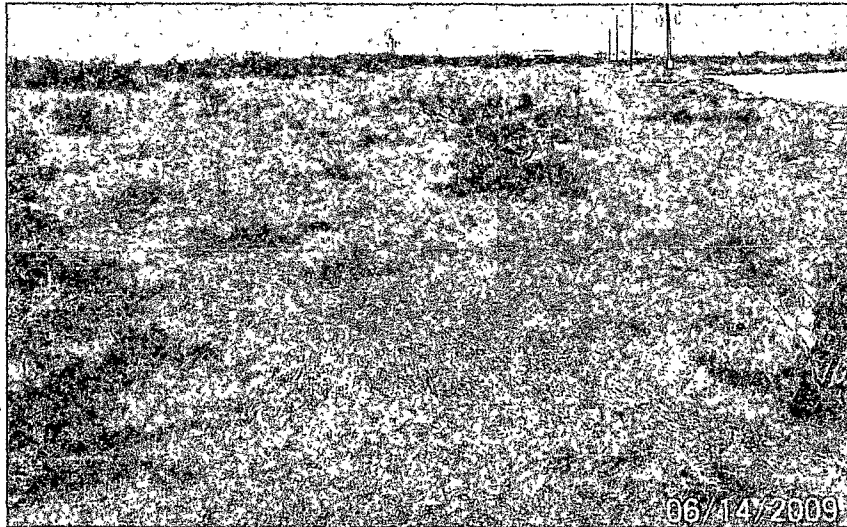
Photo # 5 Beginning View of Spill Site (Pasture)

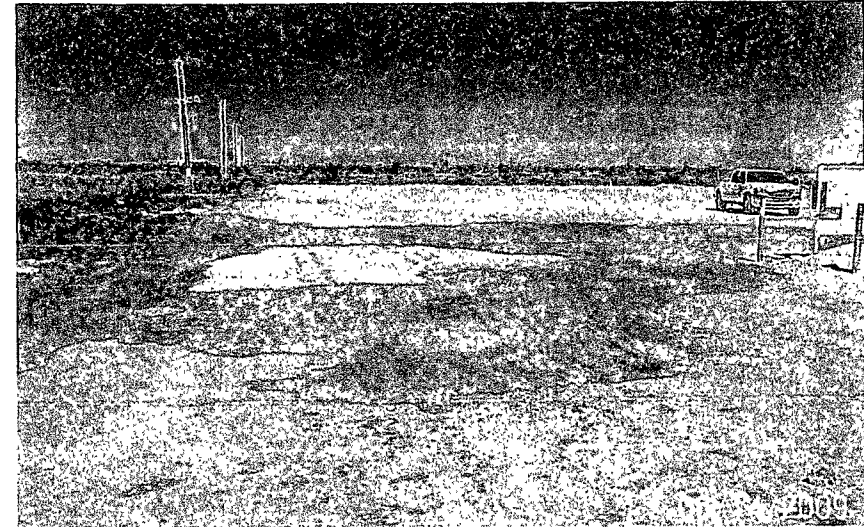
Photo #6 Beginning View of Spill Site (Road)

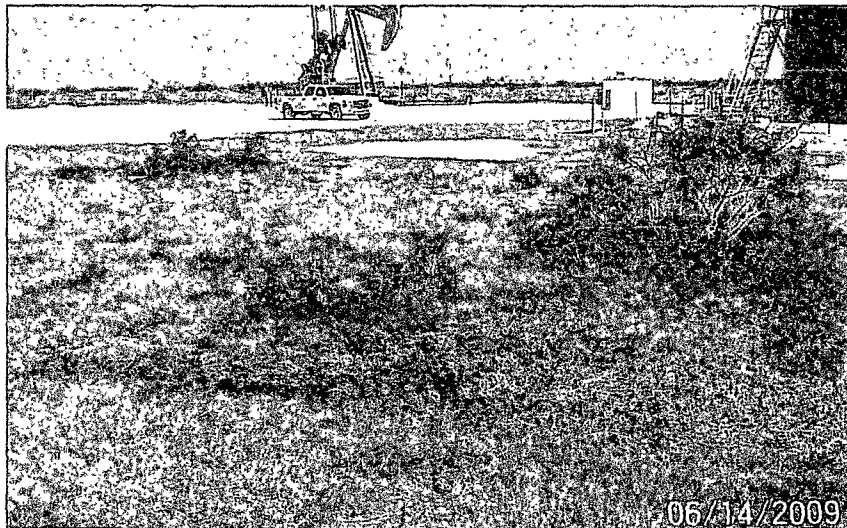
Photo #7 Beginning View of Spill Site (Pasture)

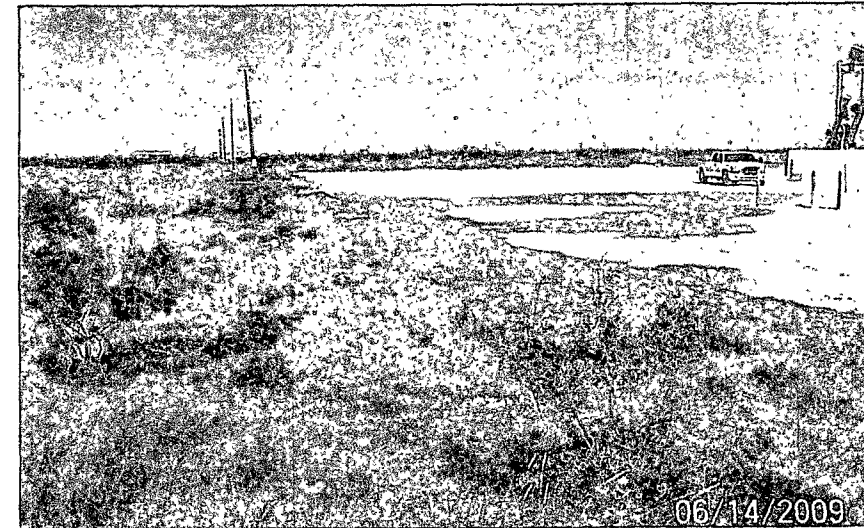
Photo #8 Beginning View of Spill Site

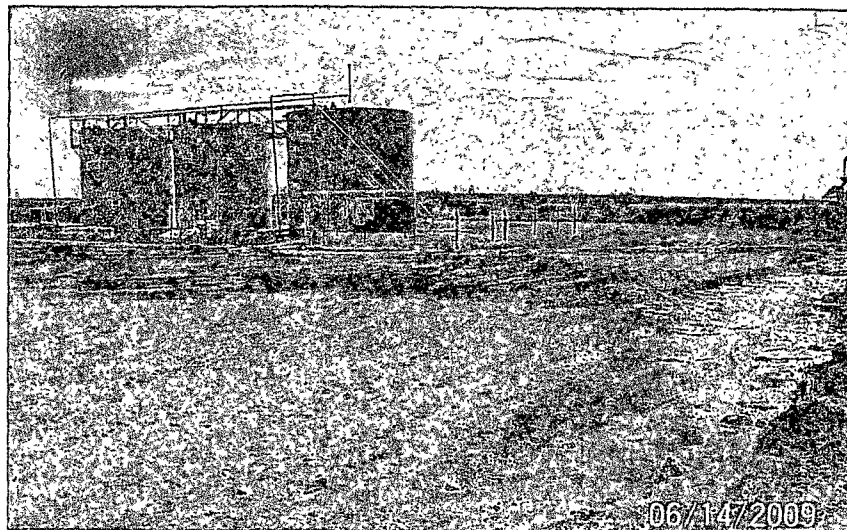
Photo #9 Beginning View of Spill

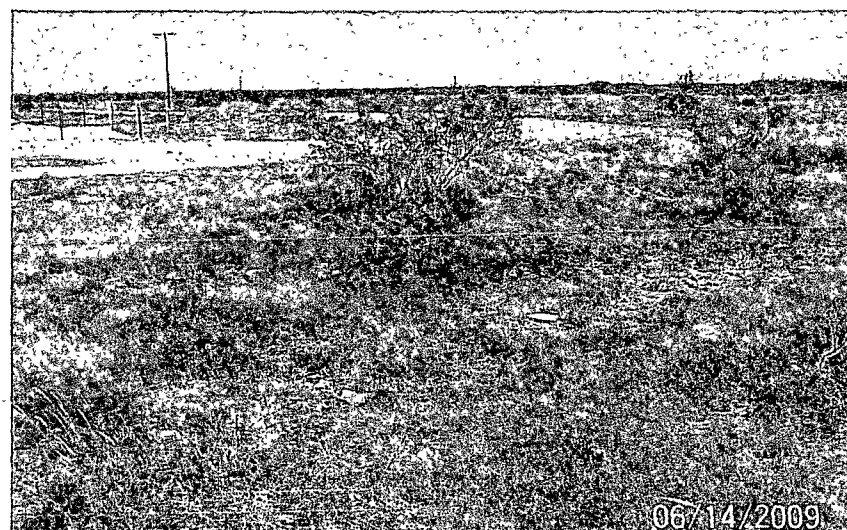
Photo #10 Beginning View of Spill (Pasture)

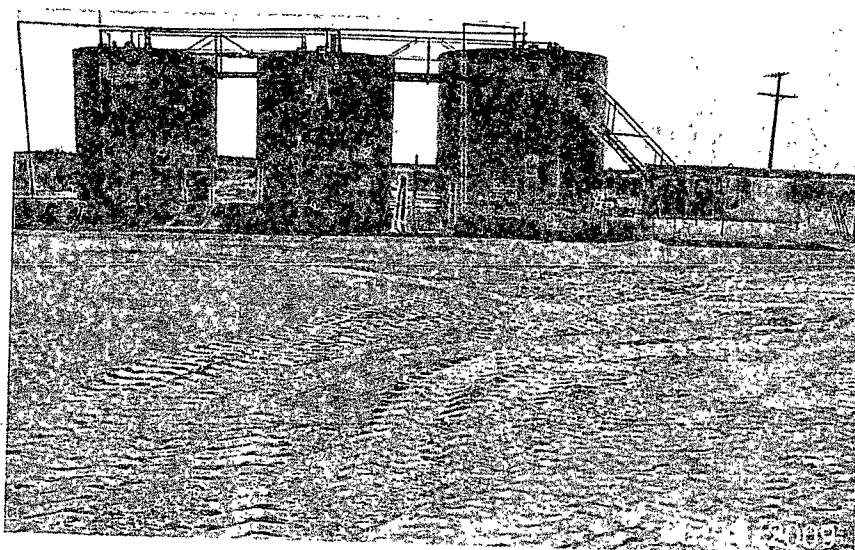
Photo #37 Final View of Spill Remediation

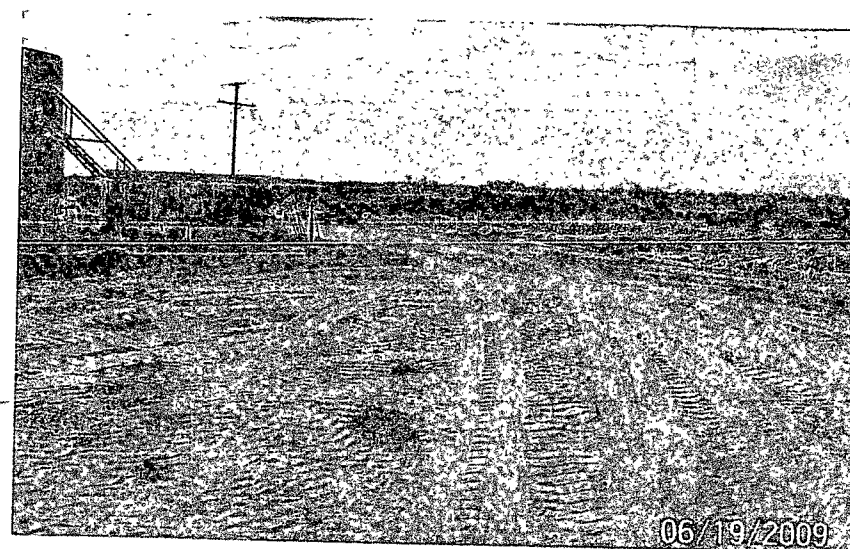
Photo #38 Final View of Spill Remediation

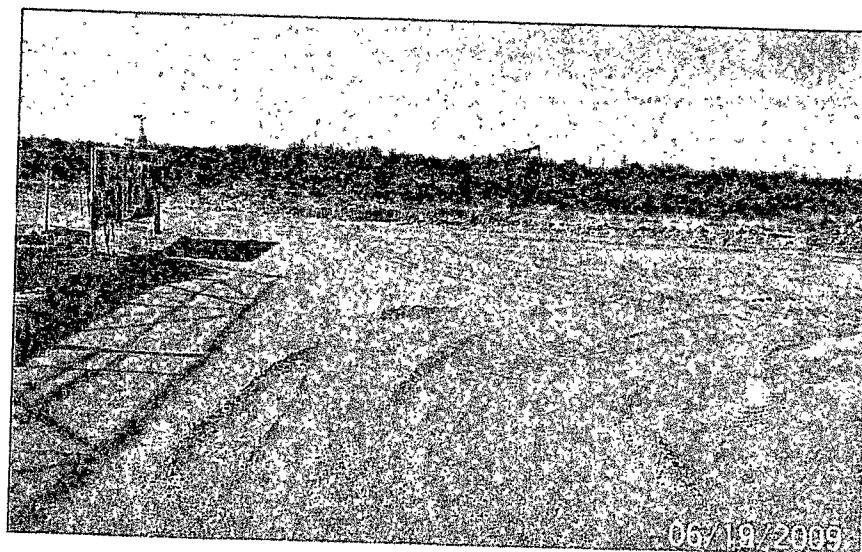
Photo #39 Final View of Spill Remediation

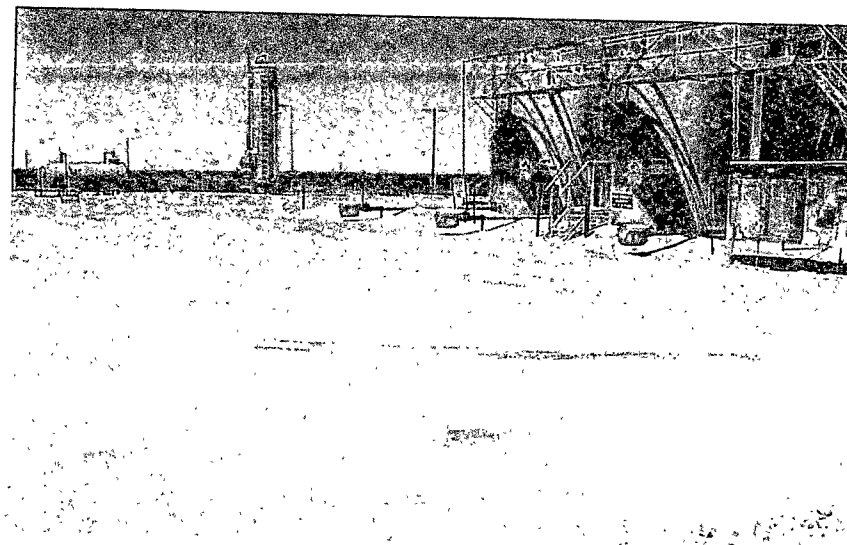
Photo #40 Final View of Spill Remediation

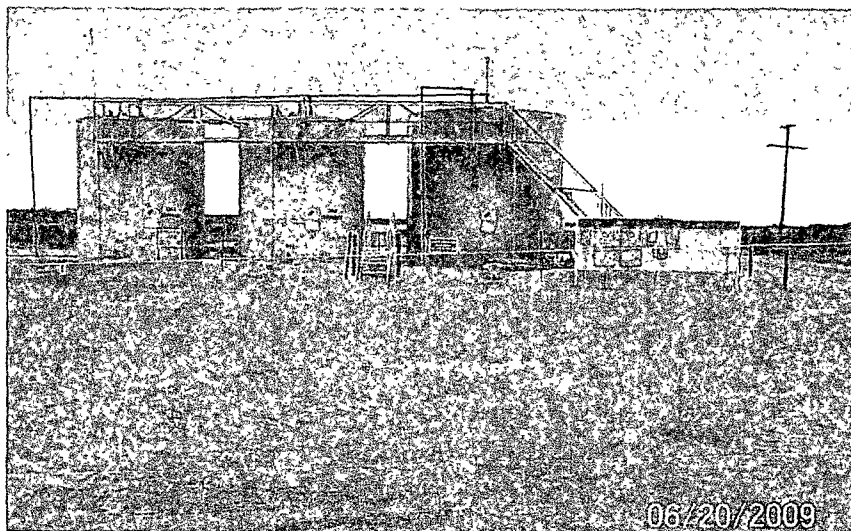
Photo #41 Final View of Spill Remediation

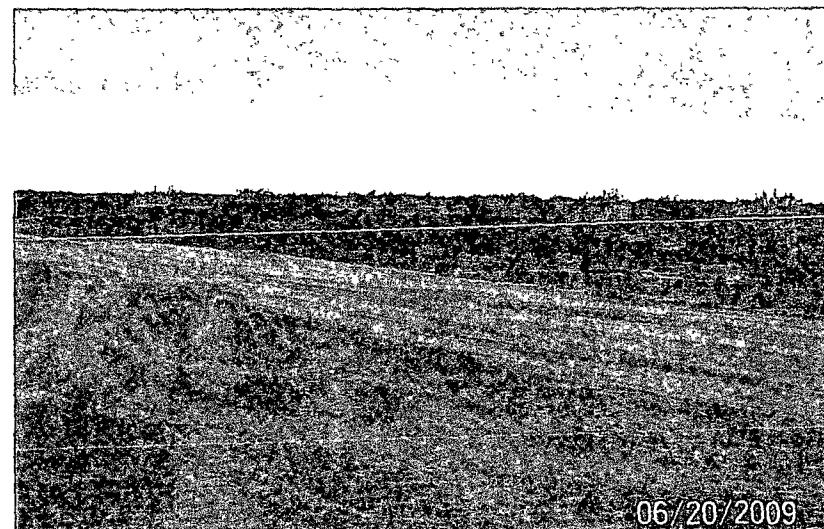
Photo #42 Final View of Spill Remediation

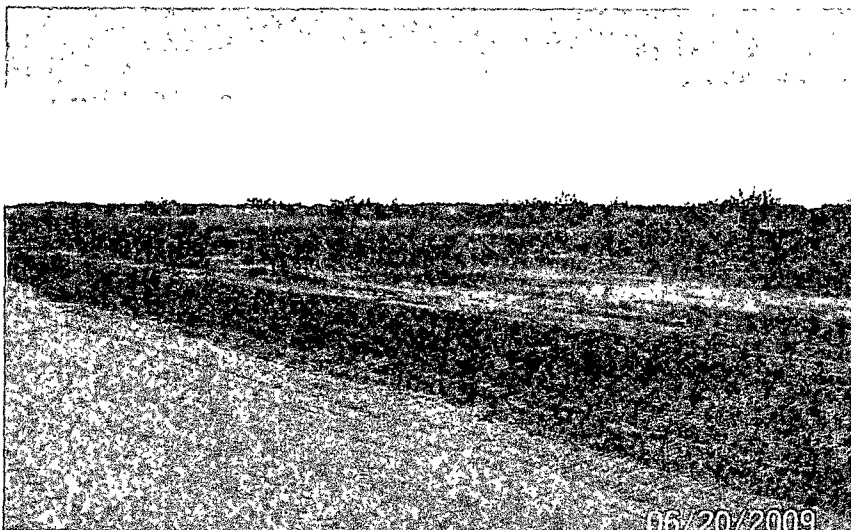
Photo #43 Final View of Spill Remediation

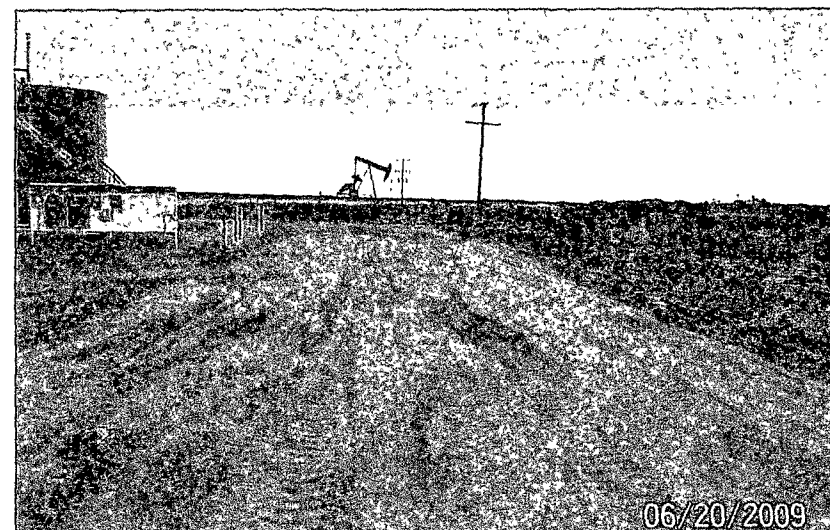
Photo #44 Final View of Spill Remediation

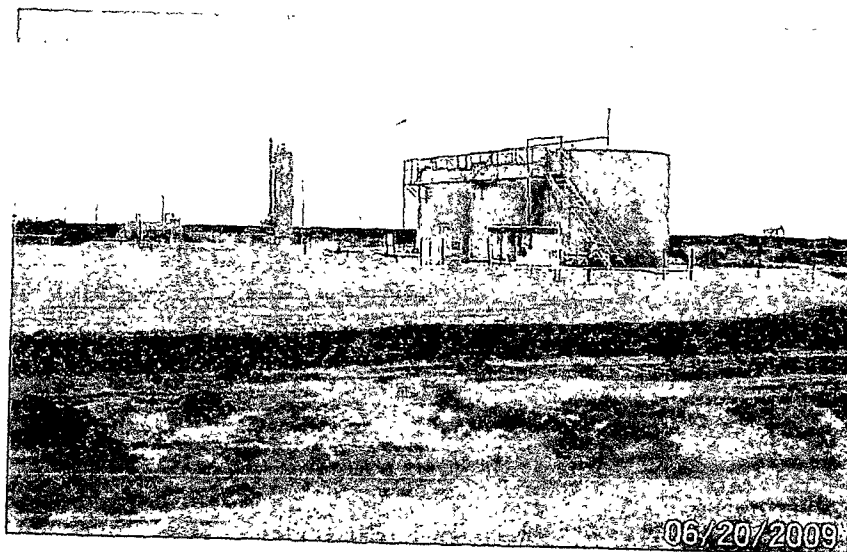
Photo #45 Final View of Spill Remediation

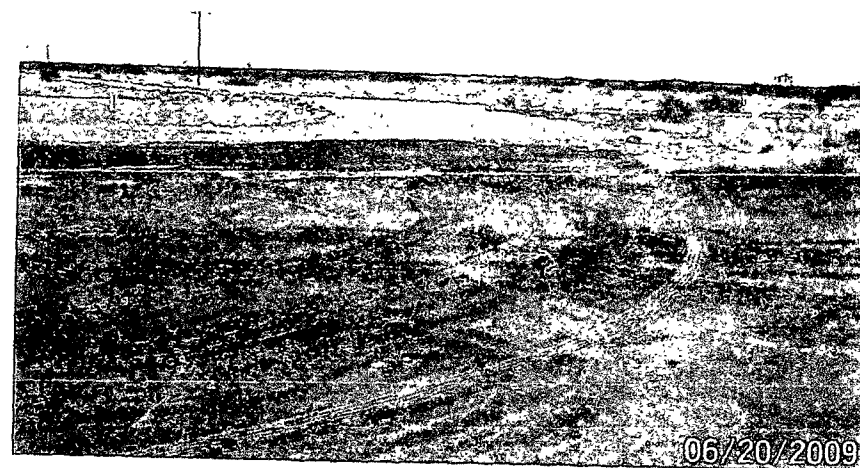
Photo #46 Final View of Spill Remediation

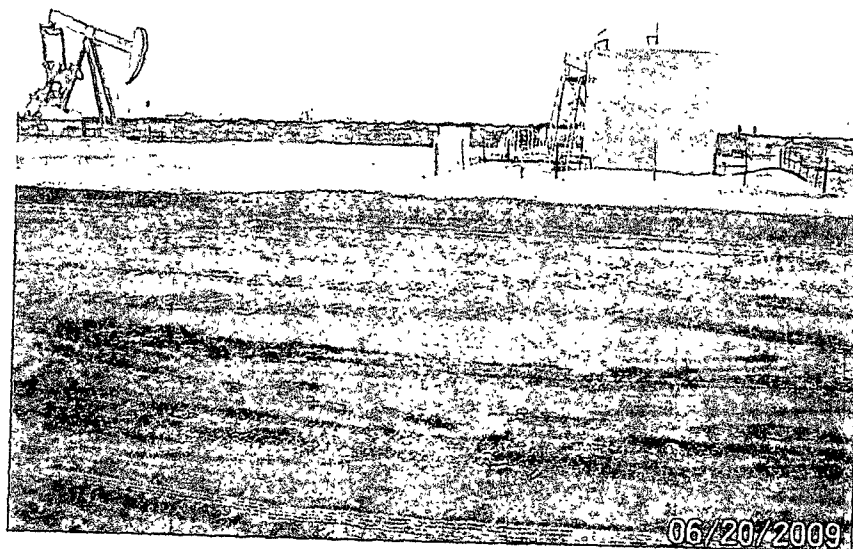
Photo #47 Final View of Spill Remediation

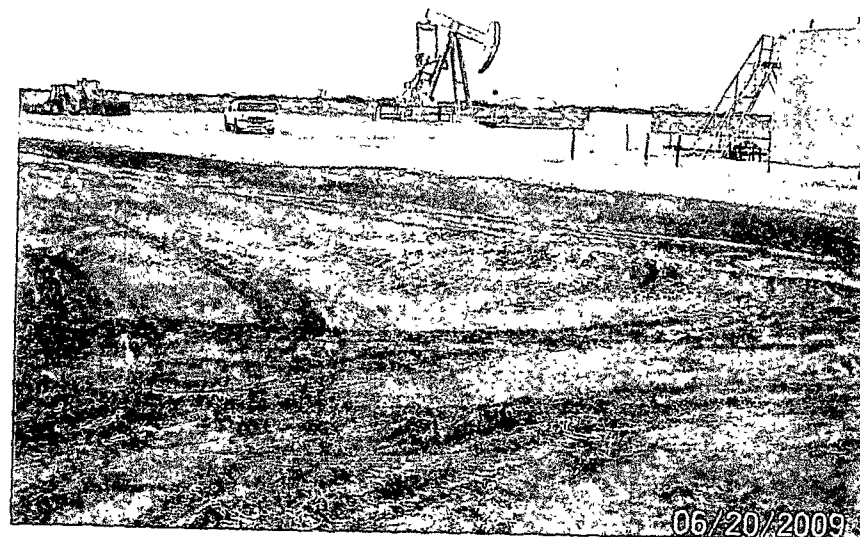
Photo #48 Final View of Spill Remediation
