WORKPLANS

RE: Investigation and Characterization Plan Rice Operating Company – EME SWD System EME N-18 <u>Junction</u>: UL N Sec 18 T 20S R 37E

Rice Operating Company - EME N-18 Junction

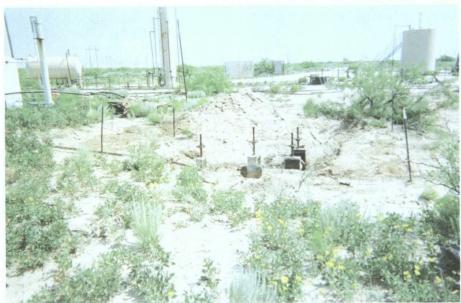
ROC removed a wooden junction box at this location in August of 2004 as part of its facility maintenance and upgrade program. (See Figure 2: Rice Junction Box Disclosure Report). As the original wood junction box was removed soils were sampled using a backhoe, creating a 35 by 25 by 12 ft deep excavation (Figures 3 & 4). The excavated soils were blended and then backfilled into the excavation to a depth of 6 ft bgs where a one foot thick compacted clay barrier was installed (Figure 5). The remaining excavated soil material was backfilled into the excavation above the clay barrier to the existing ground surface (Figure 6). The disturbed surface was then seeded with a native vegetation mix (Figure 7).

Figure 3 – Initial excavation during replacement of junction box at EME N-18.

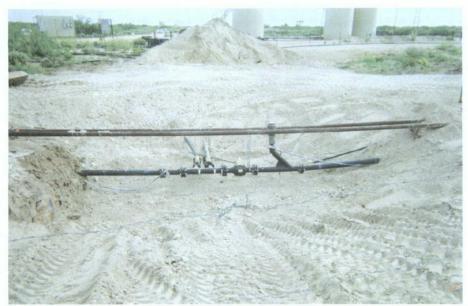
Figure 4 – Excavation of former junction box at EME N-18.

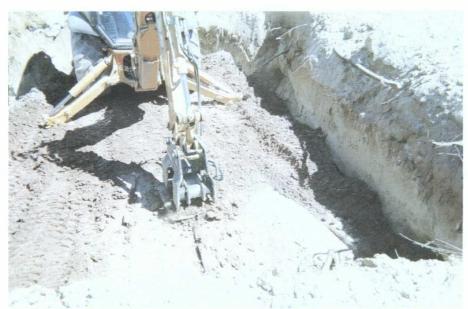
It should be noted that there is no longer a threat of continued, compounded impact at this site as the former junction box has been removed and a clay barrier installed to impede the downward migration of chlorides.

Figure 5 – Installation of subsurface clay barrier at EME N-18 Jct.

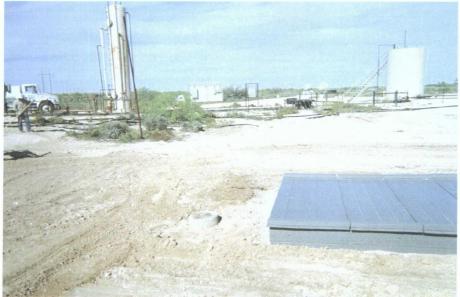
Figure 6 – New/replacement junction box at EME N-18.

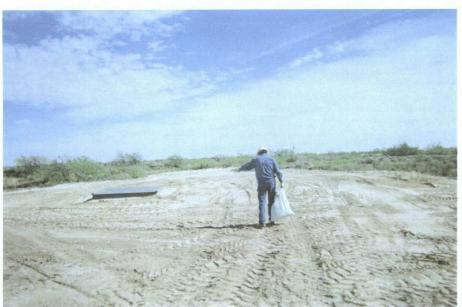
Figure 7 – Seed of surface w/ native vegetation mix at EME N-19 Junction.
