COG - RJU #119 Work Plan

October 6, 2009

Re: Work Plan for the COG Operating LLC., RJU Unit #119, Injection line leak, Unit P, Section 27, Township 17 South, Range 29 East, Eddy County, New Mexico.

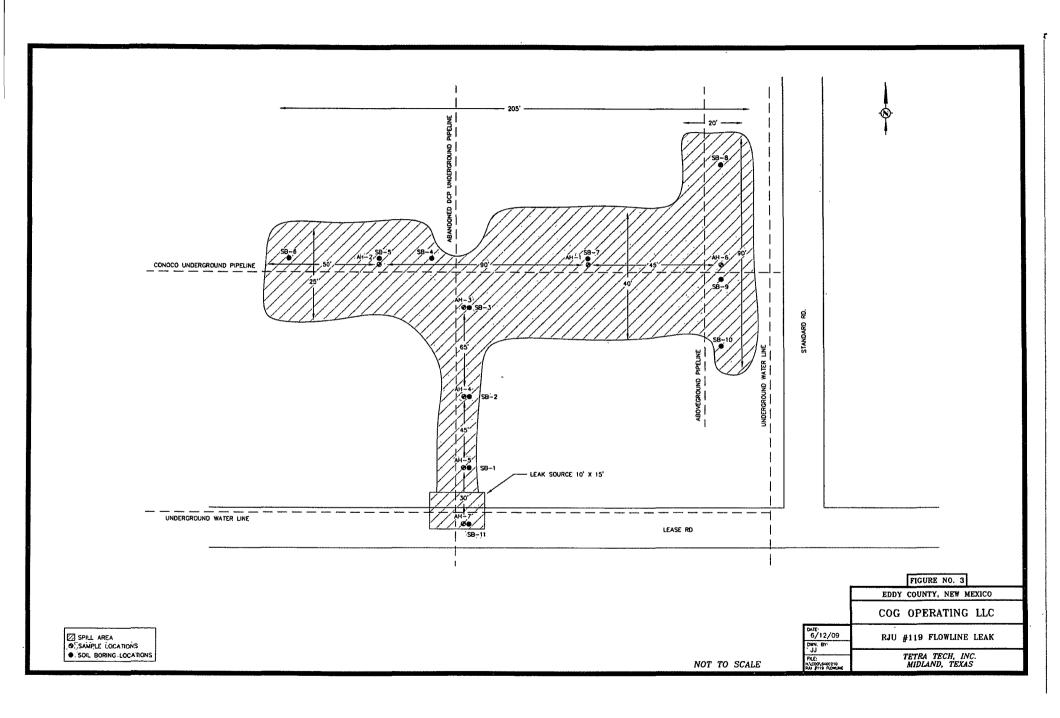
Analytical results indicate the maximum extent of chloride impact greater than 1,000 mg/kg extended from 11 feet (SB-2) to 30 feet (SB-1) bgs. All samples had chloride concentrations that decreased with depth. Borehole logs are included in Appendix C. Copies of laboratory analysis and chain-of-custody documentation are included in Appendix D. The results of the sampling are summarized in Table 1. The borehole and auger hole locations are shown on Figure 3.
