TETRA TECH

October 6, 2009

**Re: Work Plan for the COG Operating LLC., RJU #110, Unit I, Section 27,
Township 17 South, Range 29 East, Eddy County, New Mexico.**

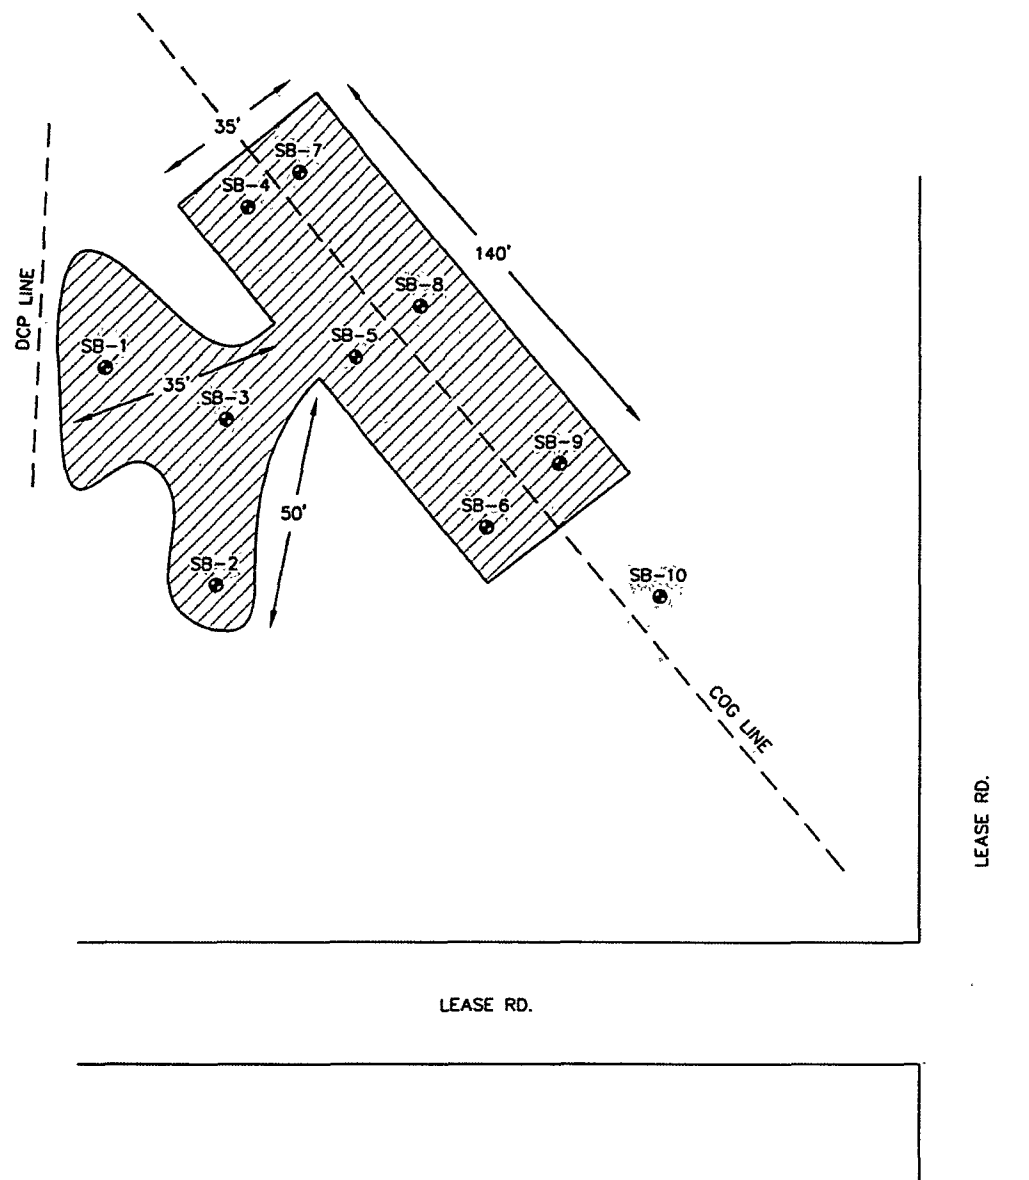
FIGURE NO. 3	
EDDY COUNTY, NEW MEXICO	
COG OPERATING LLC	
RJU UNIT #110	
TETRA TECH, INC. MIDLAND, TEXAS

On August 25, 2009, Tetra Tech personnel inspected the spill area, which measured approximately 35' x 140' along the COG pipeline and area southwest measuring approximately 35' x 50'. Prior to sampling, COG had excavated 1.0' to 2.0' of material from the site and hauled to proper disposal. In order to complete delineation of the chlorides, Tetra Tech personnel supervised the installation of ten (10) boreholes (SB-1 through SB-10) utilizing an air rotary rig. The borehole locations are shown on Figure 3.

Referring to Table 1, none of the selected samples exceeded the TPH and BTEX RRAL. Elevated chloride concentrations were detected in all of the auger holes, with the exception of SB-4 and SB-10. The chlorides concentrations declined with depth and declined below 1,000 mg/kg at depths ranging 10.0' to 30.0' below surface.
