**Release Notification and Corrective Action**

Name: Range Resources	Contact: Brian Kindred
Address:	Telephone No. 575-602-1788
Facility Name: Grizzle B Battery	Facility Type: Battery

**LOCATION OF RELEASE** *NEARBY WELL GRIZZLE B #004*  
*30-025-26713-00-00*

Ran-11-006 site photos 6-9-11

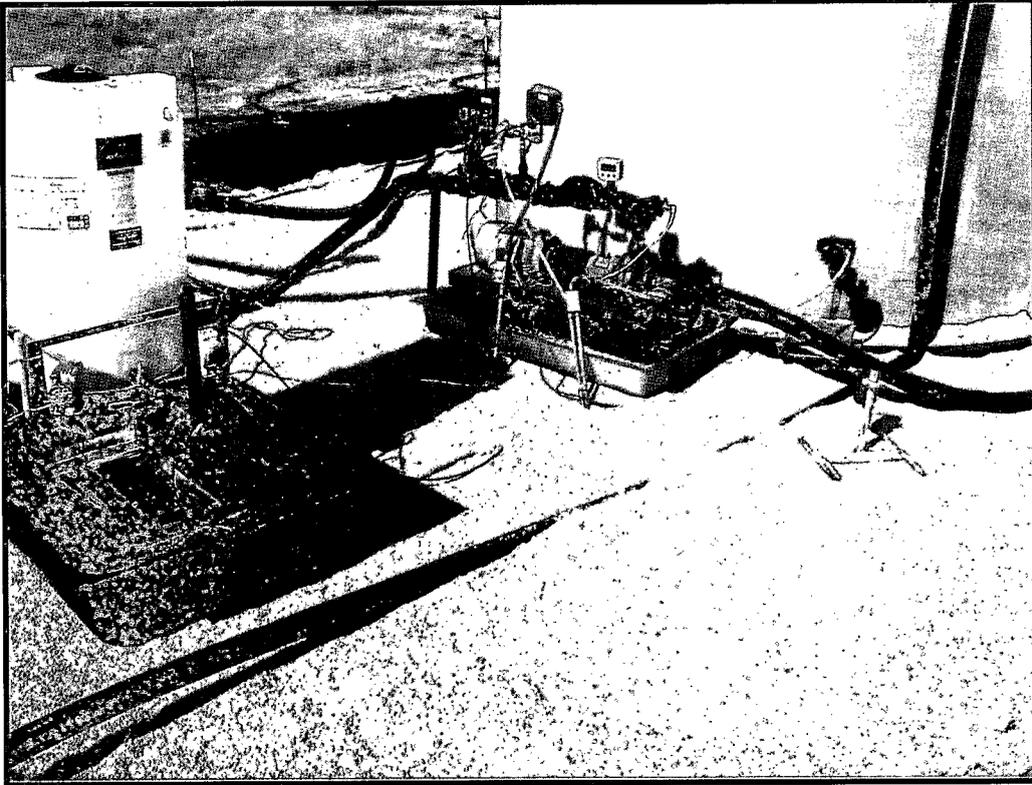
Battery location backfilled with gravel

Describe Area Affected and Cleanup Action Taken.\*  
Area inside lined berm was affected. SESI was onsite to assess site and once removal of all fluids. SESI recommends to remove gravel and take to disposal then add new gravel for backfill.

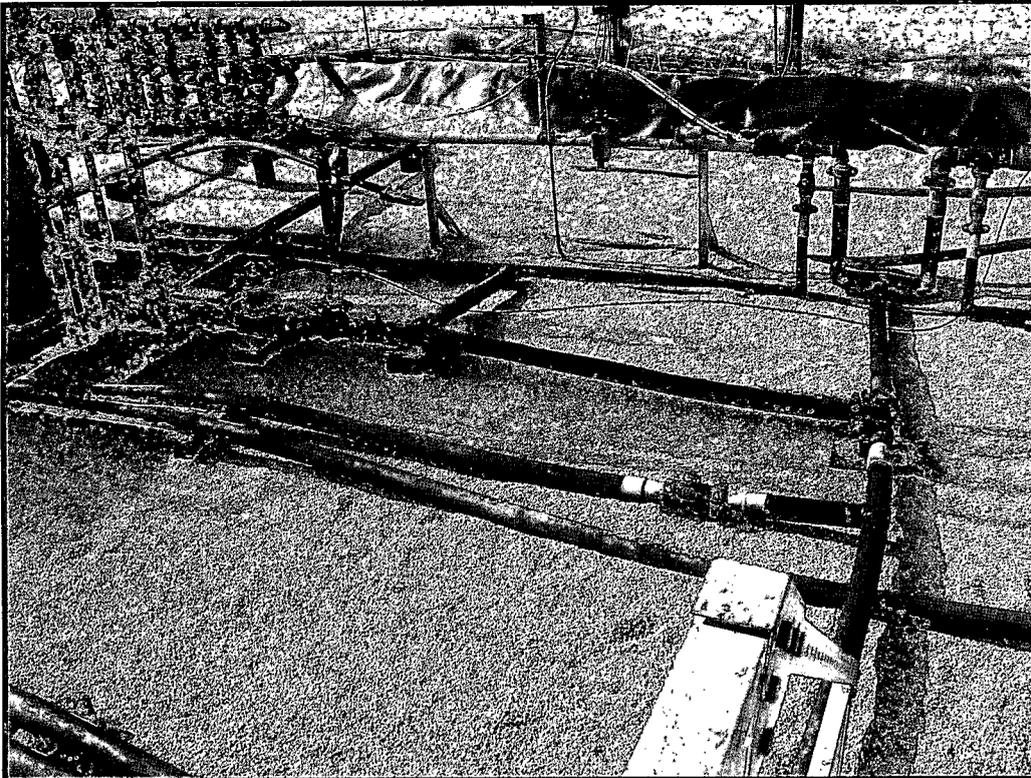
Battery location backfilled with gravel

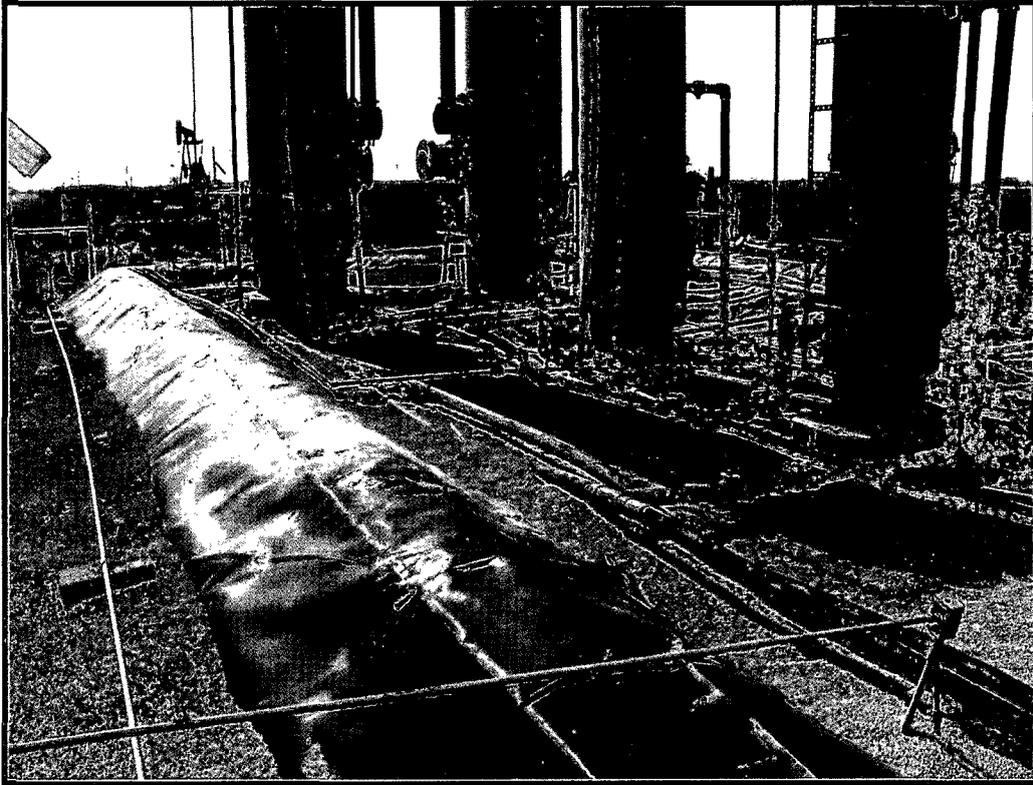
Battery location backfilled with gravel facing southeast
