**CHAPARRAL ENERGY, INC.**

**STAGE 1 ABATEMENT PLAN**

**SOUTH LANGLIE JAL UNIT**

**CONSISTING OF PORTIONS OF  
SECTIONS 7, 8, 17 & 18  
TOWNSHIP 25 SOUTH – RANGE 37 EAST  
LEA COUNTY, NEW MEXICO**

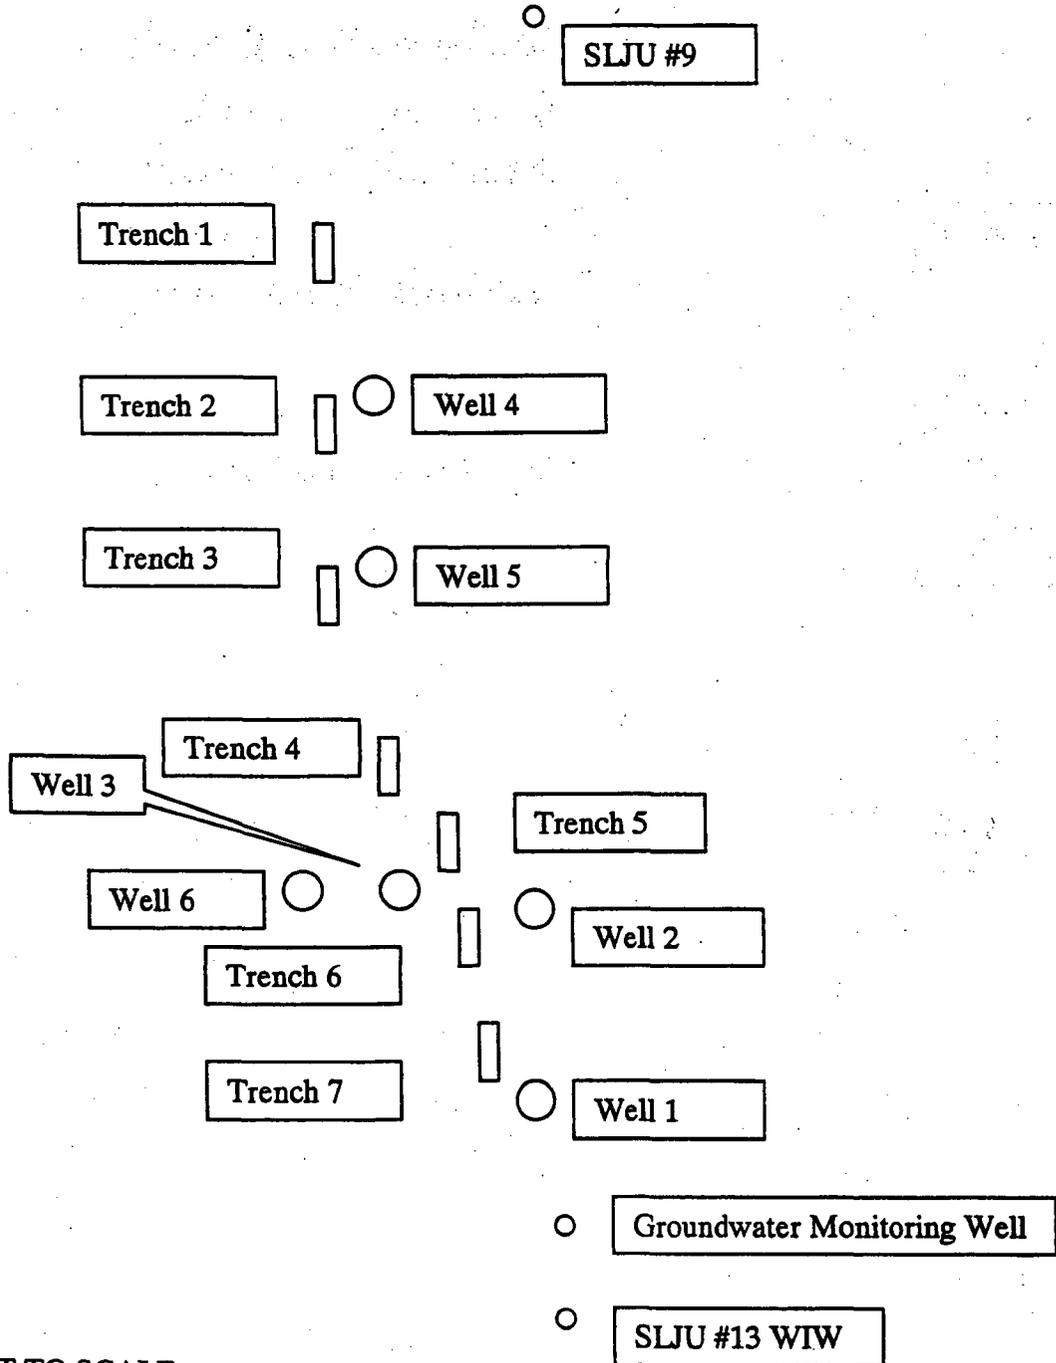
**Sampling Sites Along the Release of 10 January 1999  
Trenches and Bore Holes**

Starting on 18 January 1999, Cornerstone Environmental Resources, Inc. (hereinafter referred to as CERI), on behalf of Bristol, conducted a Phase II Environmental Assessment of the property. Trenches were dug along the path of the 10 January 1999 saltwater release between the SLJU #9 and the SLJU #13 WIW to the top of the first hard barrier (caliche) where liquids were thought to not be able to pass. Soil samples were taken in an attempt to ascertain the depth of damage due to brine from pipeline leaks or other sources. Sampling and testing showed some high chloride levels, however CERI stated it also indicated the damage done was either from earlier releases (prior to Bristol taking over operations of the unit), releases from off-site, or the presence of high chlorides could be naturally occurring. Talks were held with the NMOCD to determine the appropriate actions to be taken concerning these discoveries. The NMOCD directed Bristol to determine the source of the brine water and to perform vertical and horizontal delineation of the contamination by sampling for BTEX, TPH and Chlorides. (PHASE II ENVIRONMENTAL ASSESSMENT, South Langlie Jal Unit, Lea County, New Mexico, Not Dated, Cornerstone Environmental Resources, Inc.)

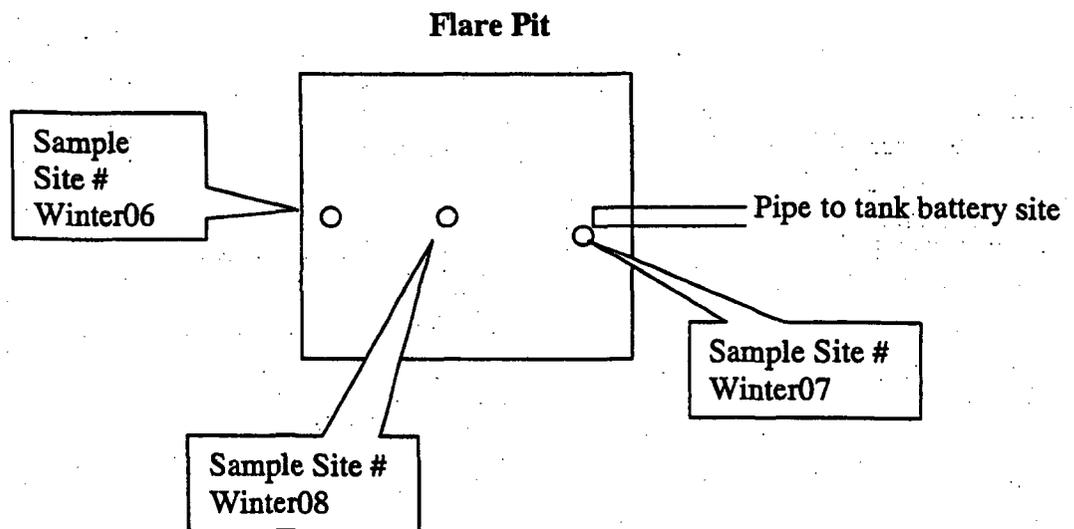
**Gutman Lease Abandon Tank Battery Flare Pit**

battery that served the plugged Gutman #2-18. No production vessels remain at this site. Soil material was found on top of a plastic tarp just west of the pit, indicating contaminated soil had been removed by parties unknown and allowed to bio-remediate in place.

Samples at Site 1 were analyzed and found to have TPH GRO of 23.1 mg/kg and TPH DRO of 13,900 mg/kg. No BTEX was detected. The positive test came from heavy, dried hydrocarbon contaminated soils that had been picked up and piled in the northeast corner of the tank battery pad. This soil reportedly can be dug up and hauled to a proper disposal facility in that it is not mobile hydrocarbon and does not appear to extend below ground level more than a few inches. Similar hydrocarbon deposits were found at Site 2 and again no BTEX was detected. Testing in 1999 (using EPA Method 8015 Modified) had detected TPH GRO of 1.55 mg/kg and TPH DRO of 4,160 mg/kg from this soil at the surface. Additional testing in June 2000, using EPA Method 418.1, detected TPH in the 8,000 to 8,800 mg/kg range at the surface. A surface sample at Site 3 showed TPH DRO of 24,300 mg/kg, but no BTEX or TPH GRO. Tests were also conducted on the soil that had been placed on the plastic tarp. BTEX, TPH DRO and TPH GRO were not detected. (See Appendix B.) However, TPH using EPA Method 418.1 did detect TPH of 8,700 mg/kg from this source. CERI recommended the top six inches of soil at each site be removed for off-site disposal and the pit backfilled with clean soil. Bristol and CERI felt that was all that would be necessary to bring these sites into full compliance with NMOCD regulations. (PHASE II ENVIRONMENTAL ASSESSMENT, South Langlie Jal Unit, Lea County, New Mexico, Not Dated, Cornerstone Environmental Resources, Inc.)
