FIELD REPORT

FILE NO A-45-A **PERMIT NO**

APPLICANT AmeriCulture Inc

SUBJECT Complaint of pink dye in water

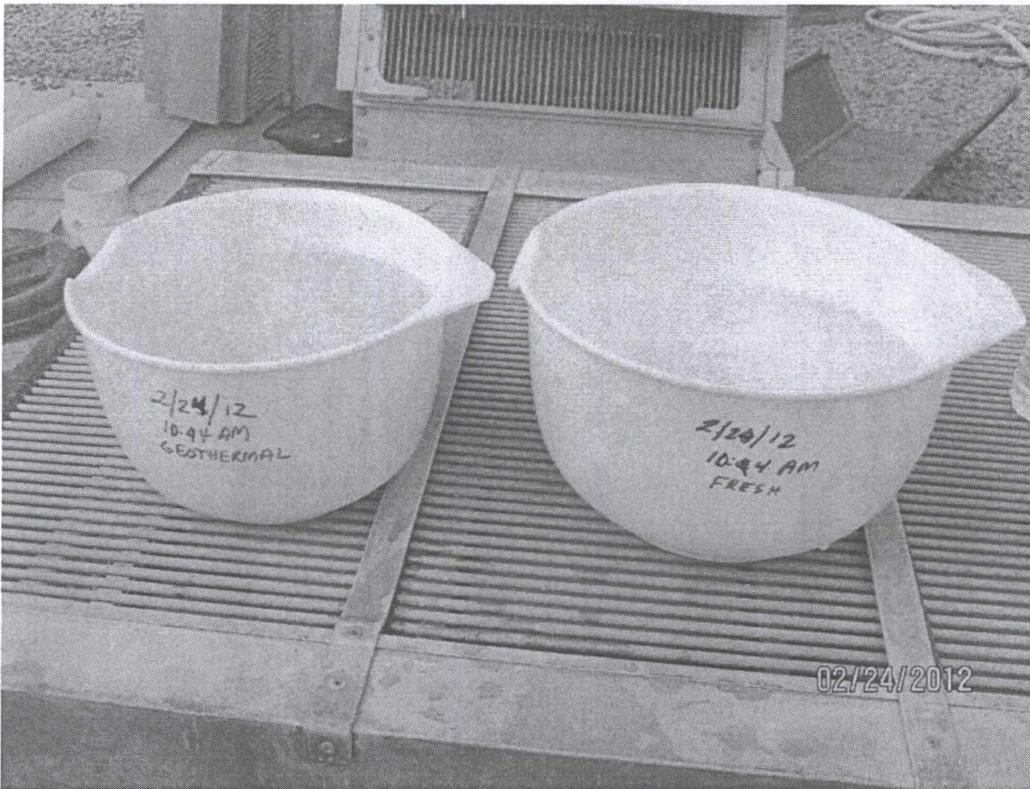
- Went to the fry barn to observe the complaint of the water being pink from the geothermal wells. Samples were taken from the geothermal source and the fresh (cold) water source. The water from the geothermal source was visibly tainted pink. The water from the fresh water source was not visibly tainted at this time. (The fresh (cold) water wells are located approx 1 mile to the west of the facility)

Fry Barn: 10:44 am sample of geothermal water and fresh water, geothermal water has pink tint

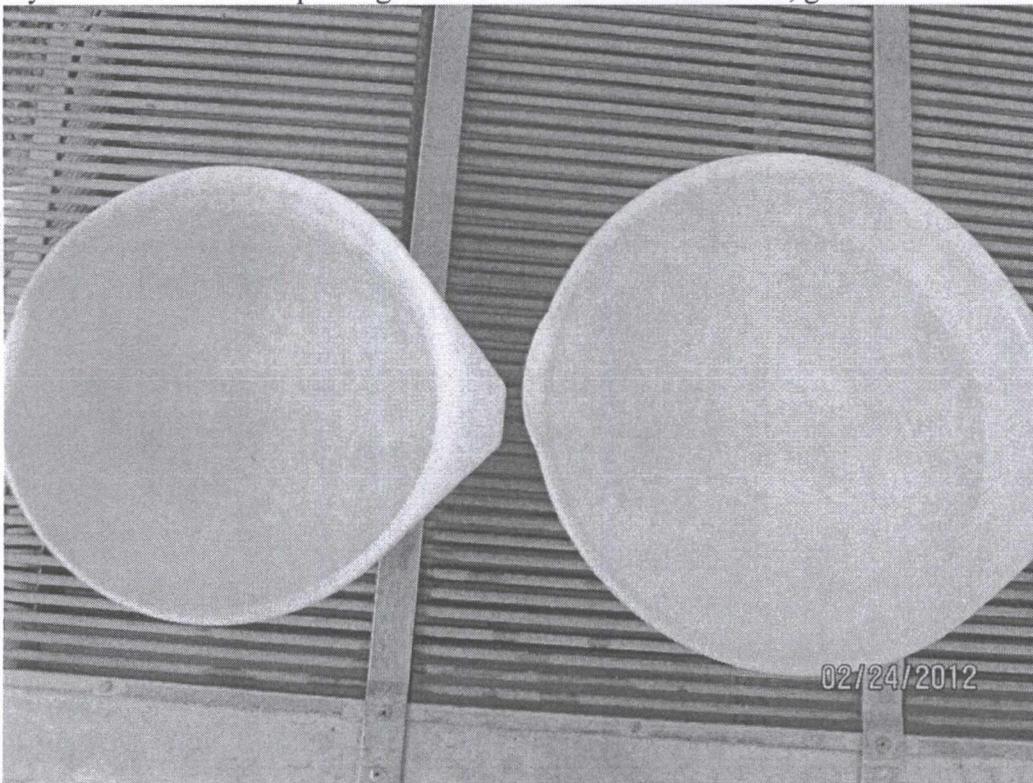
Fry Barn: Top view of 10:44 am sample of geothermal and fresh water samples

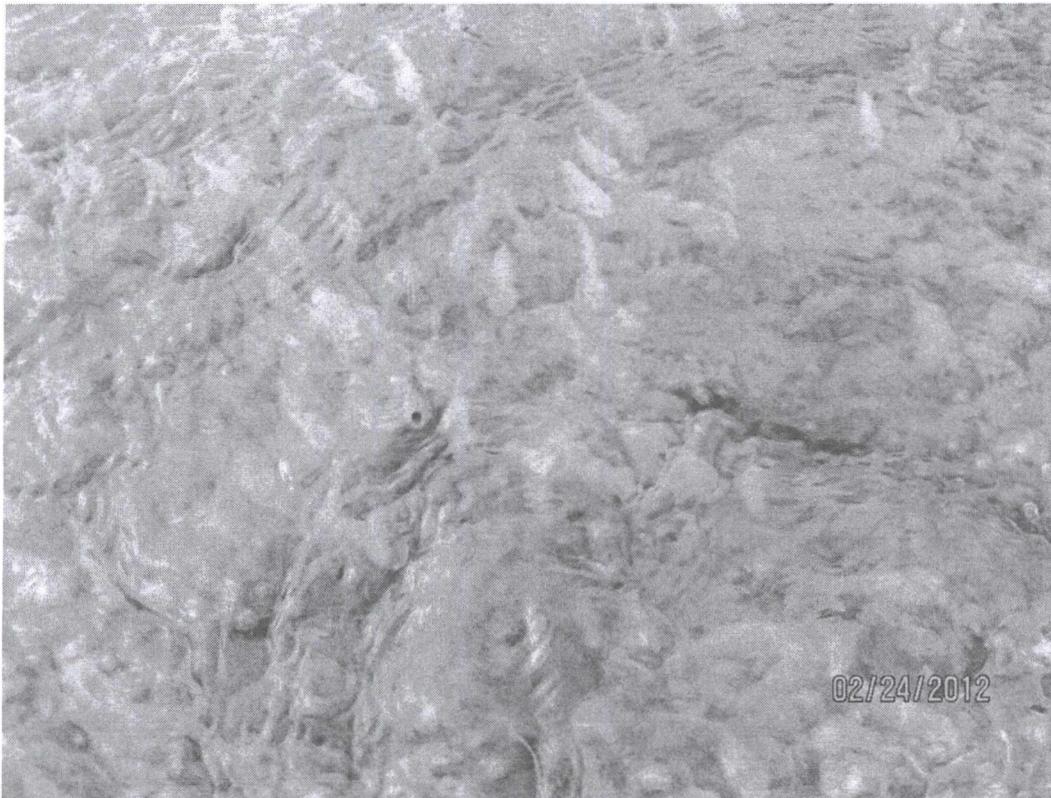
- Some of the fry in the tanks were also visibly tainted a light pink (the fry are different colors, some dark and some light cream color, the taint was noticeable on the light cream color fry).

Fry Barn: Fry Close up of fingerlings, notice pink tint to fingerlings (fry)

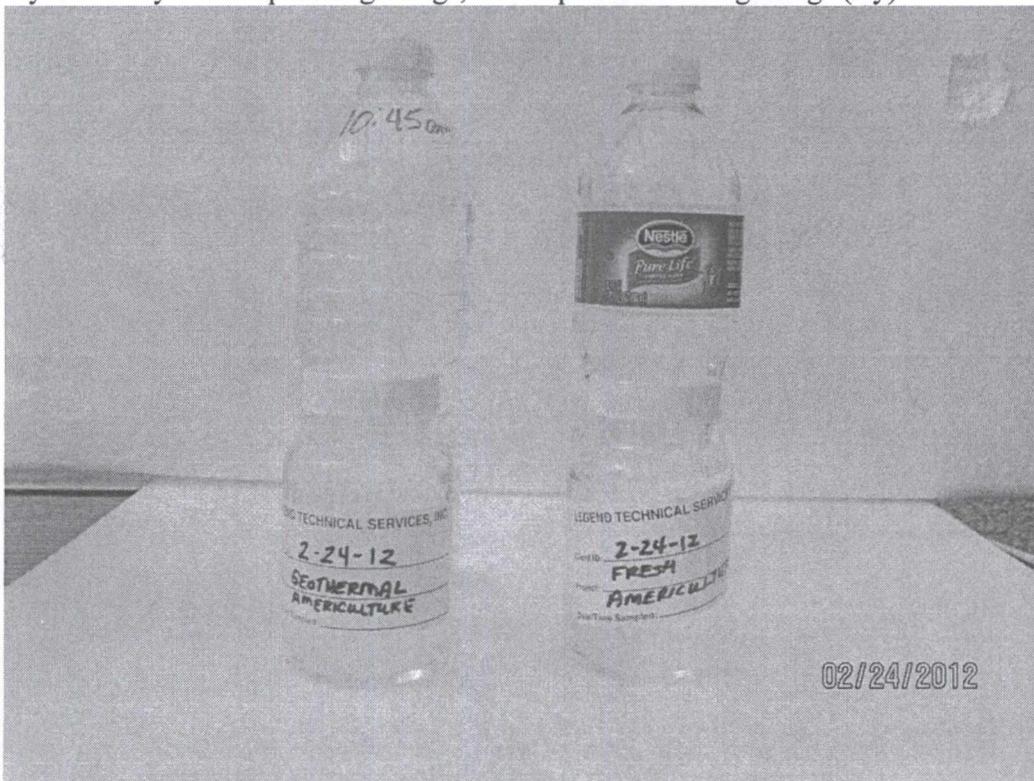
Fry Barn: Water samples taken by OSE of geothermal and fresh water.

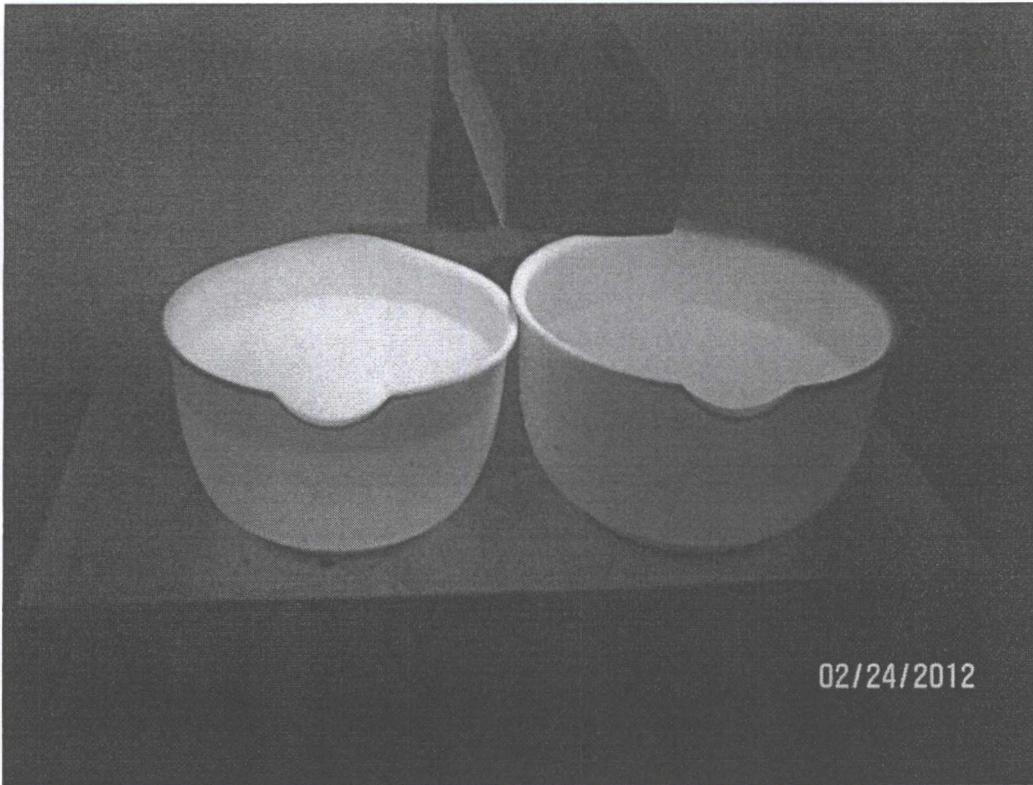
- Samples were obtained by OSE from the geothermal and fresh water sources.
- Since based on the reading of Rhodamine WT which is a fluorescent dye and can thus be detected easily and inexpensively with instruments called fluorometers, the samples were placed under a black light, the geothermal sample had a strong glow under the black light, the fresh sample did not have a glow to it. *Note this was done only to see if the dye Rhodamine could be detected with a black light*

Geothermal (on left) and Fresh (on right) water under black light: Geothermal water had strong fluorescent glow under the black light.

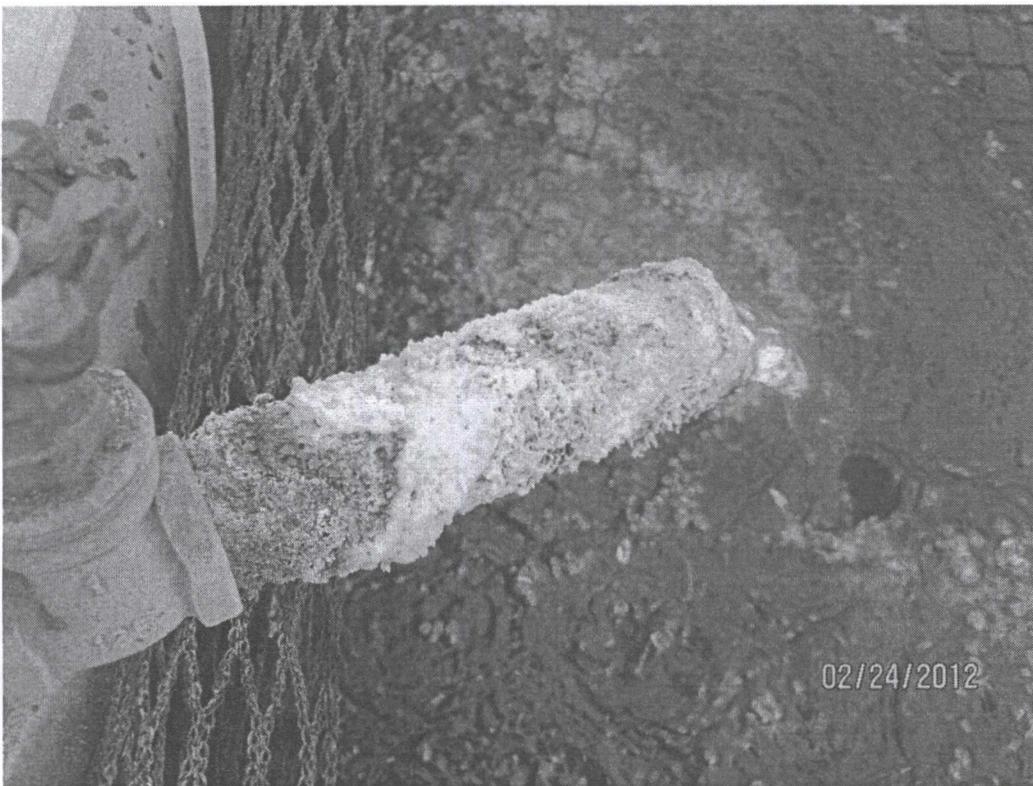
- Went to the breeder barn, the deposits on the water faucets to the tanks have a pink stain. The breeder fish had a noticeable pink taint to them.
- Inspected Rosette's State Lease wells

Breeder barn: faucet to breeder tank, pink dye has stained the deposits on the faucet.

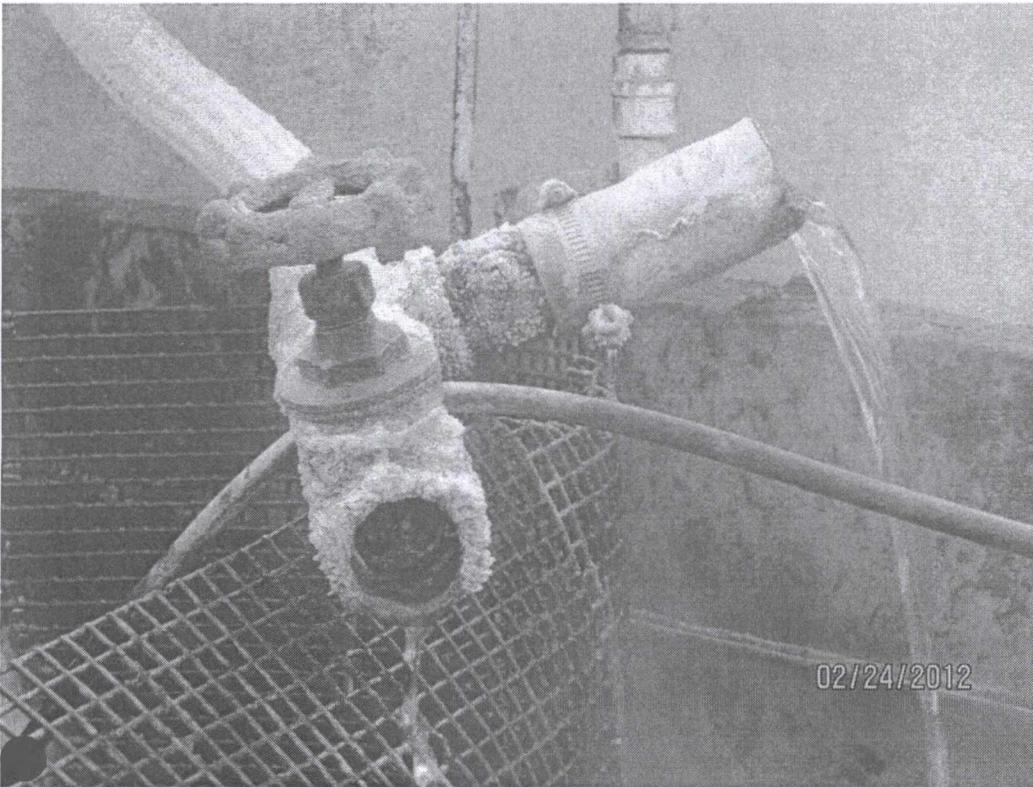
Breeder barn: more staining of deposits on tank faucets.

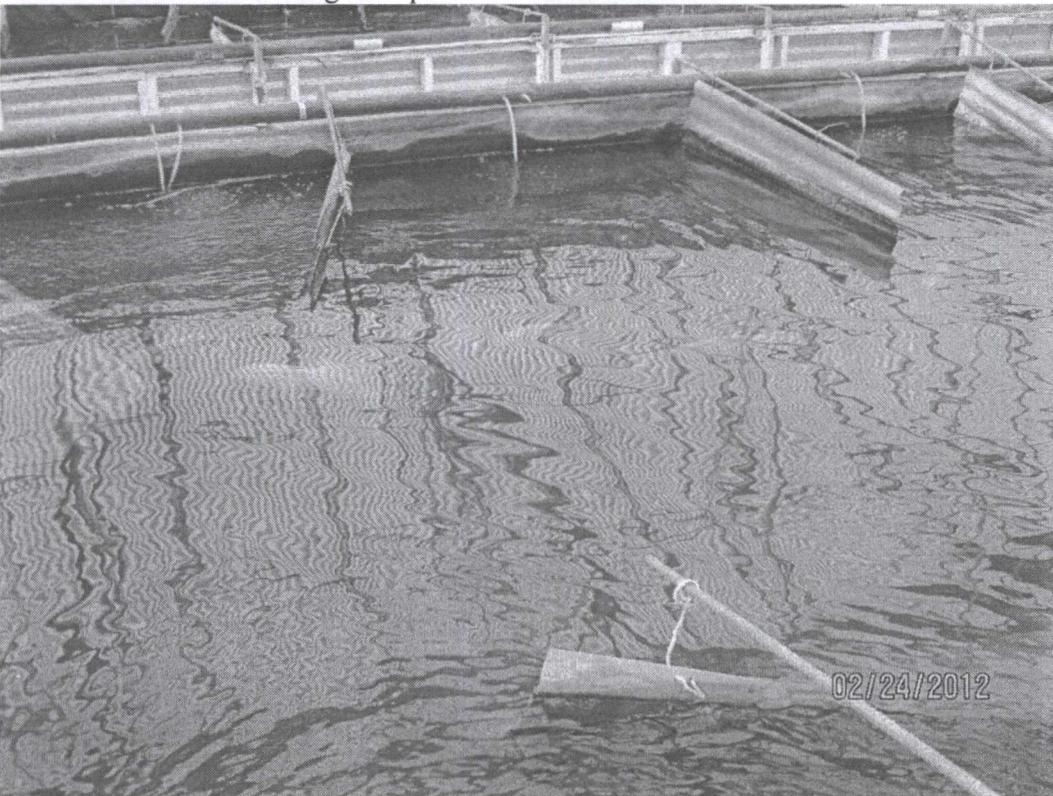
Breeder barn: breeding run showing the fish tainted pink.

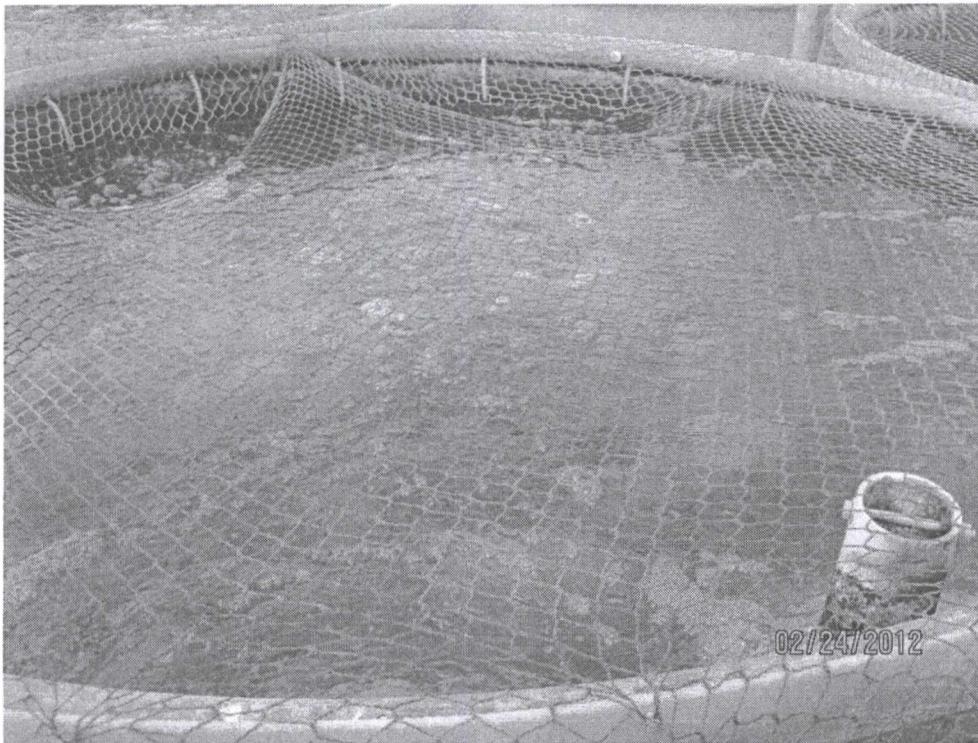
Breeder barn: circular tank of breeders, shows pink tint to fish

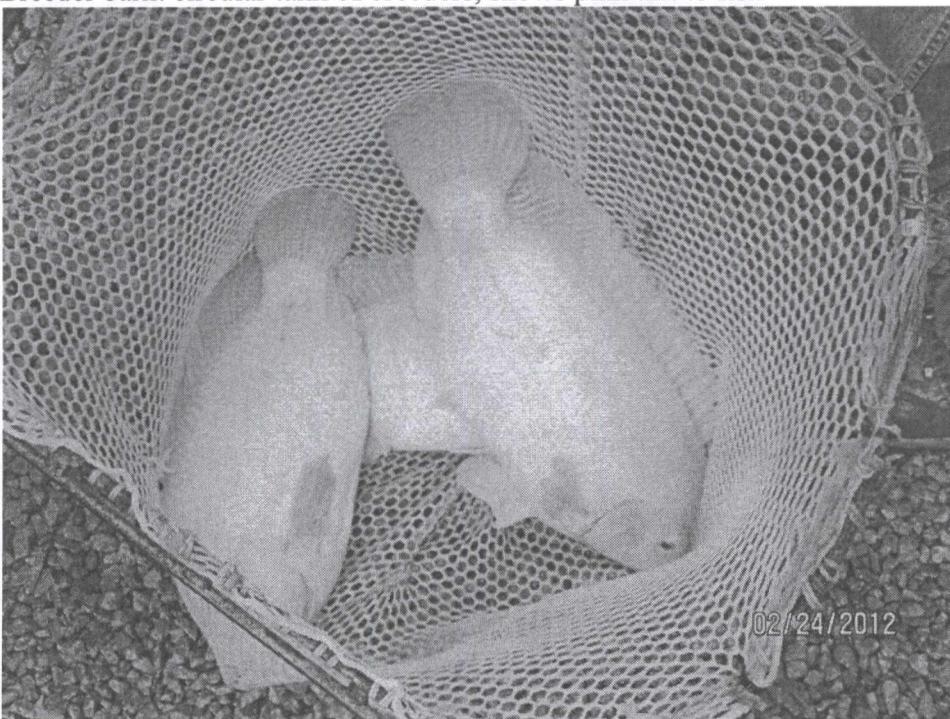
Breeder barn: fish from circular tank showing pink tint

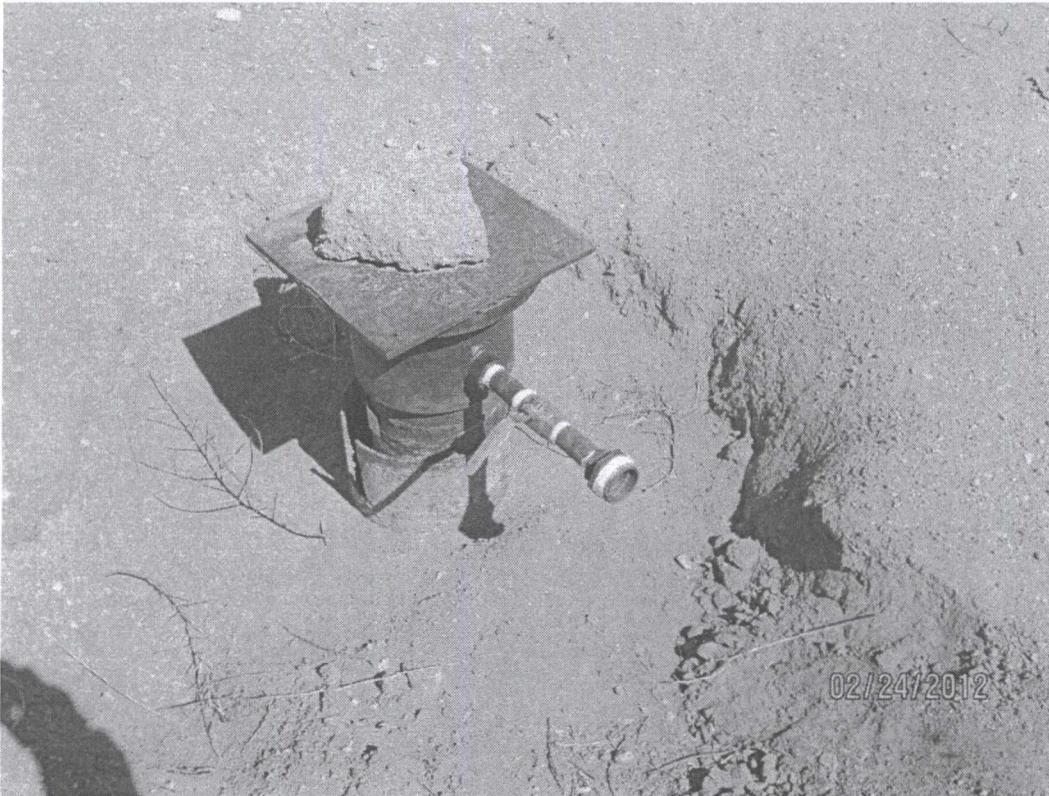
- A-36-A-S17: GPS Location: North 32°9'11.85" West 108°49'52.39"
 - This well has been capped since it was drilled by Dale Burgett, work has been done to the well recently.

- Soil patches around the well are stained pink which indicated that this well was used for the injection of the Rhodamine WT dye for the tracer test.

Well A-36-A-S17: where dye was injected (notice dye stains on soil around well)

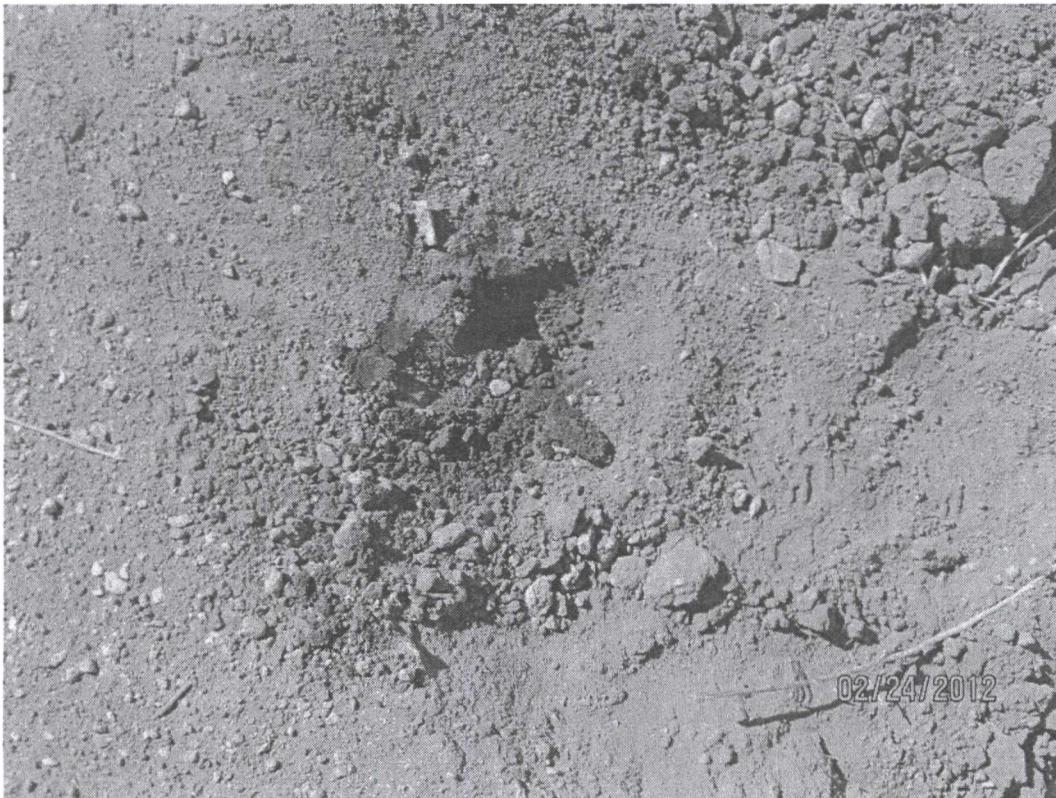
At well A-36-A-S17: close up of dye stain of soil

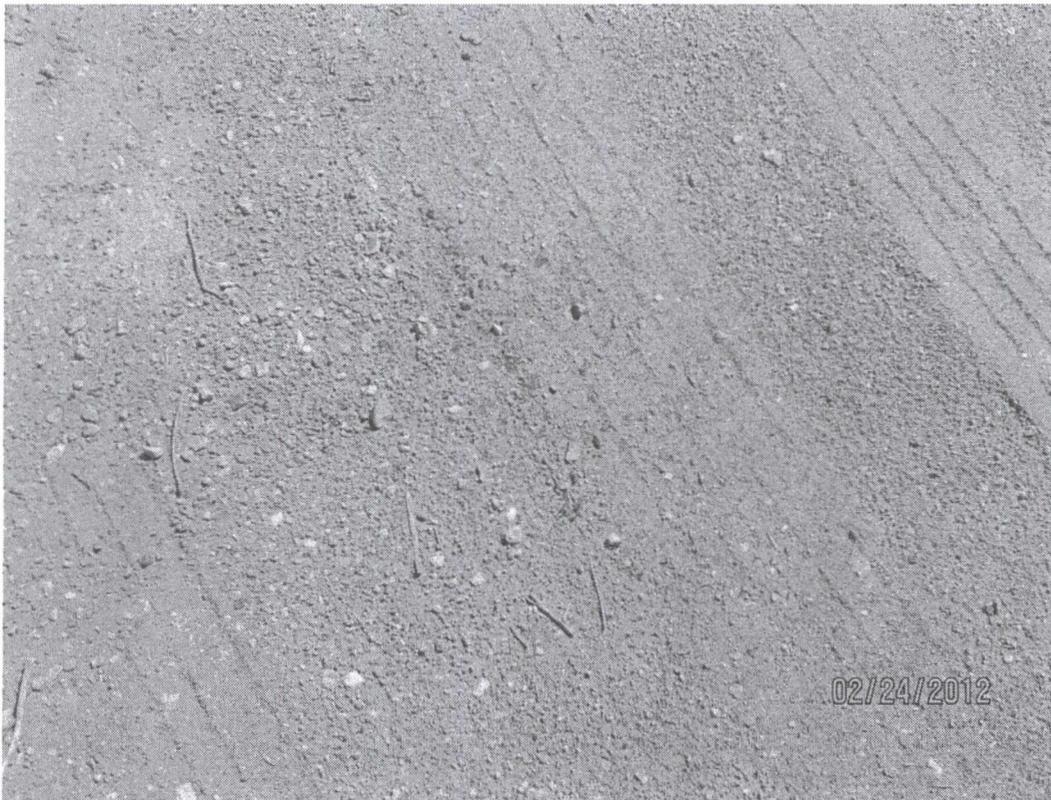
At well A-36-A-S17, leakage of dye onto soil near well

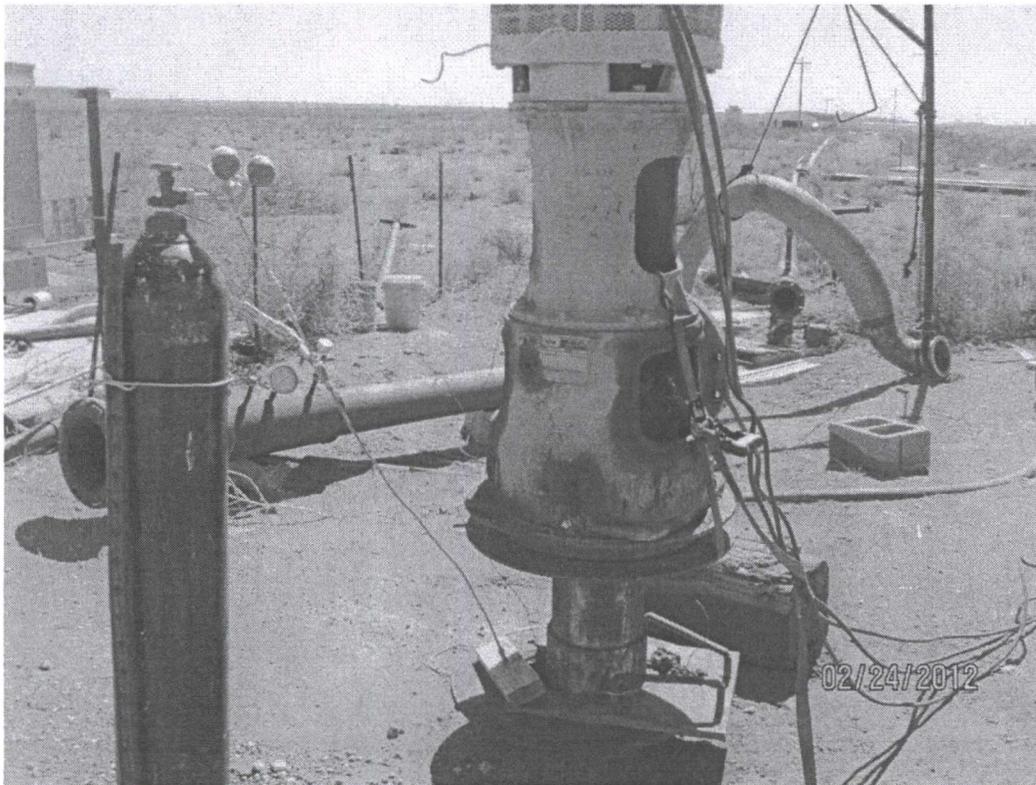
- A-36-A-S16: GPS Location: North 32°9'10.35" West 108°49'48.13"
 - Pump still on well but not connected to water lines for greenhouses
 - No sign of well recently being pumped or dye injected into well

Well A-36-A-S16 (State Lease): no evidence of pumping or dye injection

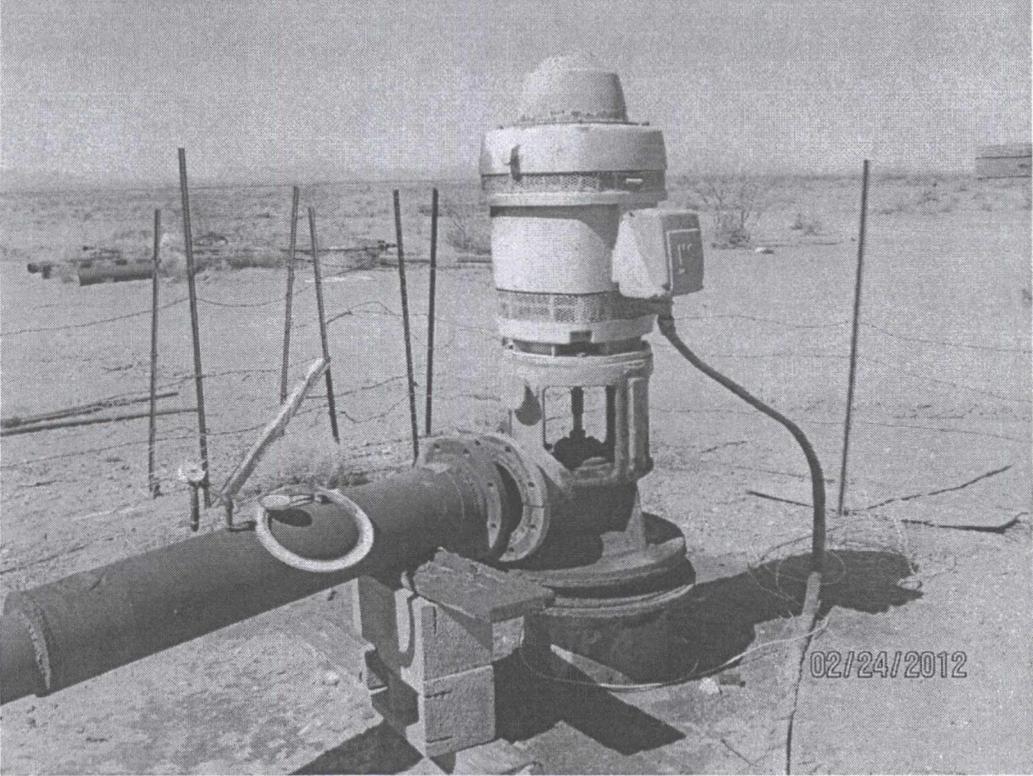
- A-36-A-S18: GPS Location: North 32°9'9.22" West 108°49'50.66"
 - Pump on well but not connected to water lines for greenhouses
 - No sign of well recently being pumped or dye injected into well

Well A-36-A-S18 (State Lease): no evidence of pumping or dye injection

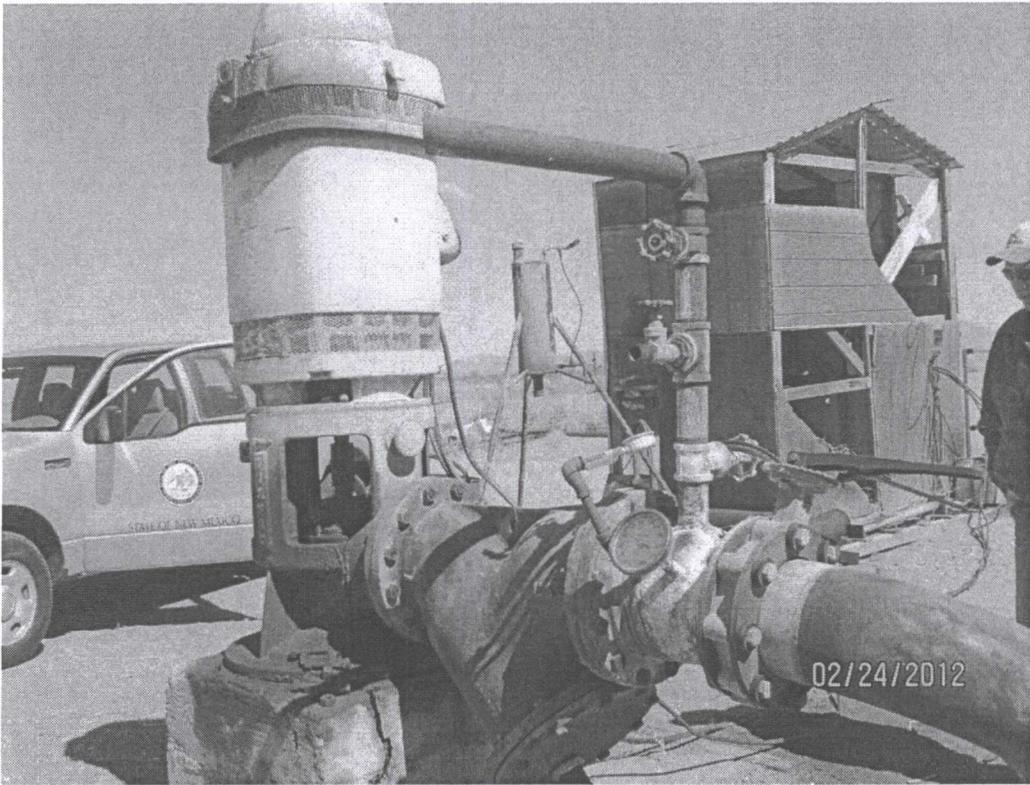
- A-36-A-S19: GPS Location: North 32°9'9.04" West 108°49'52.11"
 - Pump on well and connected to water line for green house
 - No sign of well recently being pumped or dye injected into well

Well A-36-A-S19 (State Lease): no evidence of pumping or dye injection

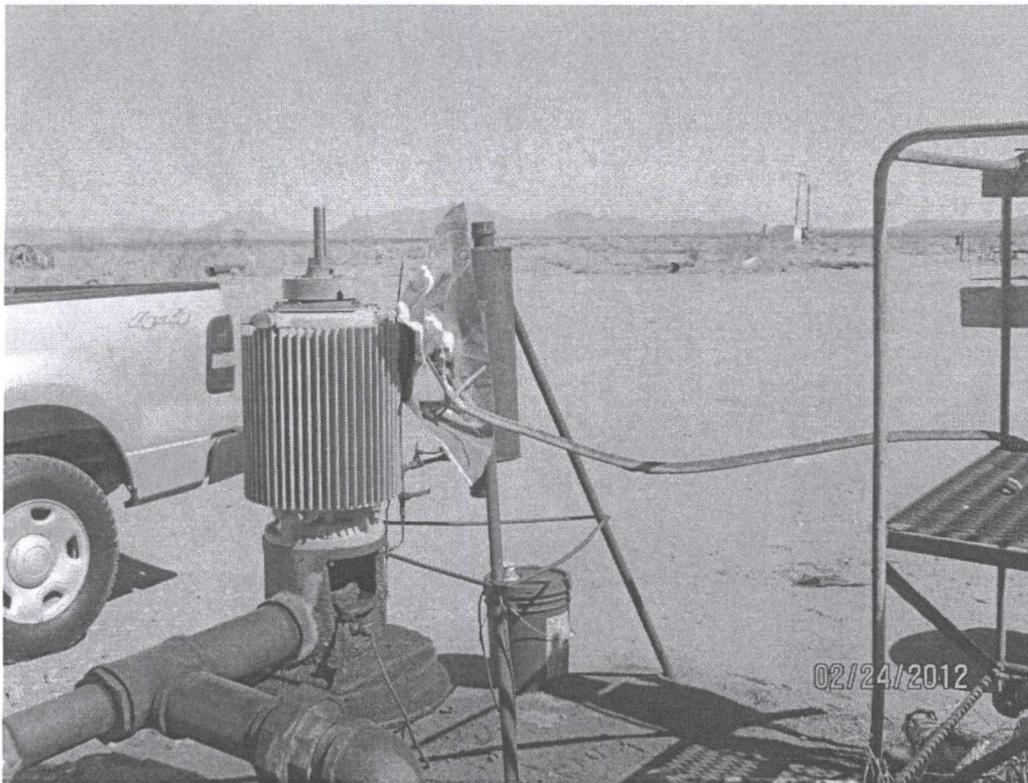
- A-36-A-S15: GPS Location: North 32°9'9.04" West 108°49'53.41"
 - Pump on well but not connected to water lines for greenhouses, there is an emergency line attached to the well for AmeriCulture in case of need.

Well A-36-A-S15 (State Lease): no evidence of pumping or dye injection

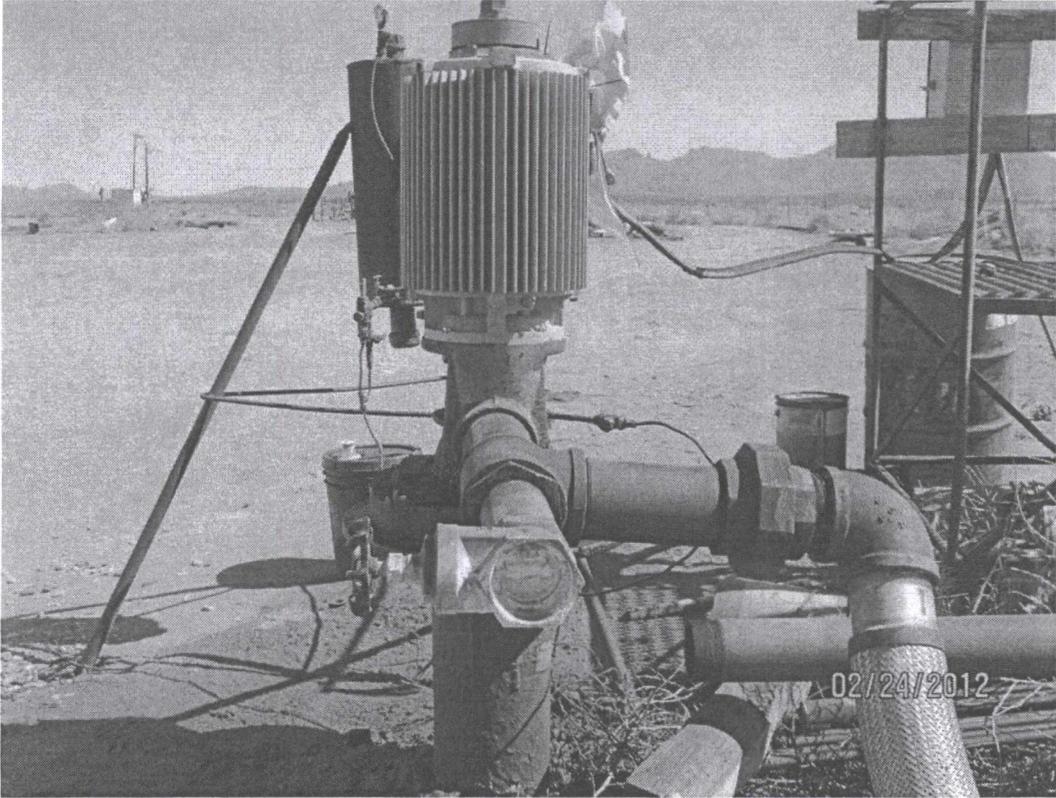
Well A-36-A-S15 (State Well): soil around ground is oil stained, not wet

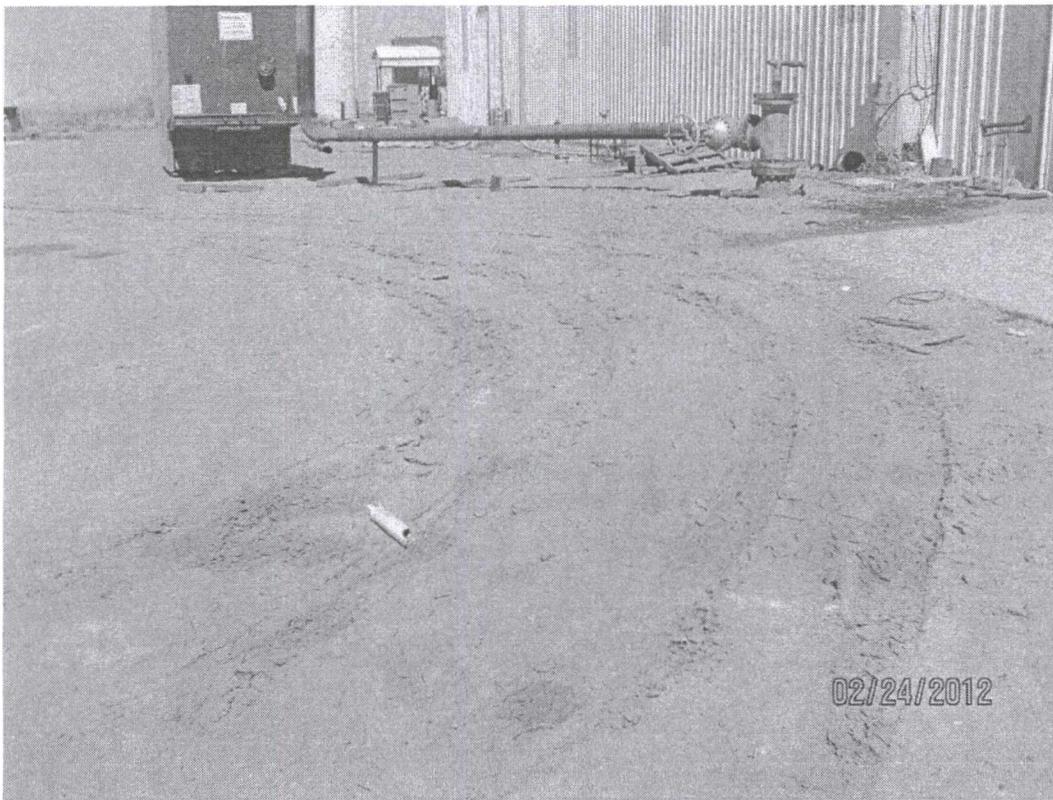
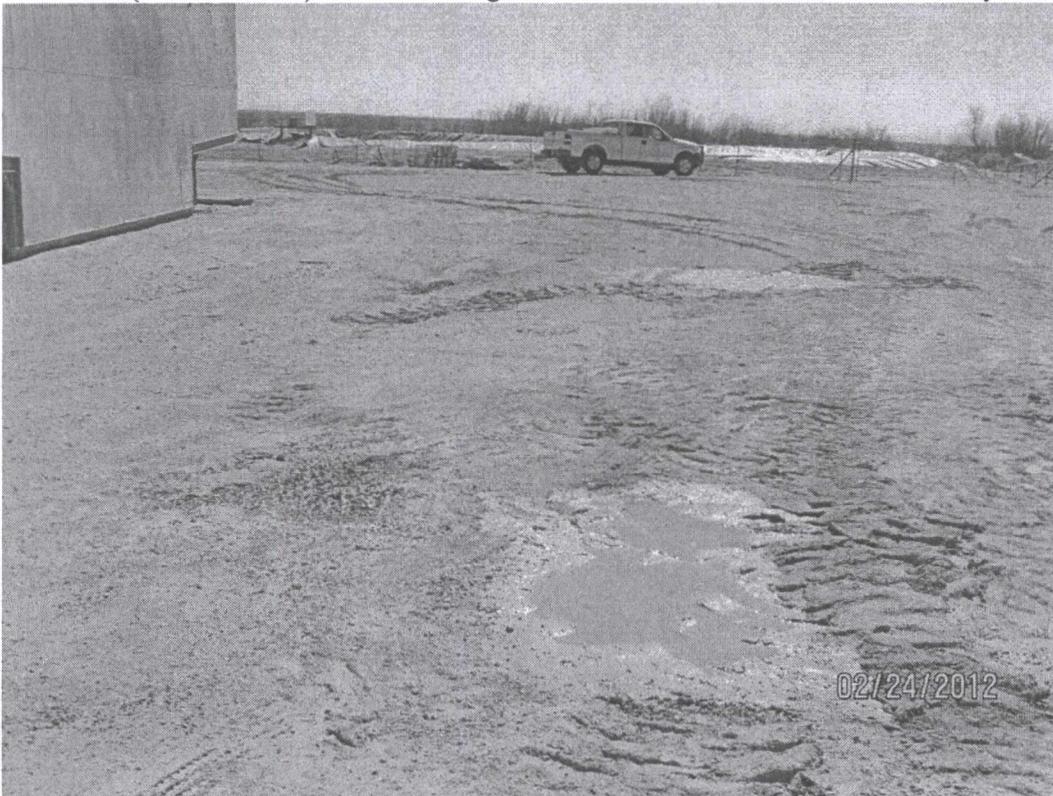
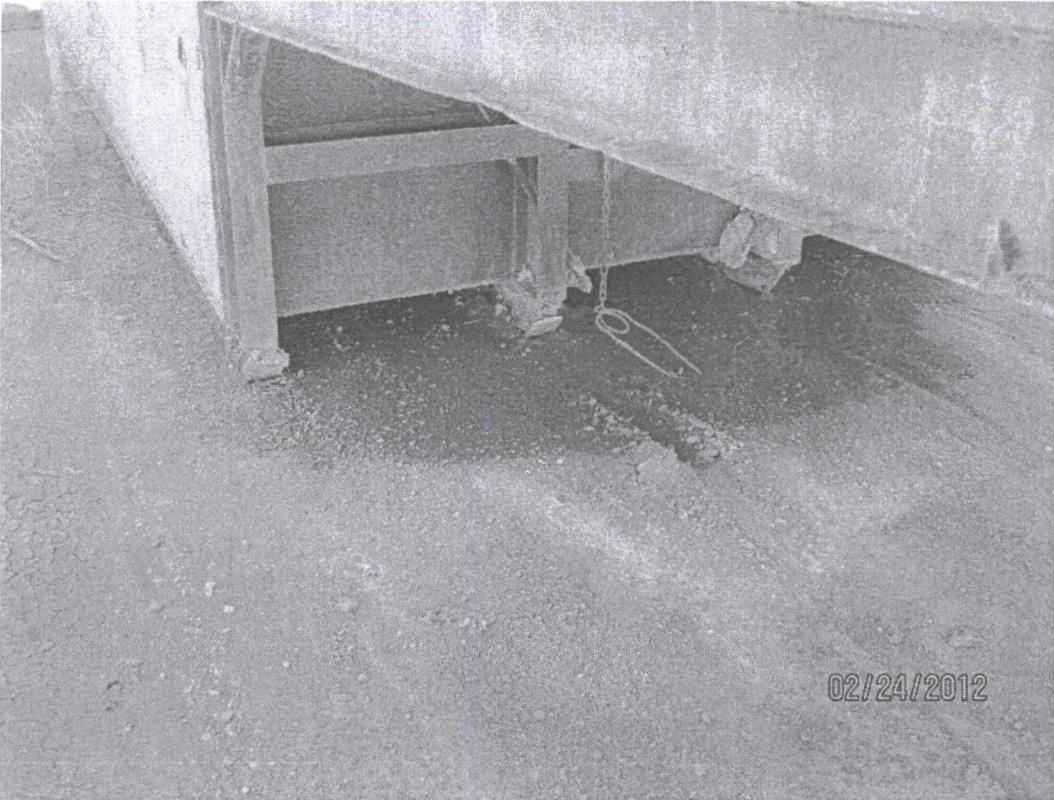
- Well still has same equipment setup as on February 9, 2012 inspection
 - Area around well and green water storage tank that well is hooked up to discharge into shows that the ground has been recently saturated as if the well was pumped.

Well 55-7 (A-758-POD1) BLM Lease: ground around well and tank had recently been saturated

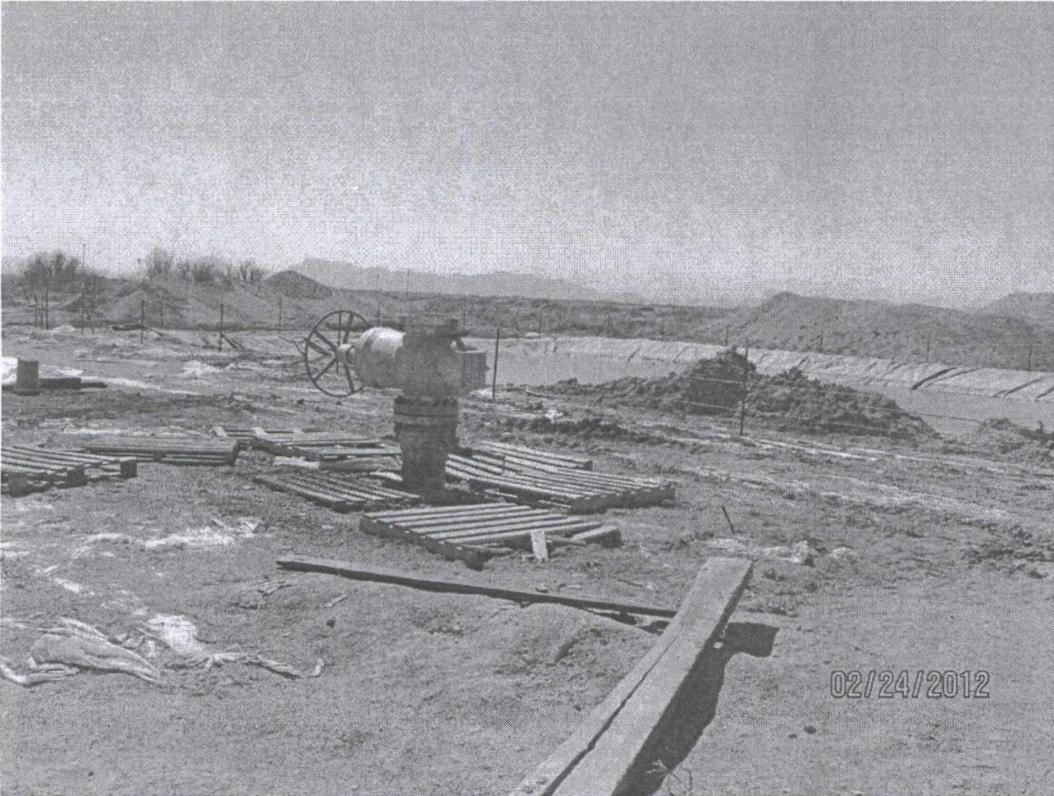
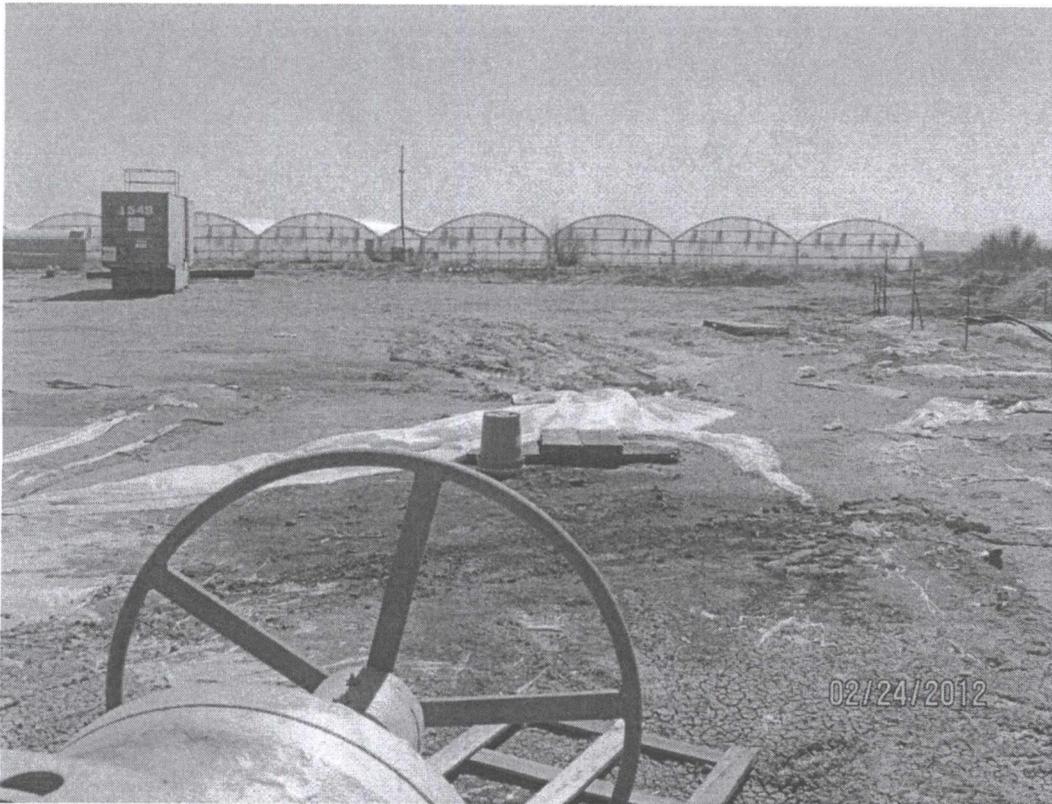
- Area around well shows that the ground has been recently saturated as if the well was pumped.
 - 45-07: A-758-POD5: GPS Location: North 32°8'39.93" West 108°50'16.19"

Well 53-07 (A-758-POD4) BLM Lease: ground around well had recently been saturated

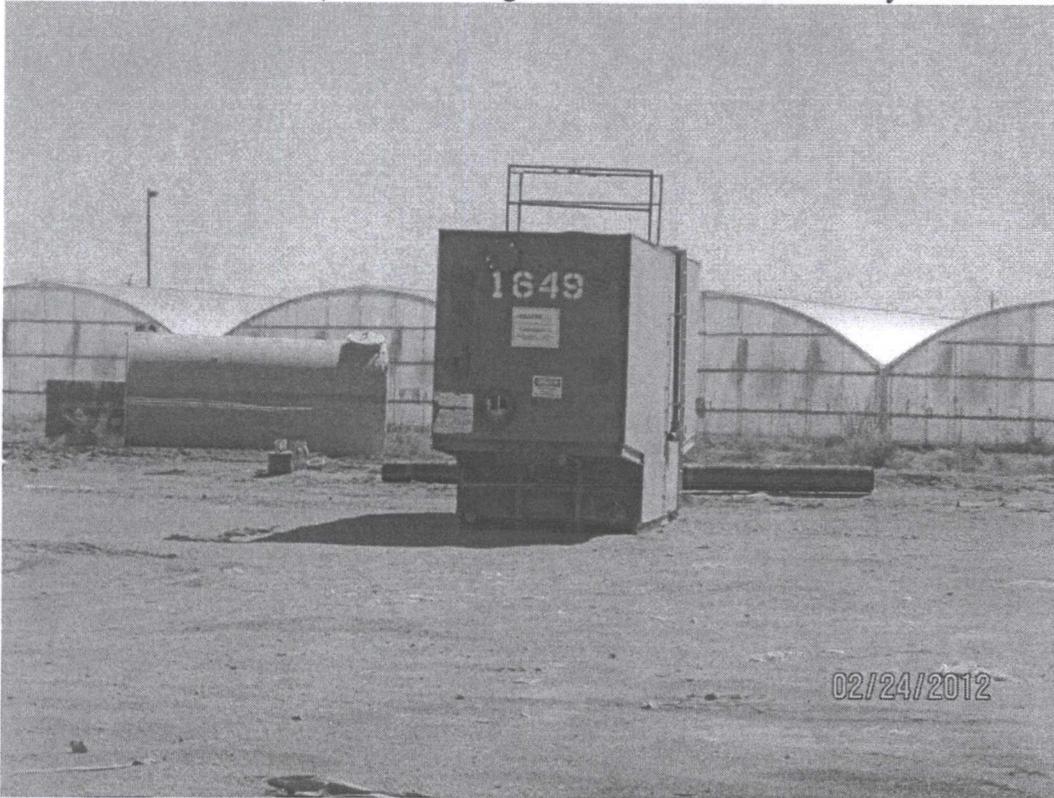
Well 53-07 (A-758-POD4) BLM Lease: tank at site of well

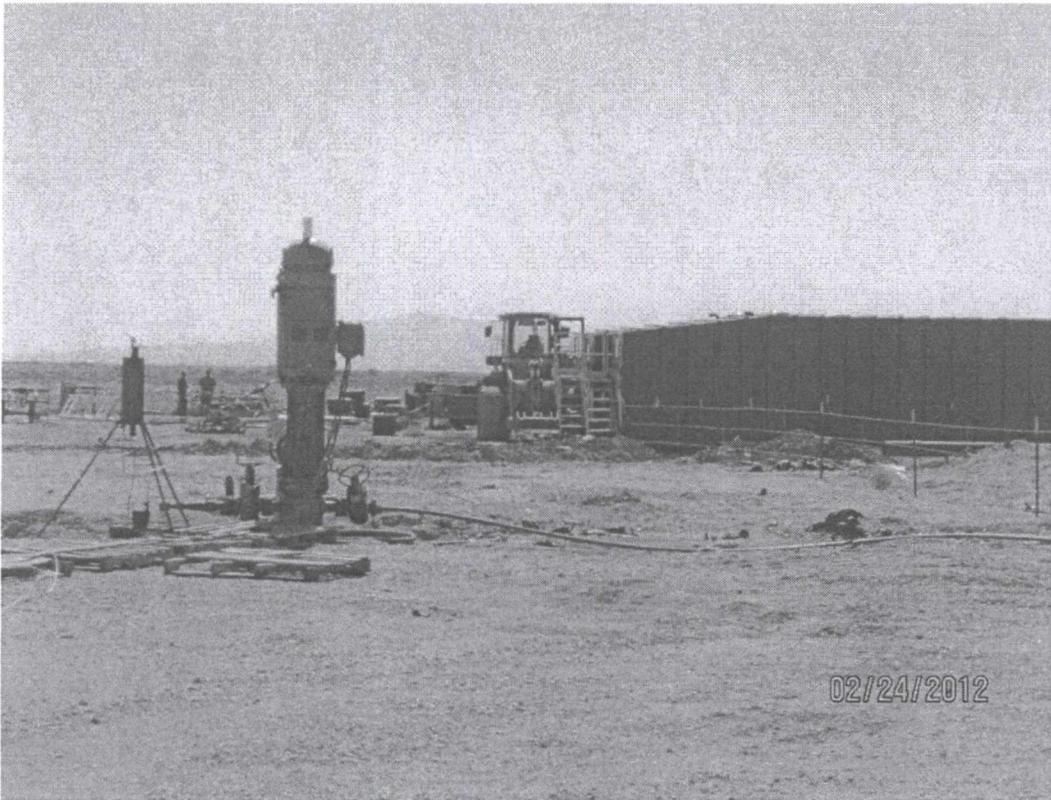
- Well still has same equipment setup as on February 9, 2012 inspection
 - Area around well is dry, it does not appear as if this well was recently pumped

Well 45-07 (A-758-POD5) BLM Lease: well equipment the same as last inspection on 2/9/12, ground around well is dry, equipment from 47-07 site has been moved to 45-07 site

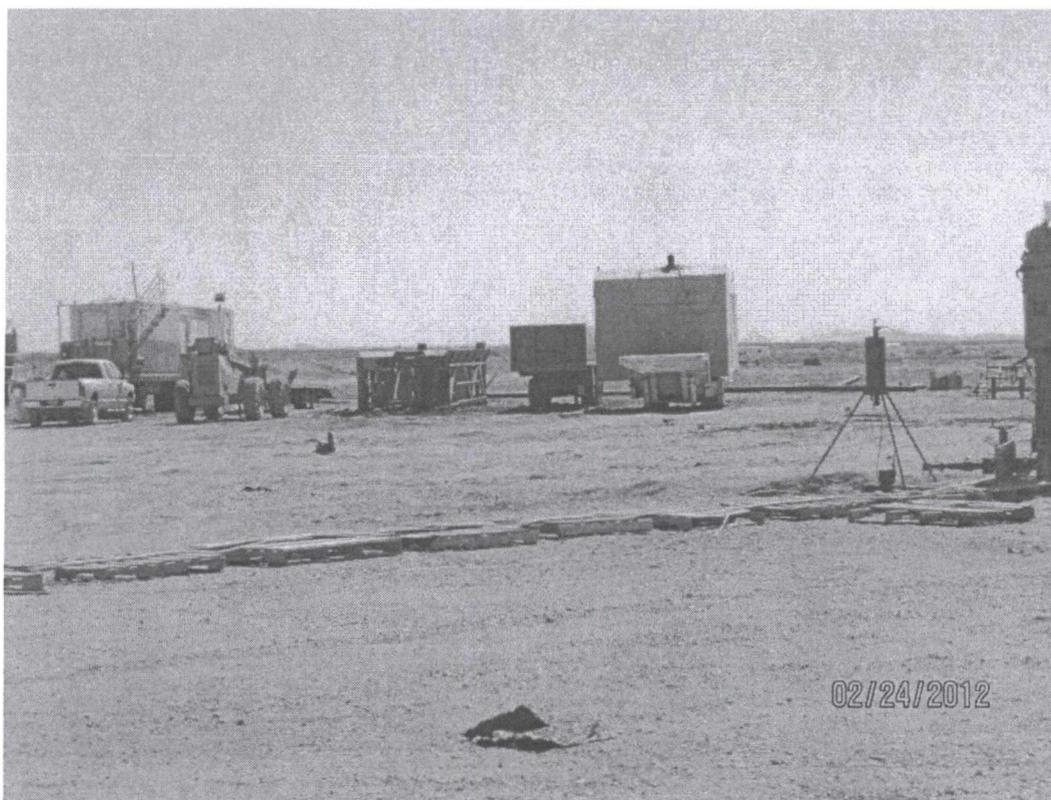
- Equipment from the 47-07 drill site has been moved up to the 45-07 site
 - 47-07: A-758-POD6: Approx GPS Location: North 32°8'27.30" West 108°50'15.70"

Well 45-07 (A-758-POD5) BLM Lease: equipment moved to site
