FIELD REPORT

FILE NO A-45-A **PERMIT NO**

APPLICANT AmeriCulture Inc

SUBJECT Complaint of pink dye in water

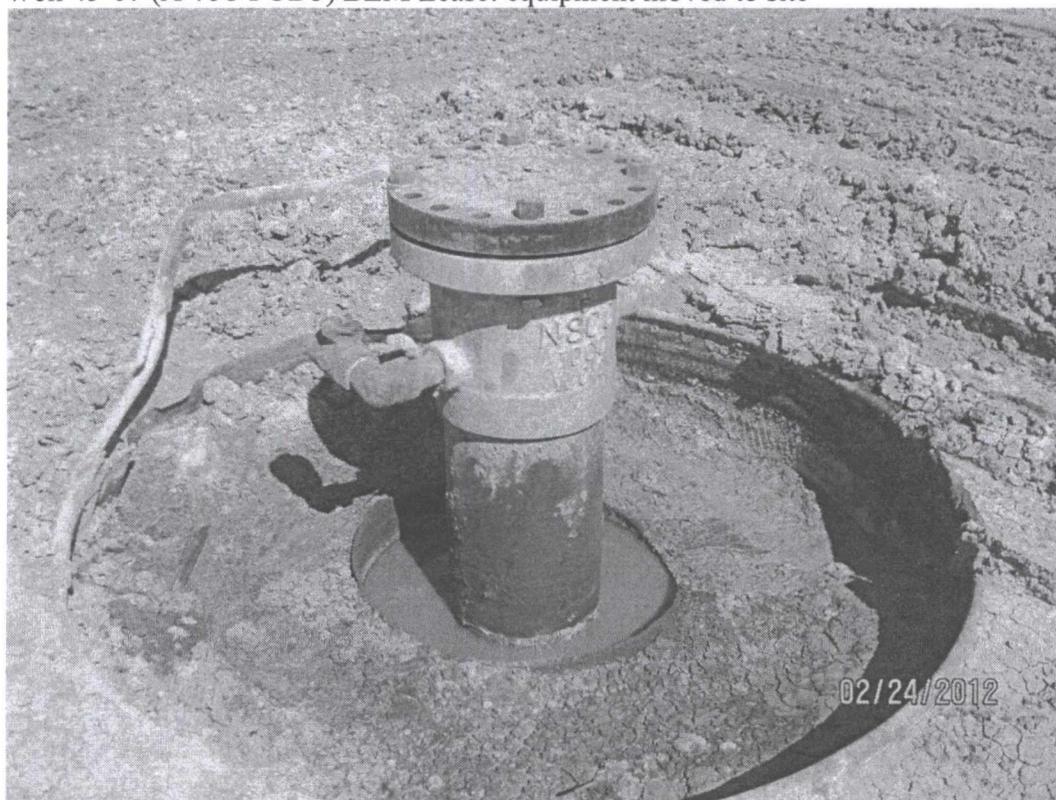
- Drill rig has been removed from site and well capped
 - Overley's Vacuum Truck Services was on site removing water from reservoir

Well 47-07 (A-758-POD6) BLM Lease: well rig removed and well capped (well was recently drilled)

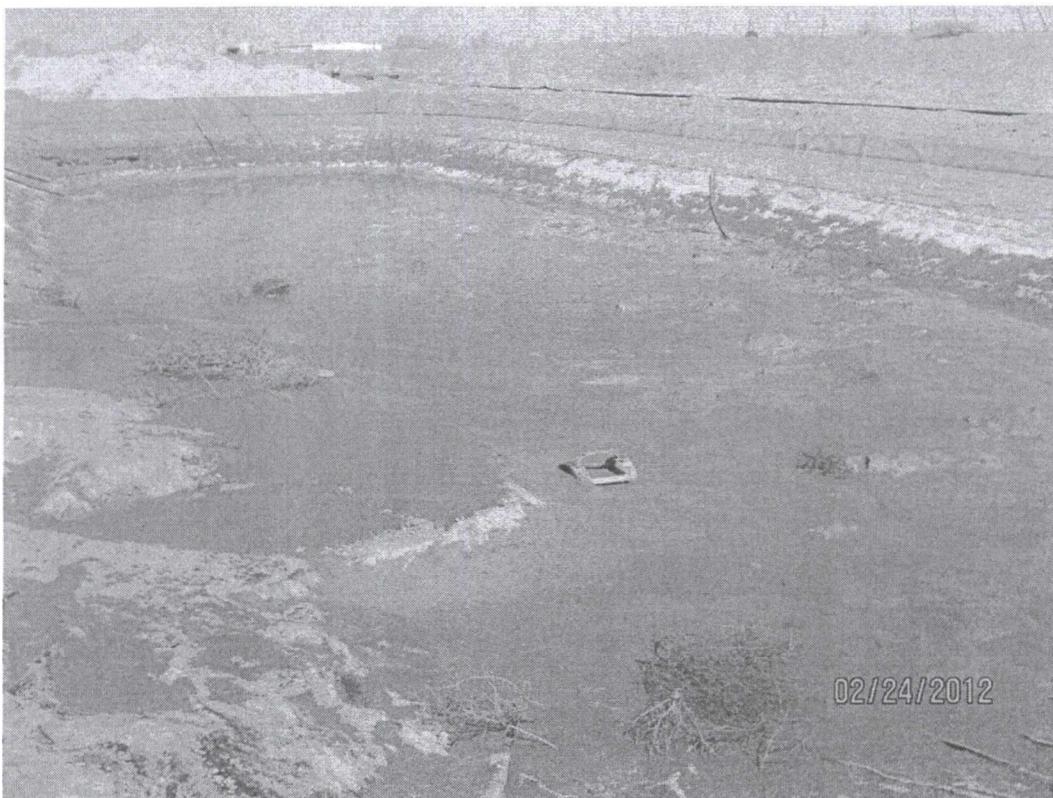
Well 47-07 (A-758-POD6) BLM Lease: reservoir (being emptied at time of inspection)

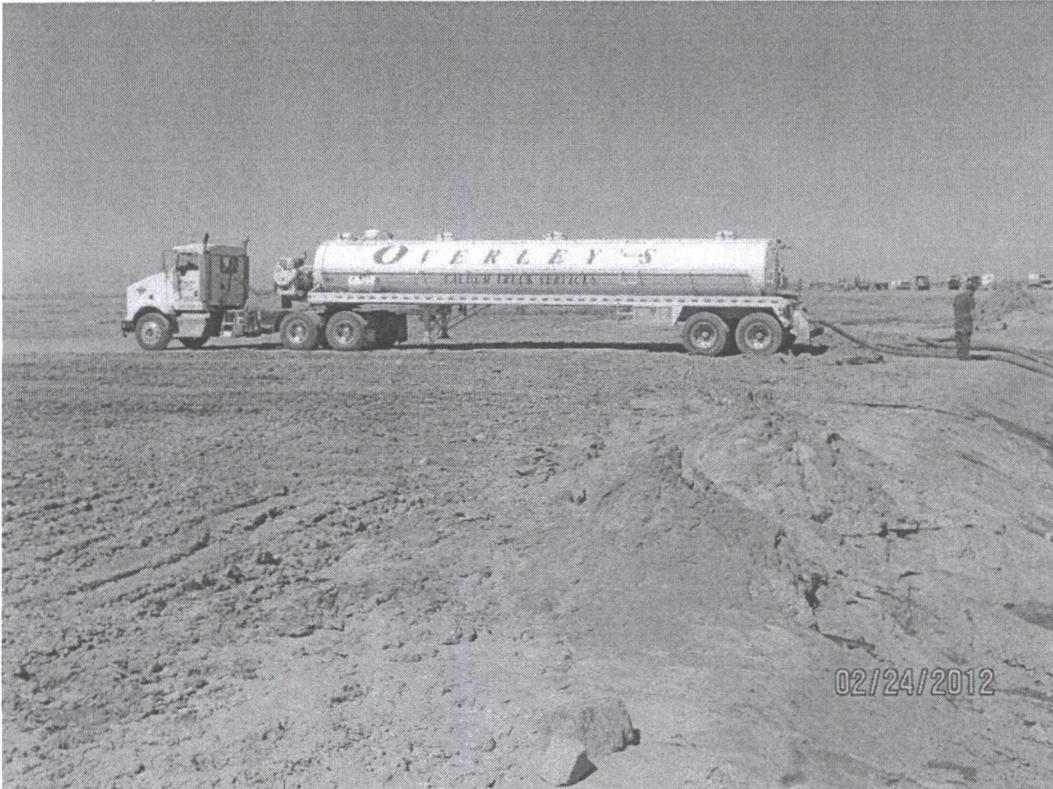
Well 47-07 (A-758-POD6) BLM Lease: vacuum tank emptying reservoir.
