LEAK AND WORKOVER SUMMARY MONUMENT AGI D #2

Monument AGI Well No 1
API 30-025-40002
Chronology of Well Operations
[Sources well file operator e mail reports and RBDMS]

Monument AGI Well No. 1 (30-025-40002)
 Casing Inspection Log: August 24, 2016
 Index of Casing Assessment Figures

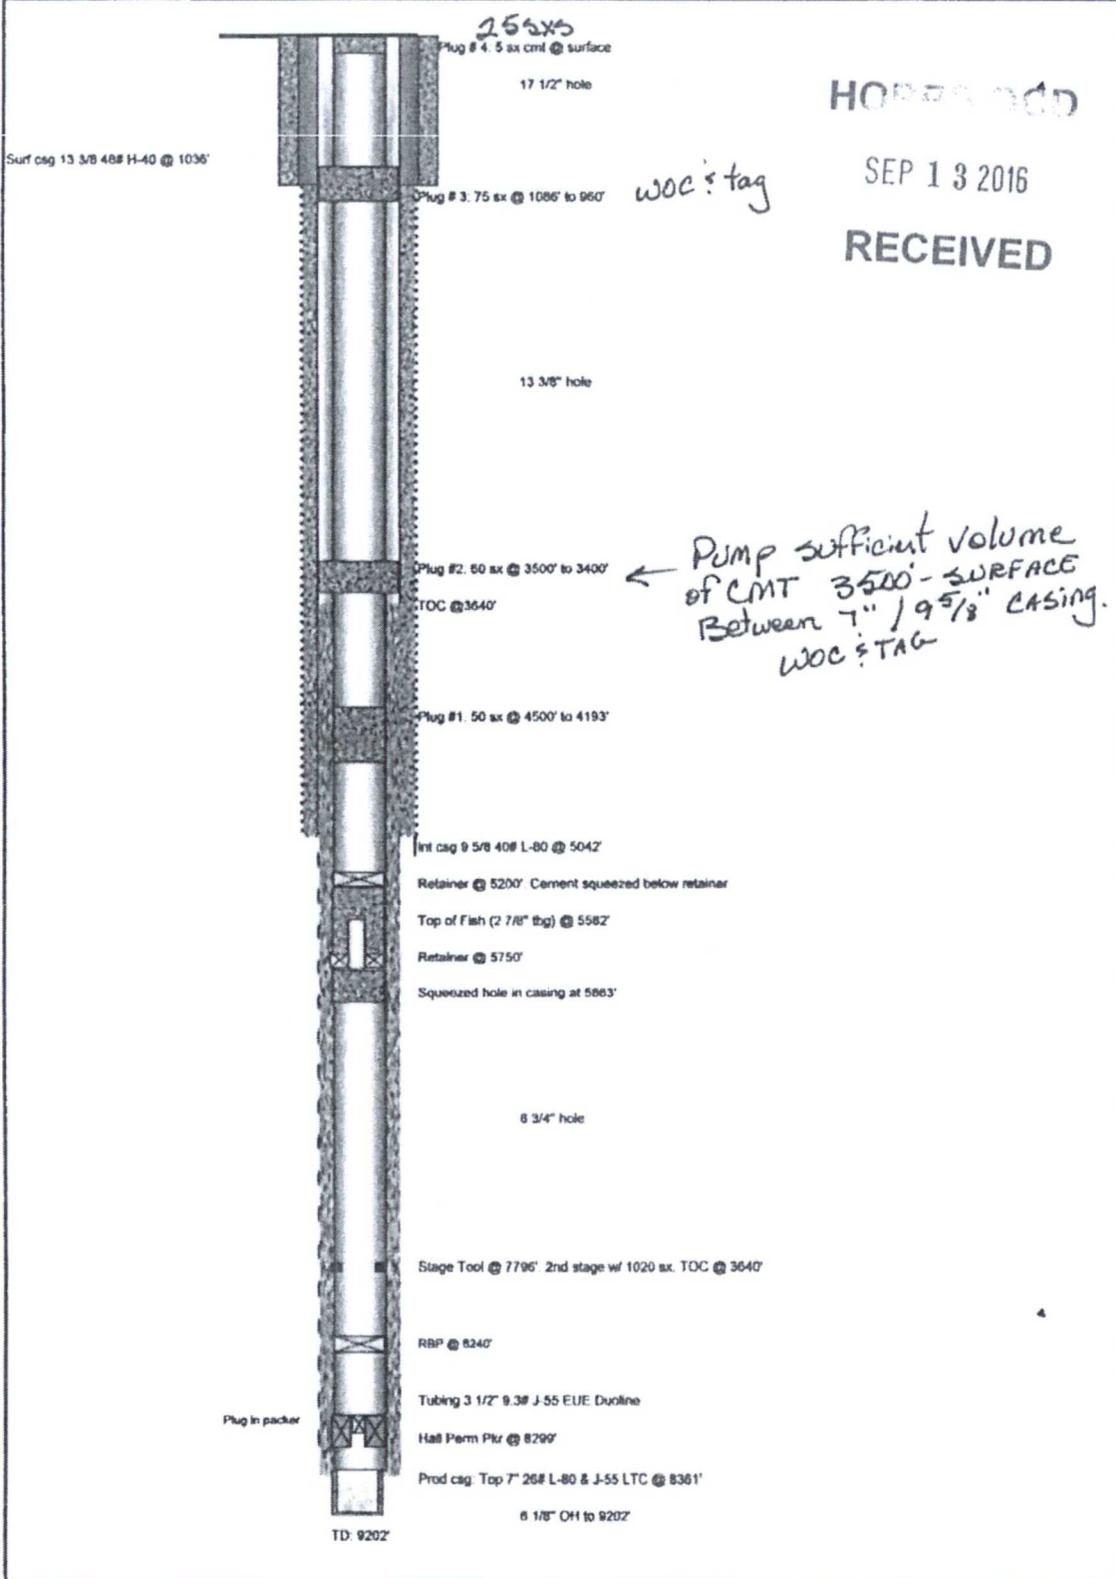
Cambrian Management EXECUTIVE SUMMARY WELLBORE DIAGRAM

- Estimated well life 30 years actual well life 4 years 7 months (12/02/2011 to 07/27/2016)
- Compromised tubing is the primary source of casing corrosion and eventual failure of casing
- Additional sources contributing to premature failure
 - 1 Early use for injection of wastewater with gas
 - 2 Use of water as annular fluid
 - 3 Possible impact from San Andres formation fluids due to ongoing waterflooding in area
- New orders for Monument AGI wells contain the following changes
 - Annual MIT
 - Diesel with biocide as annular fluid
 - Pressure/temperature monitoring
 - Operators design of double casing and cement of formations

- 1 Pick up 7 packer on work string and run in hole to 5200'
- 2 Set packer and attempt to pump into collapsed casing area
- 3 Establish pump in rate and pressure call the Cambrian office to get cement volumes
- 4 Pull out of hole with packer and run in hole with 7" retainer, set retainer at 5200
- 5 Pump Class C cement as per recommendation from Cambrian and approved by OCD
- 6 Displace cement below retainer sting out of retainer and reverse out any cement
- 7 Pull out of hole with work string LEAVE 35' CMT ON RETAINER

- 8 If unable to pump into collapse area pull out of hole with packer
- 9 Go in hole open ended to 5560 and spot 50 sx of Class C from 5560 to 5253 ↑ WOC & TAG
- 10 Pull up hole to 4500' and spot 50 sx of Class C from 4500' to 4193'

- 11 Pull out of hole with tubing
- 12 Rig up wireline and perforate 7 26# J 55 casing at 3500
- 13 Establish circulation between 7 casing and 9 5/8"

- 14 Run in hole with packer on 2 7/8" work string and set packer at 3000' 2900' PUMP SUFFICIENT volume
- 15 Re establish circulation and pump 60 sx of Class C set balanced plug TO C. 10 CMT TO SURFACE
- 16 Pull out of hole with work string and packer WOC + TAG NO DEEPER THAN 3000'

- 17 Perforate 7" at 1086 WOC & TAG NO DEEPER THAN 986'
- 18 Establish circulation between 7 and 9 5/8 annulus
- 19 Run in hole with packer on 2 7/8 work string and set packer at 800
- 20 Pump 75 sx Class C cement balance plug
- 21 Pull out of the hole
- 22 Spot 5 sx Class C cement at surface and cut off casing and weld on cap

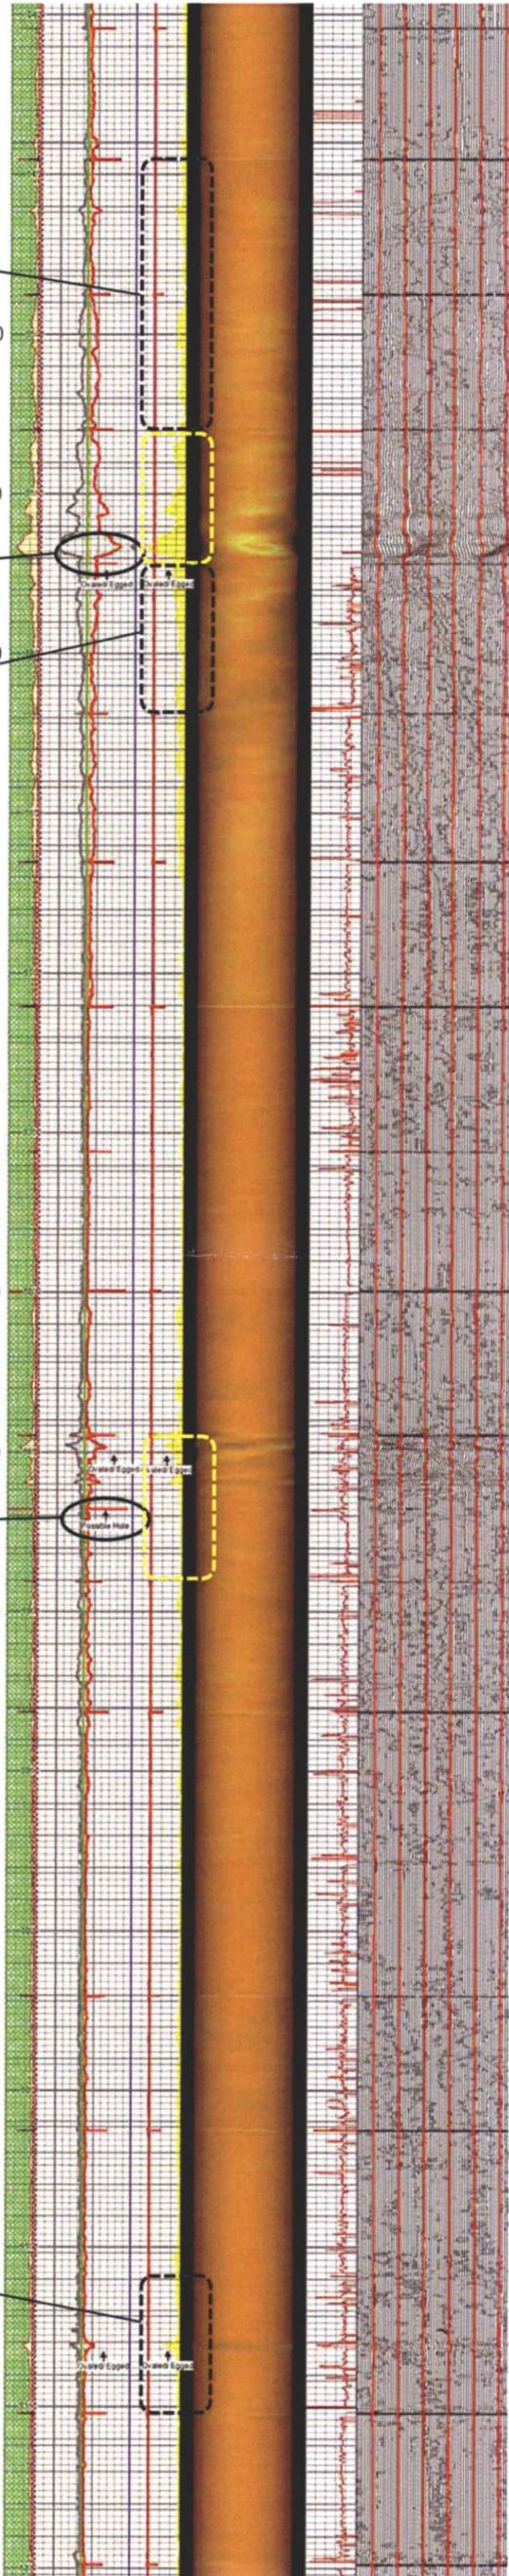
Monument AGI Well No. 1 (30-025-40002)
 Casing Inspection Log: August 24, 2016
 Casing Assessment Figure 1: 5400' to 6200'

5446 to 5529: casing characterized as "bad" in CI log

5572: possible hole identified by CI log
 Not identified in RA tracer log

5572 to 5618: casing characterized as "bad" in CI log

5866: possible hole identified by CI log
 5865: hole identified by RA tracer log

6110 to 6151: casing characterized as "bad" in CI log

Note: Casing without notations was assessed as fair to good condition.

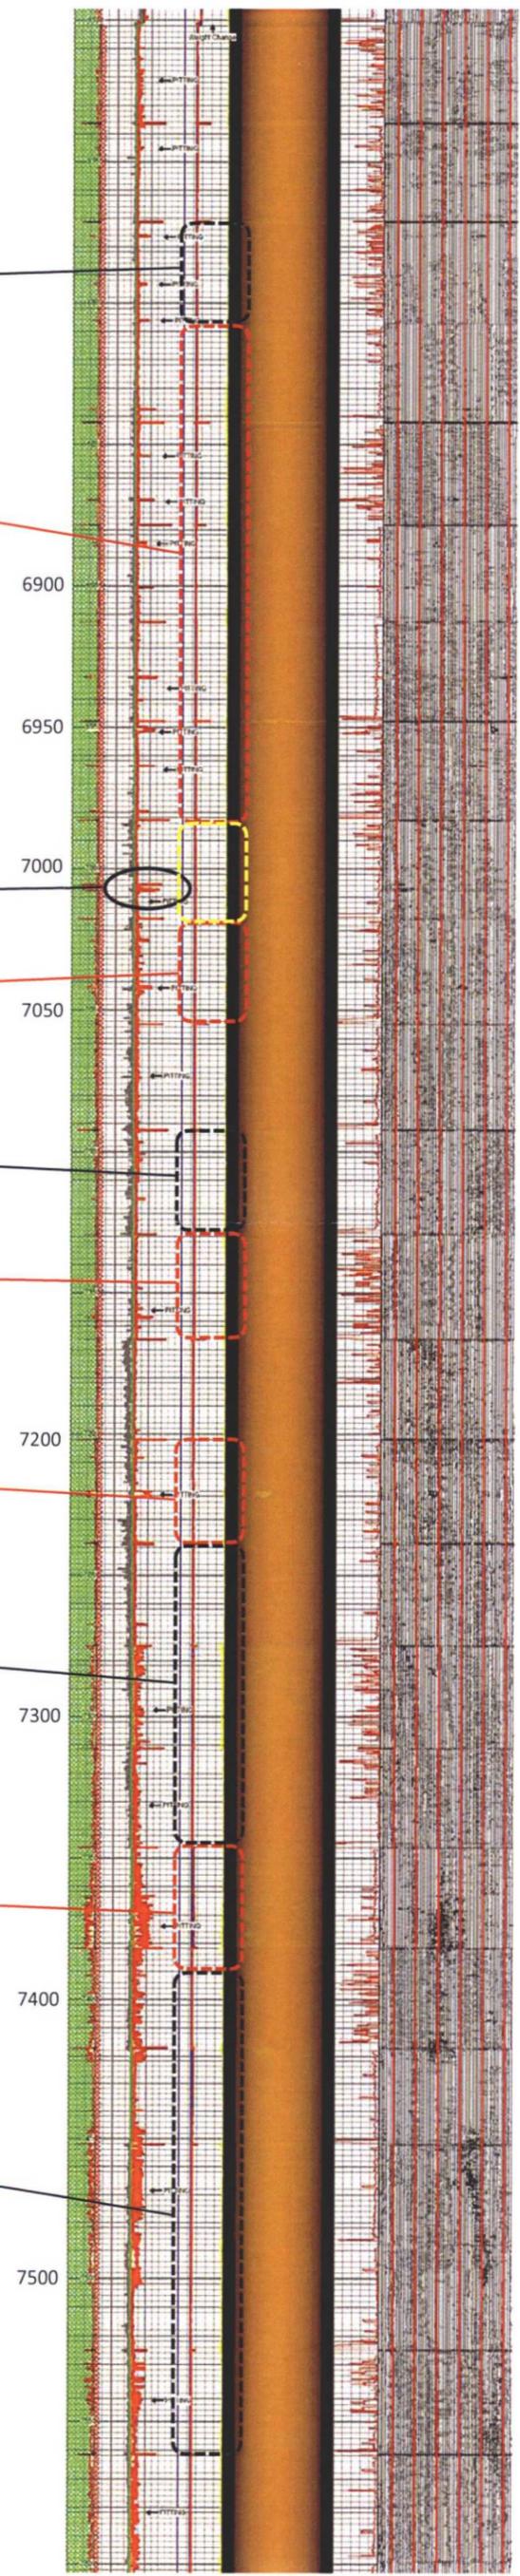
Monument AGI Well No. 1 (30-025-40002)
 Casing Inspection Log: August 24, 2016
 Casing Assessment Figure 2: 6700' to 7600'

Note: Casing without notations was assessed as fair to good condition.

6771 to 6806: casing characterized as "bad" in CI log

6808 to 6982: casing characterized as "severe" in CI log

7008: possible hole identified by CI log
 Not identified in RA tracer log

7018 to 7054: casing characterized as "severe" in CI log

7093 to 7128: casing characterized as "bad" in CI log

7130 to 7166: casing characterized as "severe" in CI log

7202 to 7238: casing characterized as "severe" in CI log

7239 to 7345: casing characterized as "bad" in CI log

7347 to 7381: casing characterized as "severe" in CI log

7382 to 7560: casing characterized as "bad" in CI log

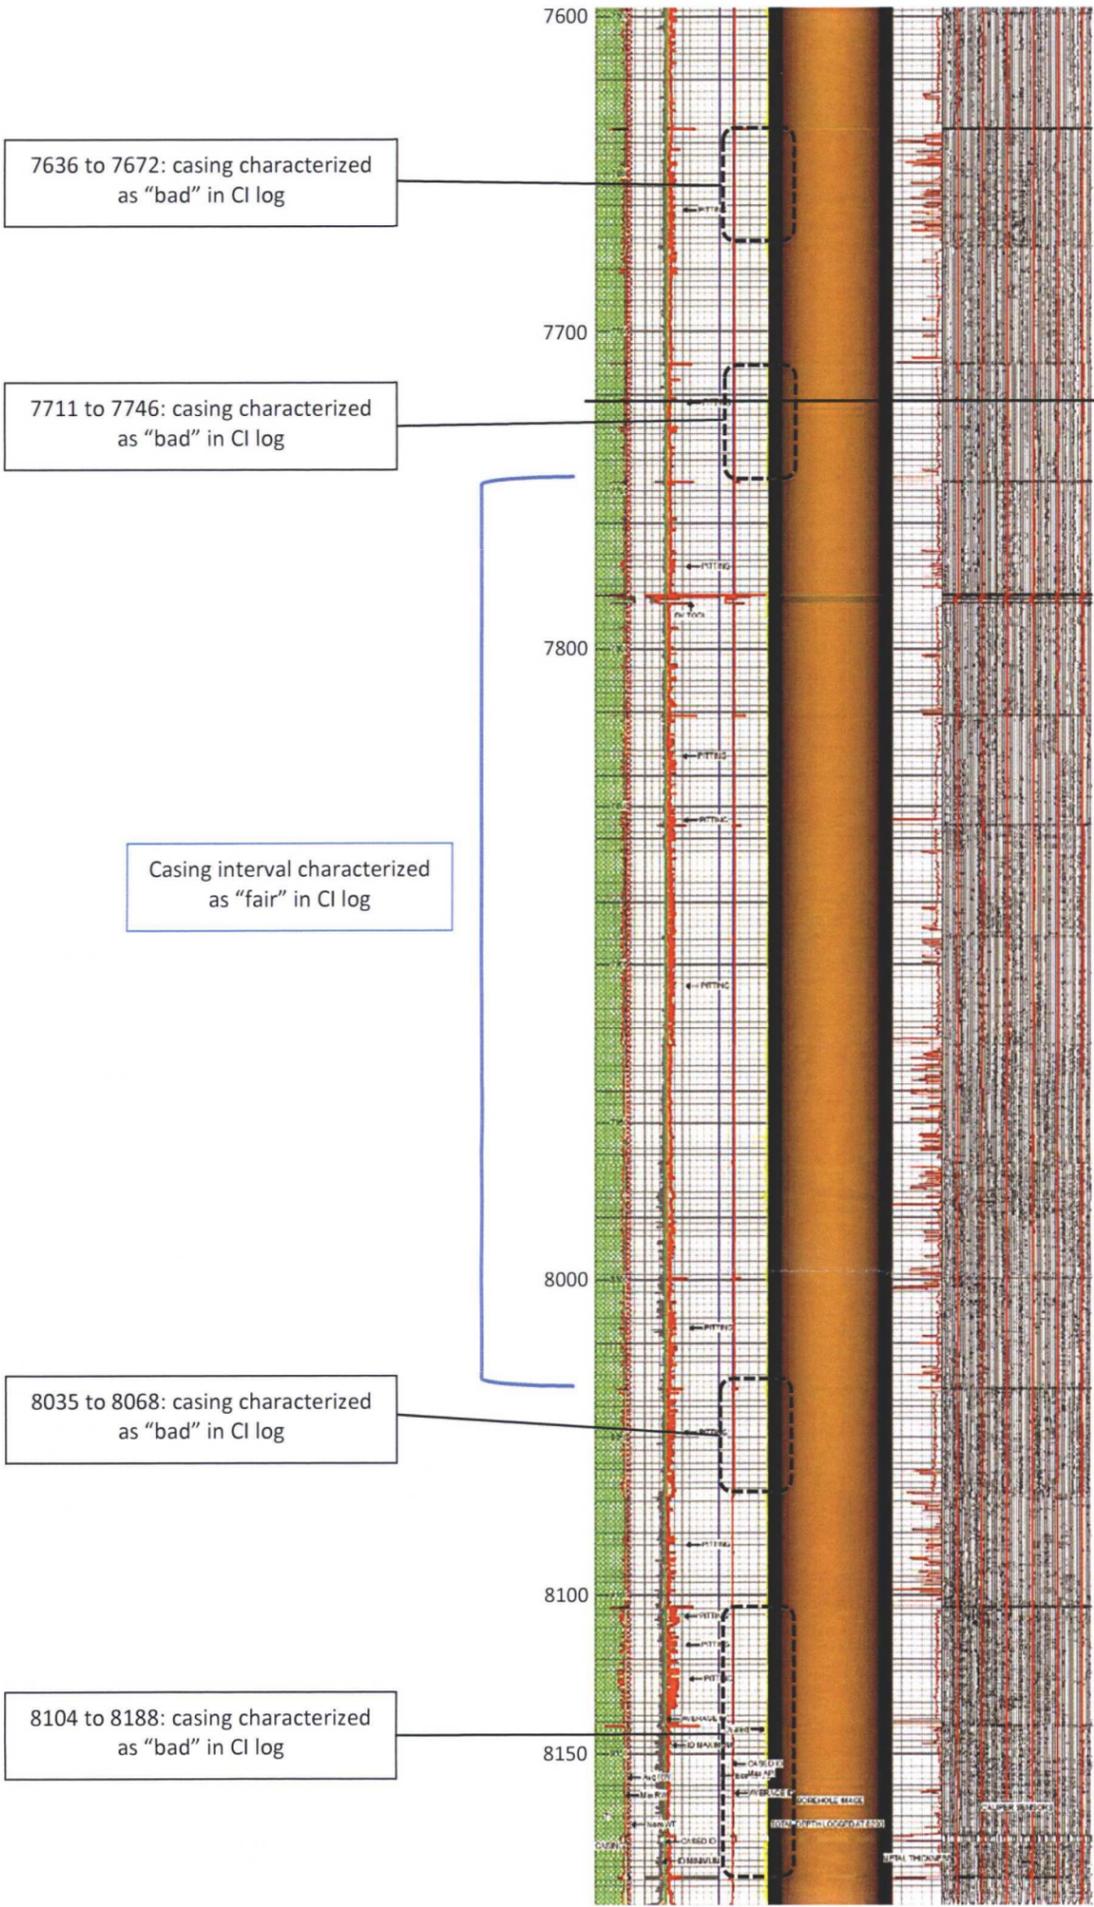
Monument AGI Well No. 1 (30-025-40002)
 Casing Inspection Log: August 24, 2016
 Casing Assessment Figure 3: 7600' to 8200'

Note: Casing without notations was assessed as fair to good condition
