DAUGHERITY ST. #1

Jackie Brewer D/B/A
Sandlott Energy
Case 14074
OCD Exhibit No. 17

Date: Thursday, October 20, 2005
To: Environmental Compliance Officer, NMOCD District II
Subject: Daugherty State Tank Battery - Sandlott Energy

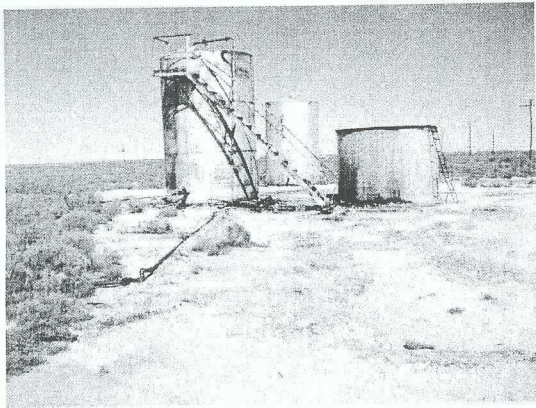
Photo of Tank Battery location, looking north.

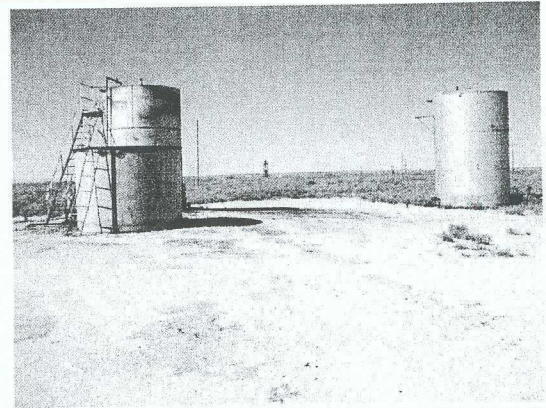
Photo of Tank Battery location, looking west.

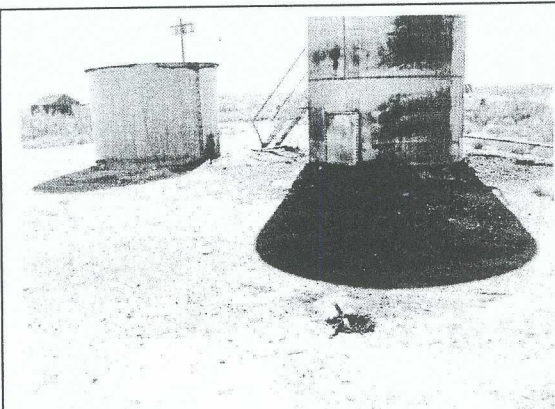
Photo of sample one location, north of tanks.

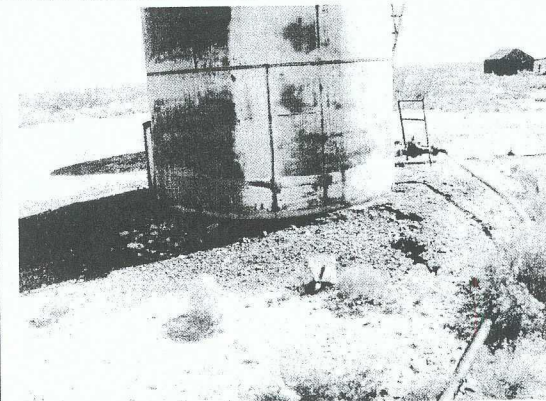
Photo of sample two locations, northwest of tanks.

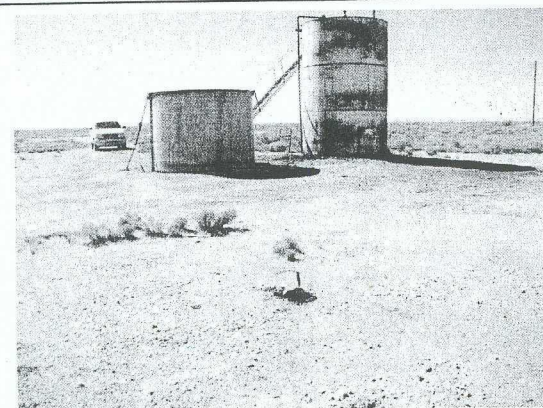
Photo of sample three location, northeast of tanks.

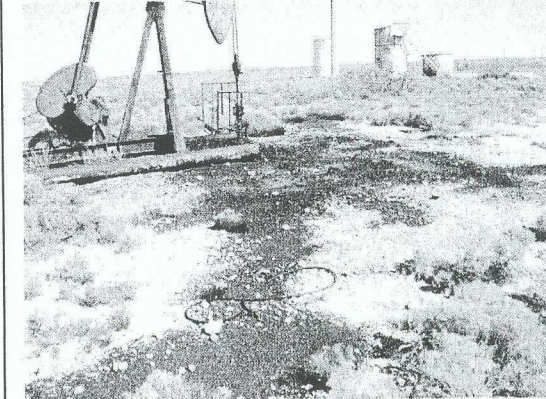
Photo of Tank Battery location from Daugherty State 1 well.
