ADDENDUM

Exhibit No.

Description

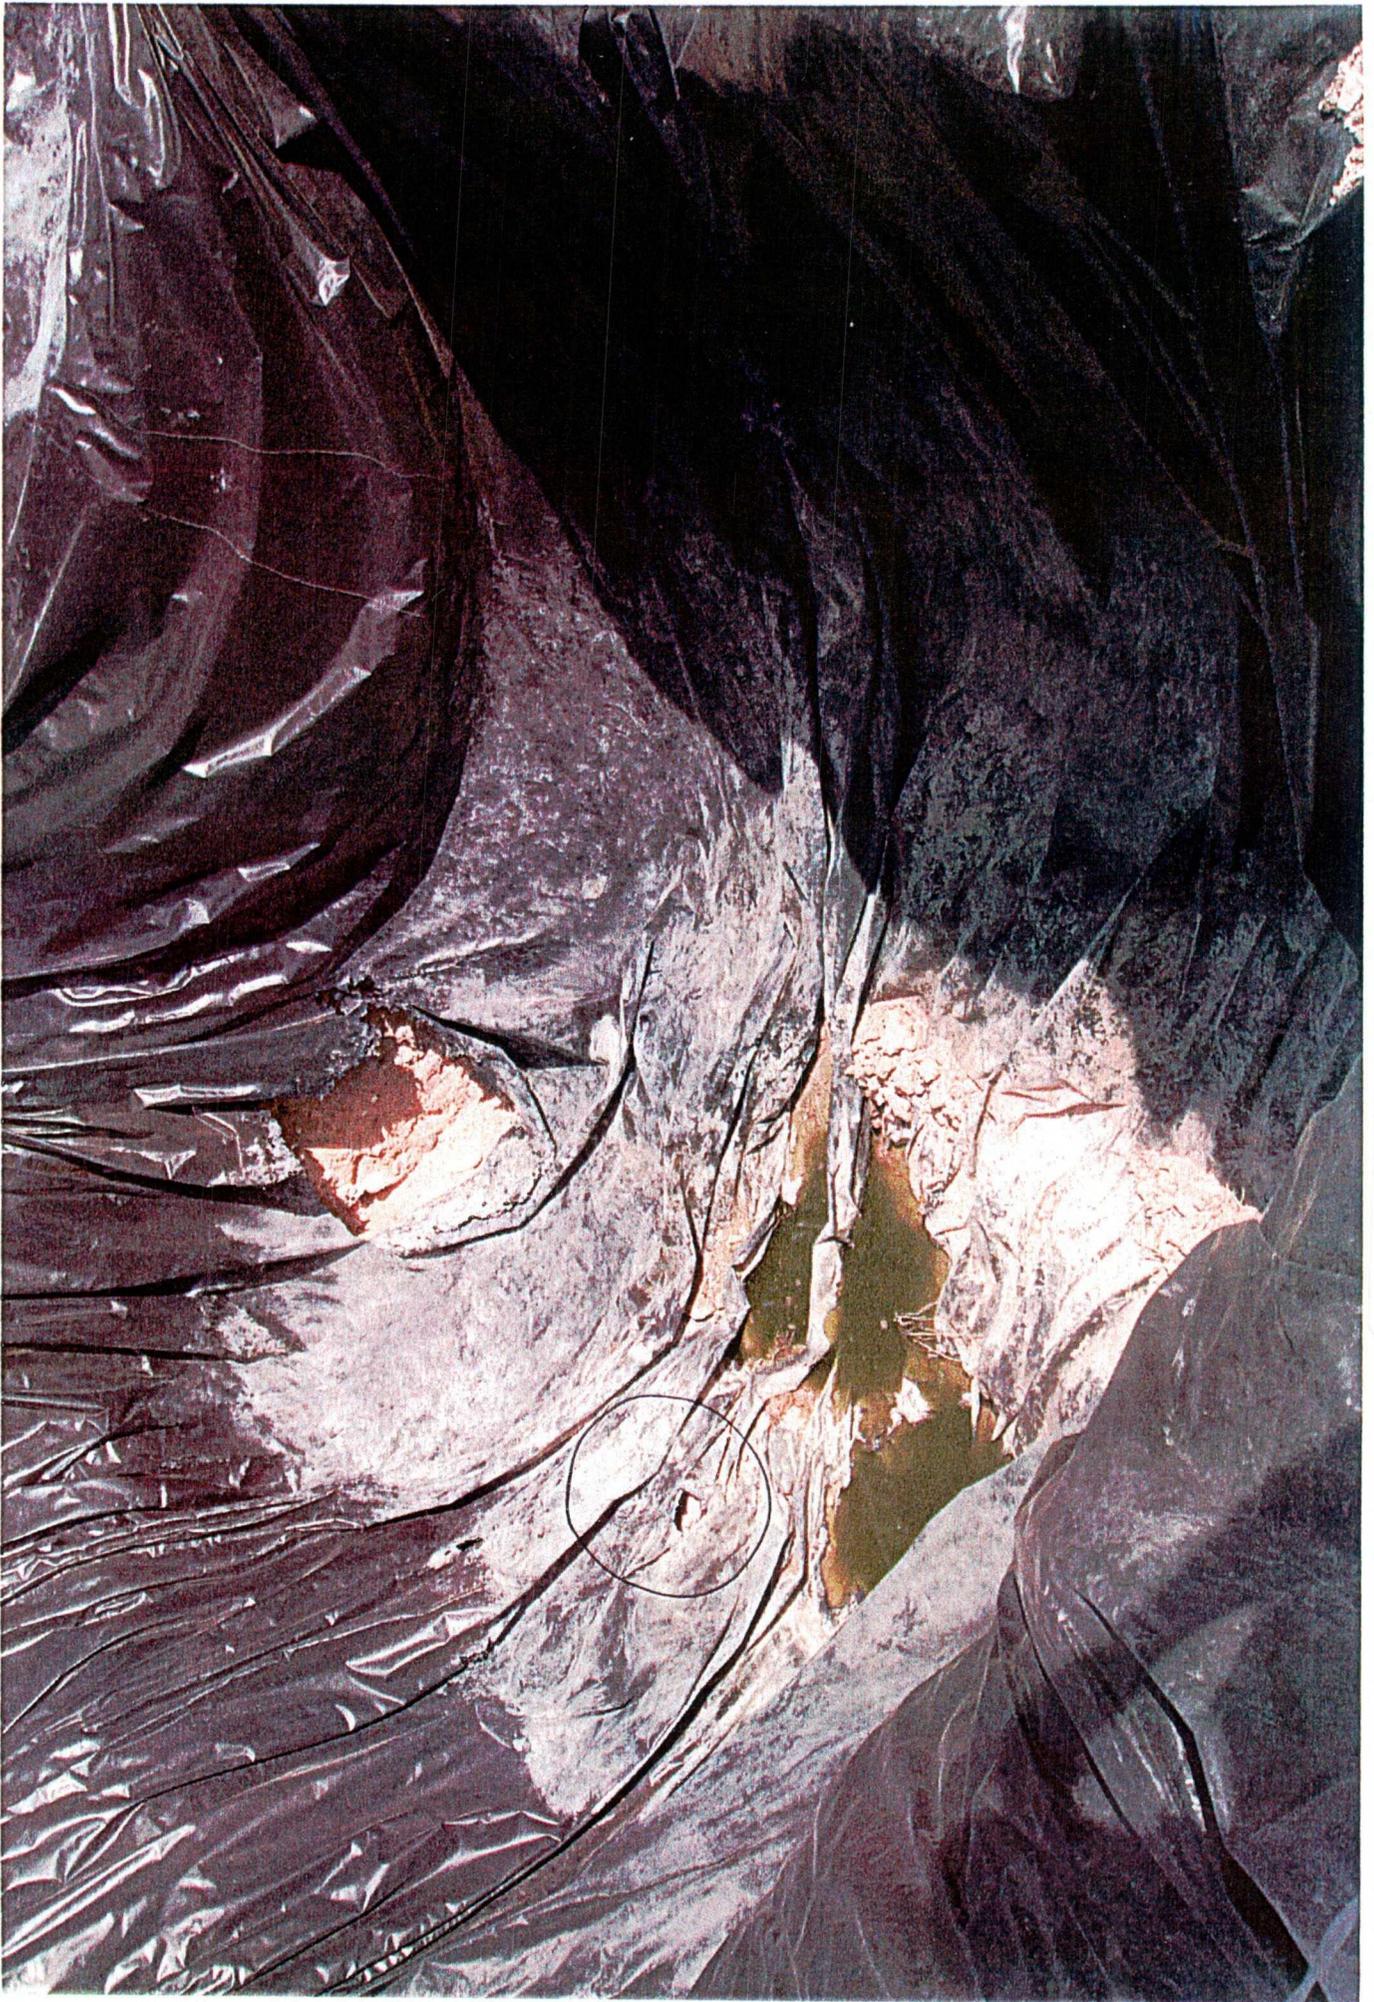
Exhibit 1C

1A	Reserve pit; note that the plastic liner is ruptured.
1B	This is what is left after the drilling rig is shut down.
1C	Holes in the liner; fluids have leached into the soils.
1D	Work over pit.
1E	Unlined pit.
1F	Pit with trash; the berm material will be pushed in at closure.
1G	Hydrocarbons in pit.
1H	Trash in pit.
1I	Drying stage.
1J	Drying stage.
1K	Drying stage.
1L	Drying stage; the materials that were dumped on edge will likely be put back in.

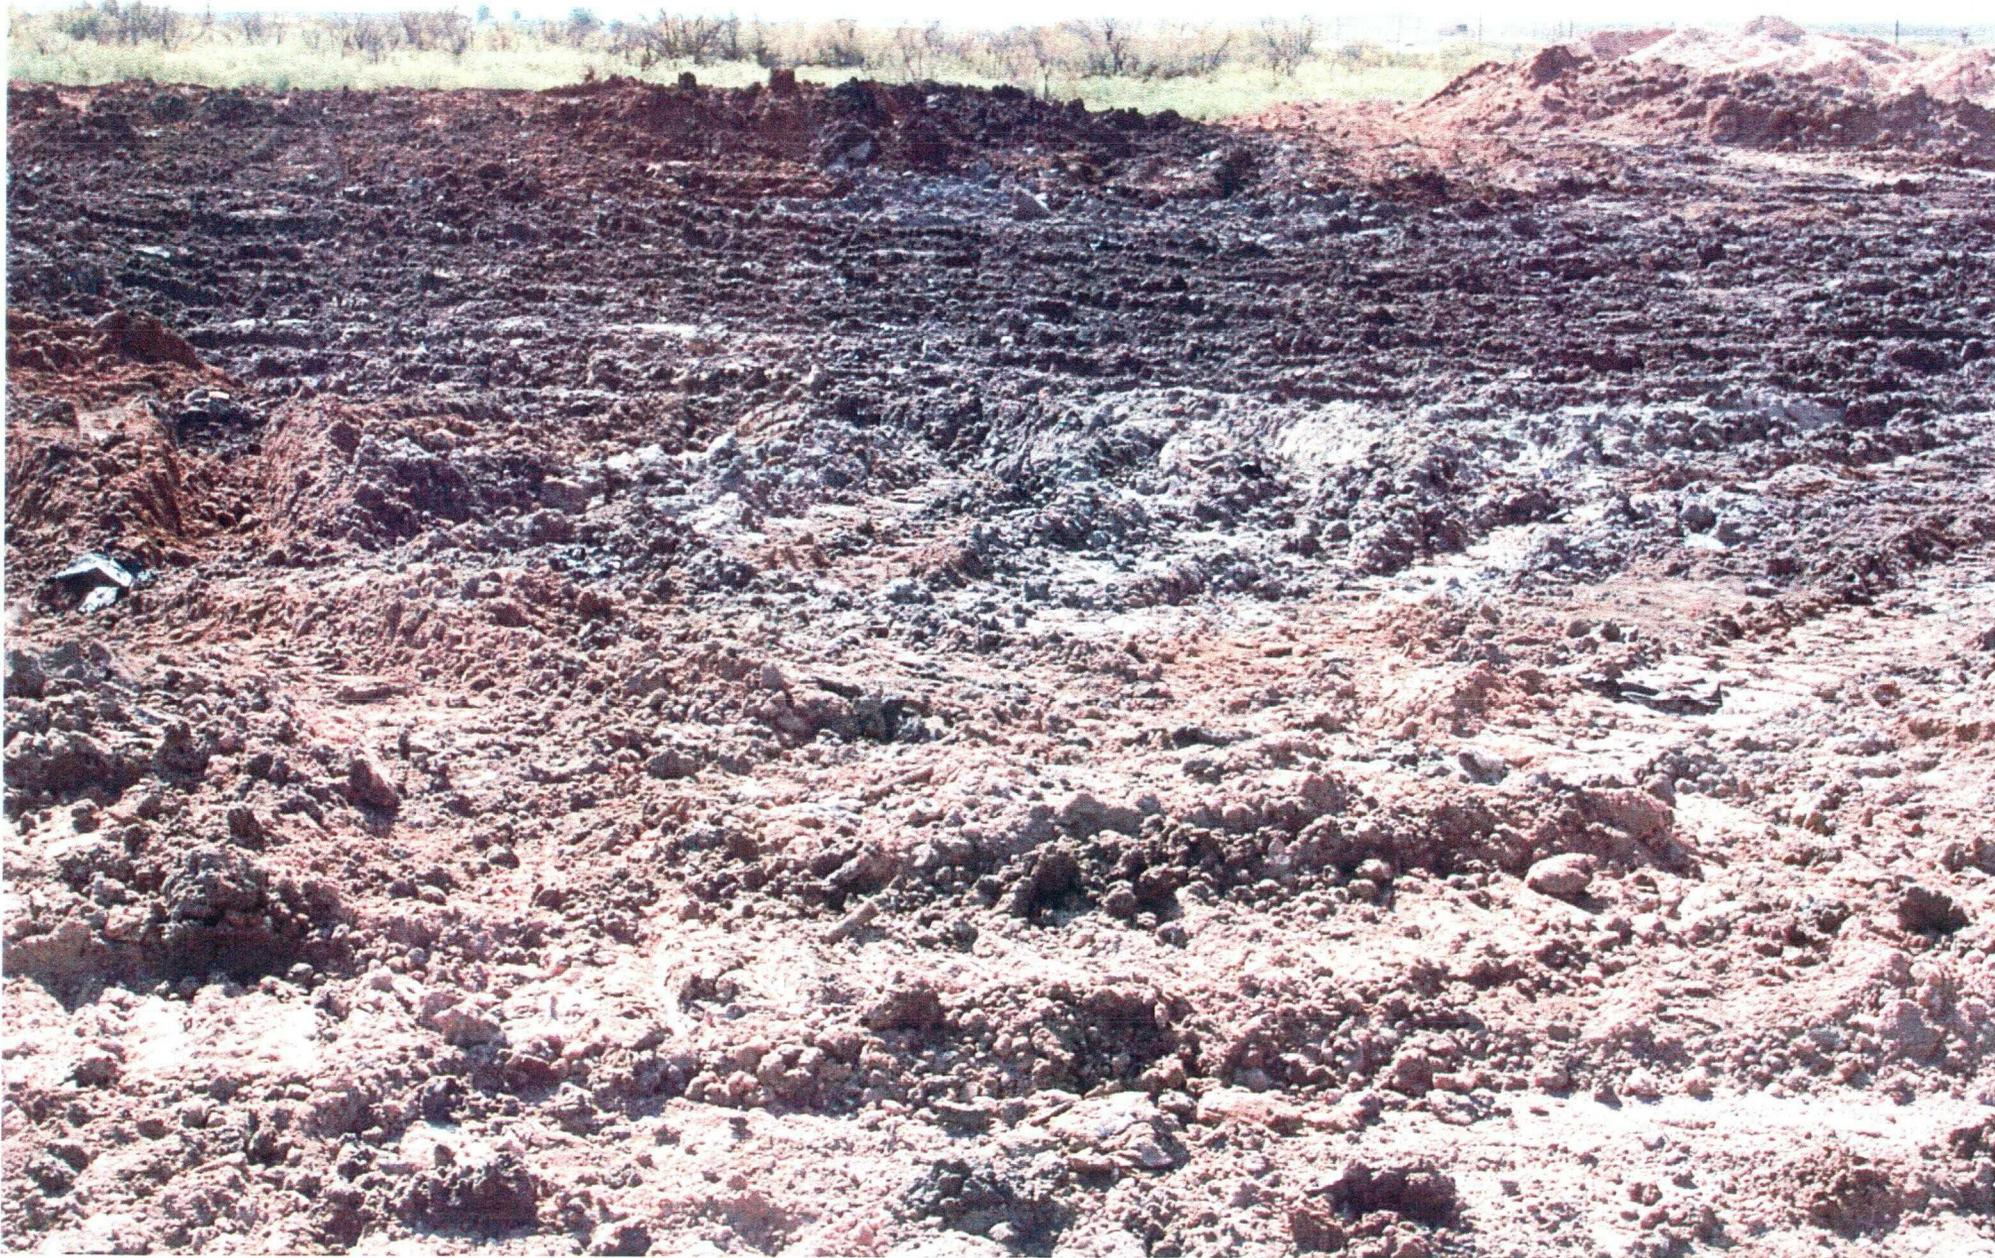
Exhibit 1M

1M	Cover up stage; contamination is readily visible.
1N	Coverage and closure commences.
1O	Dozer at work; in proximity to a wash and gulley; rain water comes through Pecos River drainage.
1P	Finished (?) product.
1Q	Finished (?).
1R	Finished (?).
1S	The fly-off or drain-off frm closed pit has killed vegetation.
1T	Ditto.
1U	The fence line shows that there is either fly-off or drain-off away from the original pit site.
1V	Is this reclaimed, restored, and revegetated?
1W	Is this clean?
1X - 1LL	Miscellaneous photographs.
