1. Type of Well: Oil Well	Gas Well Other INJECTOR		8. Well Number	69
2. Name of Operator			9. OGRID Numb	er 4323
CHEVRON U.S.A. INC.				
3. Address of Operator	5V 4 9 70705		10. Pool name or	
15 SMITH ROAD, MIDLAND, TI	EXAS /9/05		DOLLAKHIDE I	UBB DRINKARD

Major Rig Work Over (MRWO) Tubing Repair

•	Job Start Date: 7/10/2014 Job End Date: 7/26/2014
Well Name WEST DOLLARHIDE DRINKARD	Lease West Dollarhide Drinkard Unit	Field Name Dollarhide - Primary	Business Unit Mid-Continent
UNIT 069		Donathing Timilary	
Ground Elevation (ft) Original RKB (ft)	Current RKB Elevation		Mud Line Elevation (ft) Water Depth (ft)
Report Start Date: 7/10/2014			
MOVE RIG REV UNIT & ALL TKS & I	-Olub	Com	
TGSM REV JSA ON RU	EQUIP		
RU KEY RIG 399			
CREW TRAVEL			
NO ACTIVITY ON LOCATION			
Report Start Date: 7/11/2014			
Neport Guit Date. 111 112014	The second secon	Com	William Control of the Control of th
NO ACTIVITY ON LOCATION			
CREW TRAVEL			
	U WIRELINE PERF RD WIRELINE (
	OWN PUMP 11 BBW DOWN TBG TE		
HOLDING RIH W/PERF GUN SHOT	4 CIRC HOLES @ 6800' POOH OPI	EN TO TK NO FLOW RD WIRELI	EPTH POOH BLEED DOWN WELL PLUG NE .
NOWH COULD NOT GET CAR OF A	ATIONAL WH WROTE HWP HEAT	ANU COT POTU CAD CET	
N

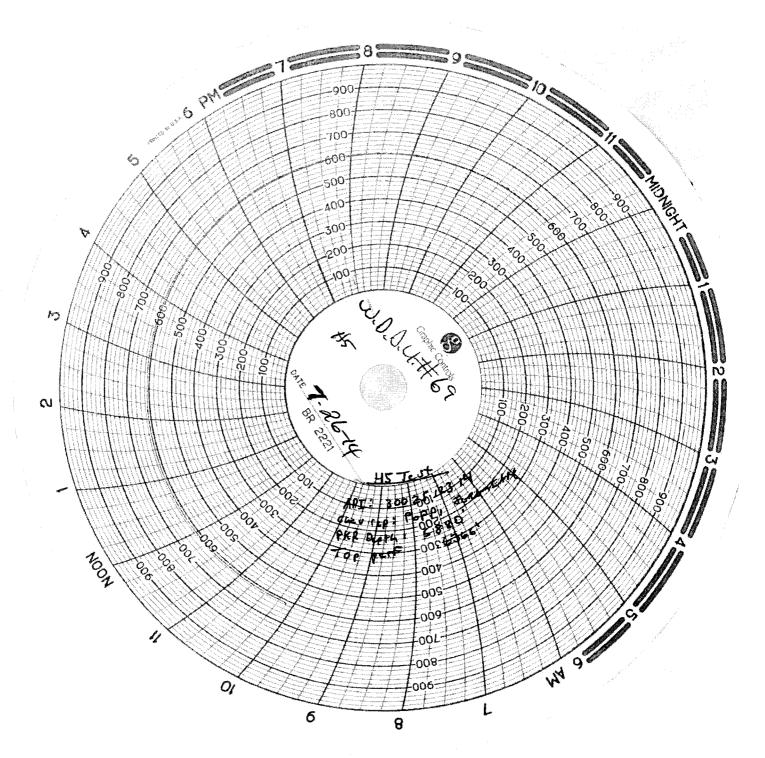
M:		c. 32, Township S024, Range E	DATE CHKD:	Apr. 30, 201	14	
.D: Dollarhide (W SE/UNIT: West D JNTY: Lea		inkard Unit	BY: WELL: STATE:	J. Daraie WDDU #069 New Mexico)	
SP COM	UD DATE: MP. DATE: EPENED: STATUS:	4/11/1954 5/20/1954 3/30/79 Injector (water)	Elevat E	KB = +13' ion = 3158'GL TD = 6890' TD = 6471' API = 3002512314 NO = FB3253		
12-1/4*			5/1954 : First entry, comp			
hole			3/1970: Conversion to (nj from 5644'-6828'.	ection, Ran 4" Flus	sh Joint (FJ) liner	
			3/1984; Coll tubing c/o. A	cidize w/ 5000 gal	Is 15% NEFE HCI	
			12/1998: Tubing failure .			
			8/2000 : Coil tubing c/o ar PBTD @ 6471'.	id acidize w/ 5 bb!	s 15 %NEFE HCl. New	
			2/2014: Packer failure. Wrig ready pending TRRC a		D&C for repair (job	
m	A STATE OF THE STA	Tubing Tubing - OD 2-3/8* Tubing Sub - OD 2-3/8* Casing Surface Csg Production Csg. FJ Liner	2-3.8° J-55 4.70# T&C EUE1.995 ID 1.901 Drift 2-3.8° J-55 4.70# T&C EUE1.995 ID 1.901 Drift 8-5.6° 24# J-55 Unkown thread 8.097 ID 7.972 drift 5-1/2° 9.00# J-20 Buttress 5.192 ID 5.067 drift 4° 11.60# Round short 3.428° ID 3.303° drift	Top depth	Bottom Dep 13 00 5913 00 Bottom Dep 13.00 13.00 5644.00	5913 5917

ricta 5080 inkad		Two Cosings Icome, Top of Lnr. © 5844* Packer set © 5890* Perf. Drinkard: 6366*-80*. 84*-8	ts at location 17-, 97-6402; 63:-69:w/56 shots (28: @ -2 sp	476 ft	•

Thanks for the contacting me and providing the e-mail with attachments. Based on the information provided in your well diagram, I would suggest that you also include in your letter the fact that the interval above the perforations is "double-lined"; that this portion of the well has two casing strings (liner and production), both with cement. This will reduce any concern that failure (pitting, etc.) of casing with the packer will result in injection out of zone since I'm confident that this proposed location for the packer is above the Unitized Section of the Drinkard. PRG
