1R - 425-3

Corrective Action Plan

Vacuum K-35-1 Boot
UL K Sec 35 T17S R35E
OCD Case Number 1R0425-03

February 28th, 2007

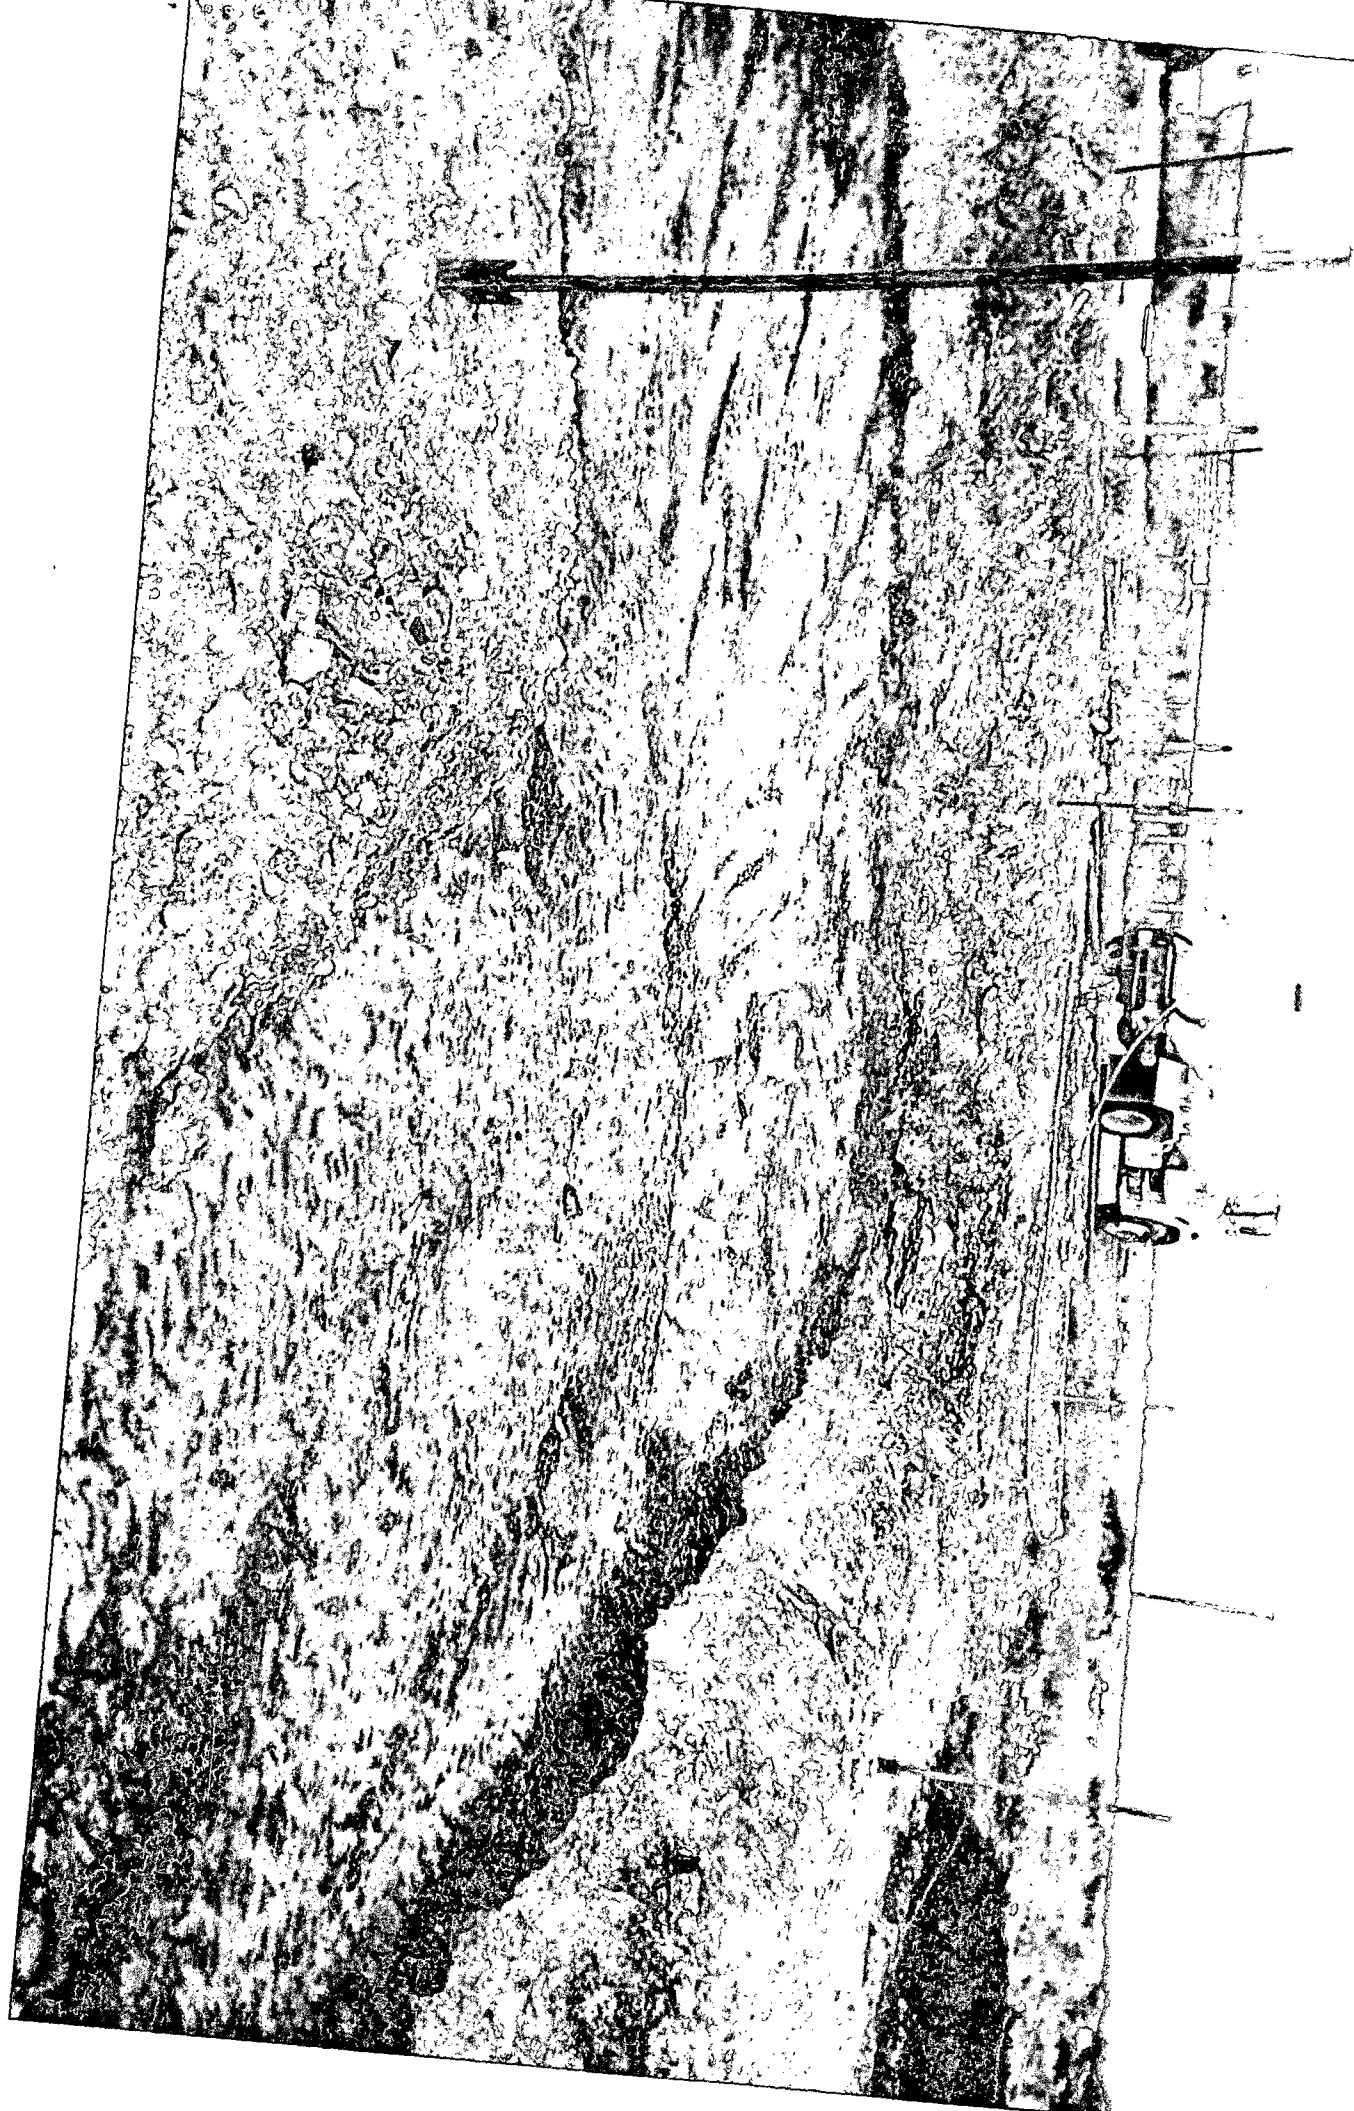
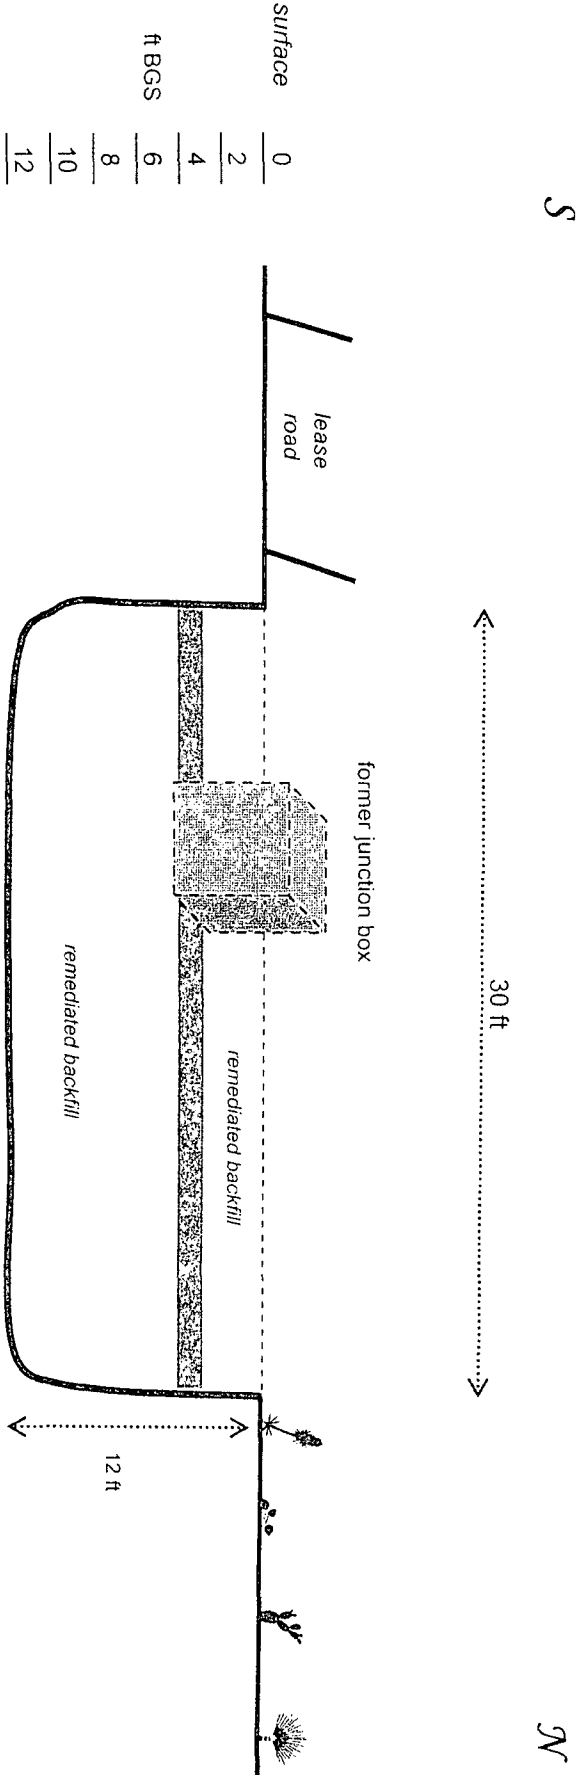
Vacuum K-35-1 boot

The old, wooden junction box was removed and soils beneath it were excavated to a depth of approximately 12 feet over a 30 by 30 ft area. The excavated soil was blended on site and then backfilled into the excavation to a depth of 4 feet below ground surface. At 4 feet depth, a compacted clay barrier was installed to inhibit further downward migration of any remaining chlorides, by limiting downward infiltration below the barrier and by facilitating evapo-transpiration above it. The excavation was then backfilled with native material.

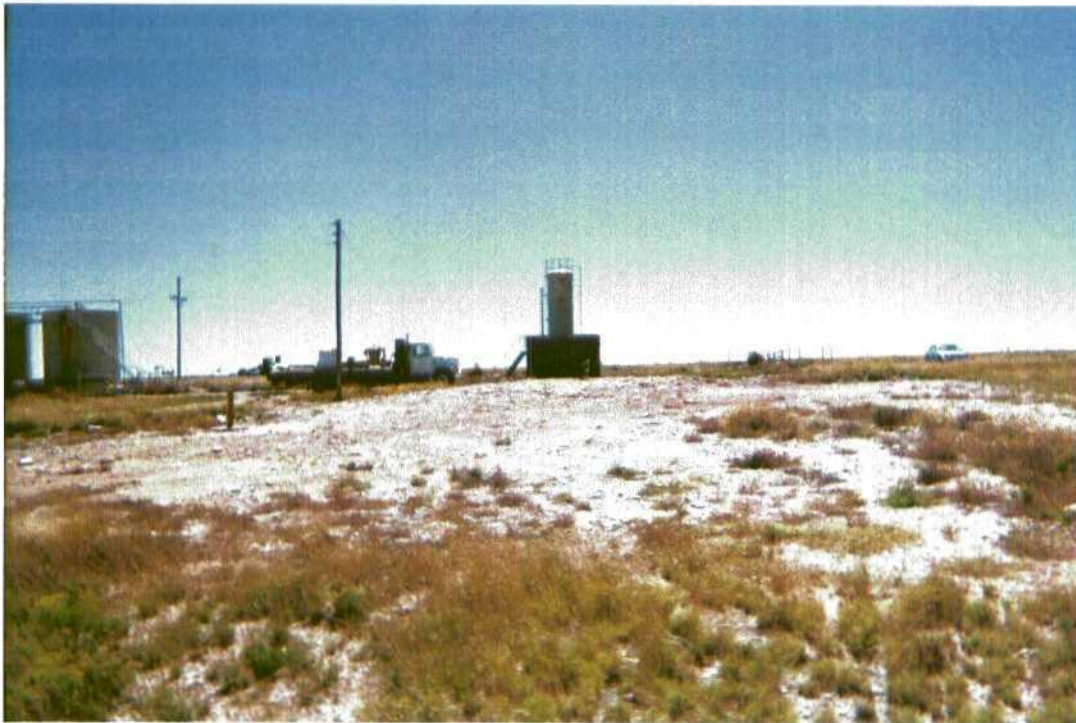
Figure 4 – Harrison and Cooper drilling K-35-1. View looking south from edge of affected area. Photograph taken Friday, June 23rd, 2006.

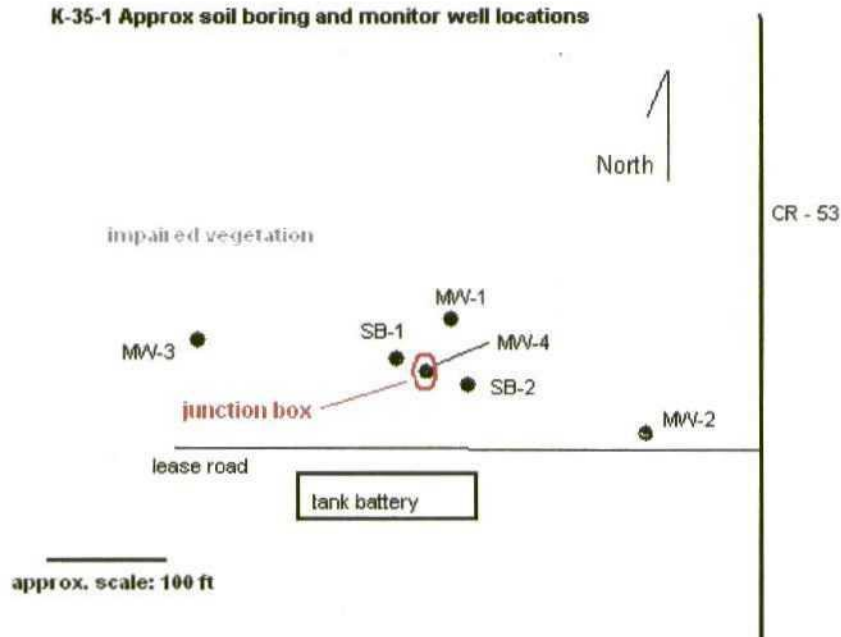
K-35-1 Approx soil boring and monitor well locations

Figure 5 – Approximate soil boring and monitor well locations.

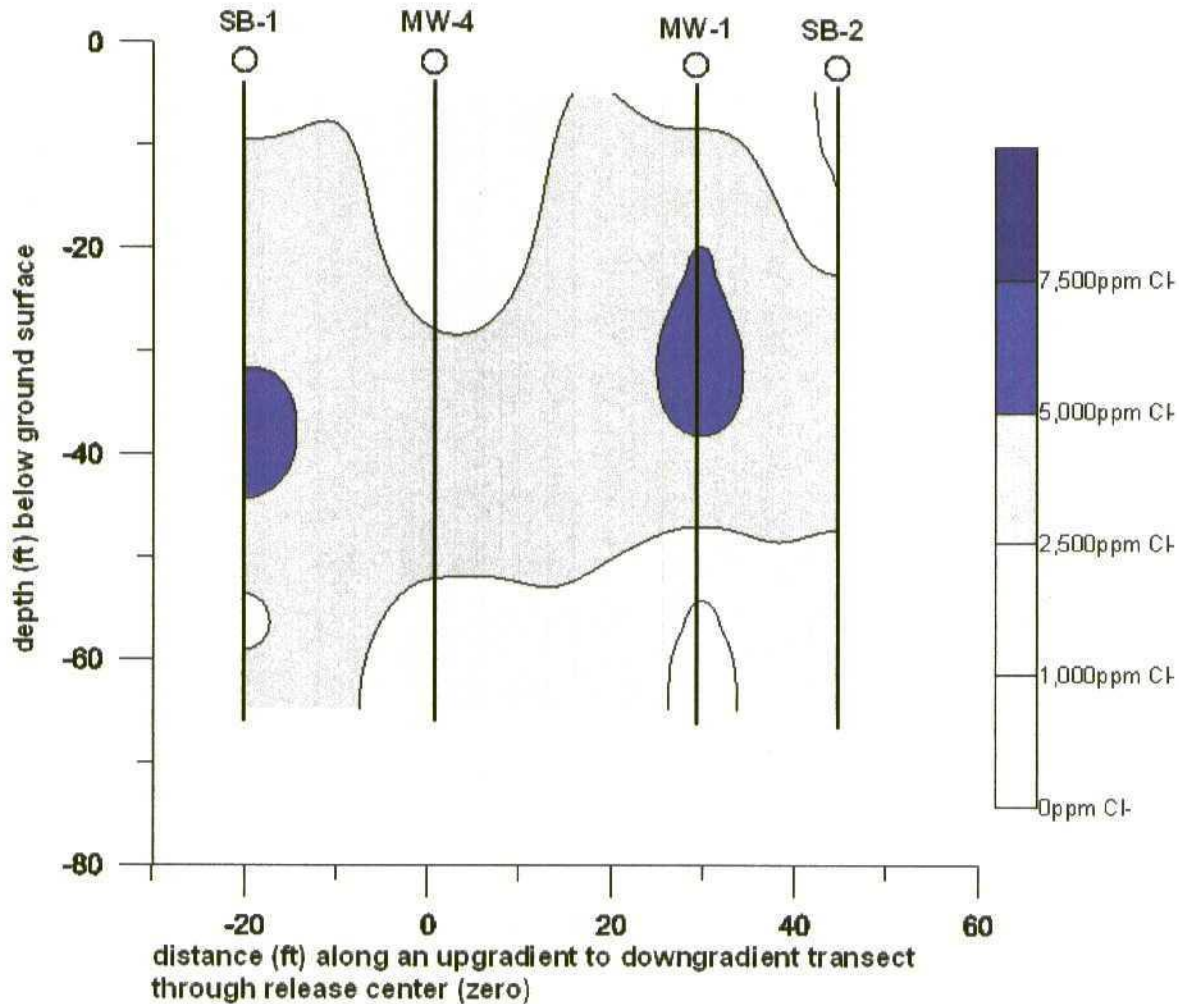
Field measurement, confirmed by laboratory analysis, revealed that soils near the boot were impacted by chlorides from the surface to the present water table; (Figure 6). There were no hydrocarbons revealed by field organic vapor analysis, also confirmed by laboratory analysis.

Figure 6 – Interpolated soil chloride concentrations in a vertical slice along an upgradient to downgradient transect across the former boot (from SB-1 to SB-2, w/ estimated equivalent downgradient distance for MW-1).

Elevated soil chloride concentrations were found near the surface and with depth in samples taken at the boot and approximately 50 ft downgradient. All of these sampling points were located within an area of impaired vegetation (outlined in Figure 5). More distant soil samples taken when installing upgradient (MW-3) and downgradient (MW-2) monitor wells had chloride levels below 125 ppm throughout their depth. It is of note that measured soil chloride contamination is correlated with the apparent surface effects on vegetation.

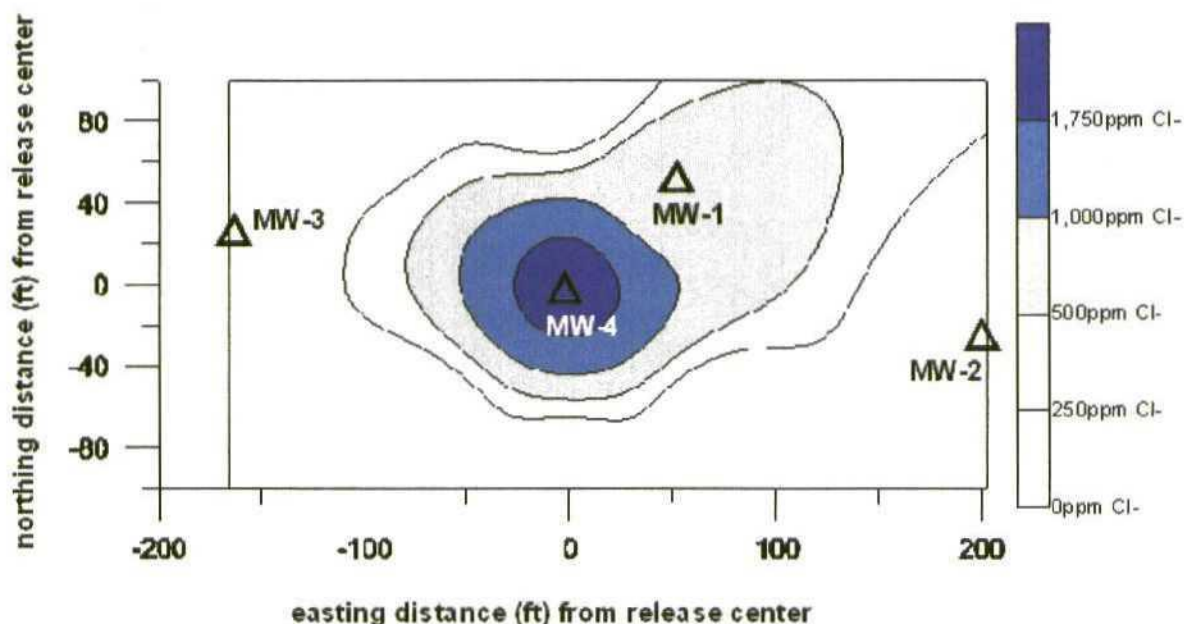
Figure 7- Interpolated groundwater chloride concentrations sampled October 19th, 2006 (plan-view).

The center of mass of groundwater chlorides, measured on 10/19/2006, is clearly located beneath the boot (MW-4). Although the concentration observed (2,000 ppm) is above the NM groundwater standard of 250, it is not alarming. Rather, this relatively moderate elevation in groundwater chlorides over the effected area is within the range that natural dilution would be expected to attenuate without substantial downgradient effects.

The data presented in tabular form with Figure 7 indicate that there has been some apparent change in chloride concentrations from the initial sampling date in June to October. However, it will require one or two follow-up quarterly measurements in order to determine if groundwater chloride concentrations are, in fact, changing, or if these short term variances reflect sampling or measurement error.

1. **Groundwater chloride removal and monitoring.** Groundwater will be withdrawn from the monitor well (MW-4) near the former boot to determine if limited pumping will effectively attenuate chloride concentrations. We anticipate withdrawing as much water as the well will deliver over the course of (approximately) a few hours twice weekly for about a month. We will monitor groundwater chloride concentrations during each pumping event to determine if this effort is successful in substantially attenuating chloride levels, or if further pumping or another remedy seems warranted. All chloride-laden groundwater removed from the well will be handled according to regulations and protocols appropriate for oil field produced waters.

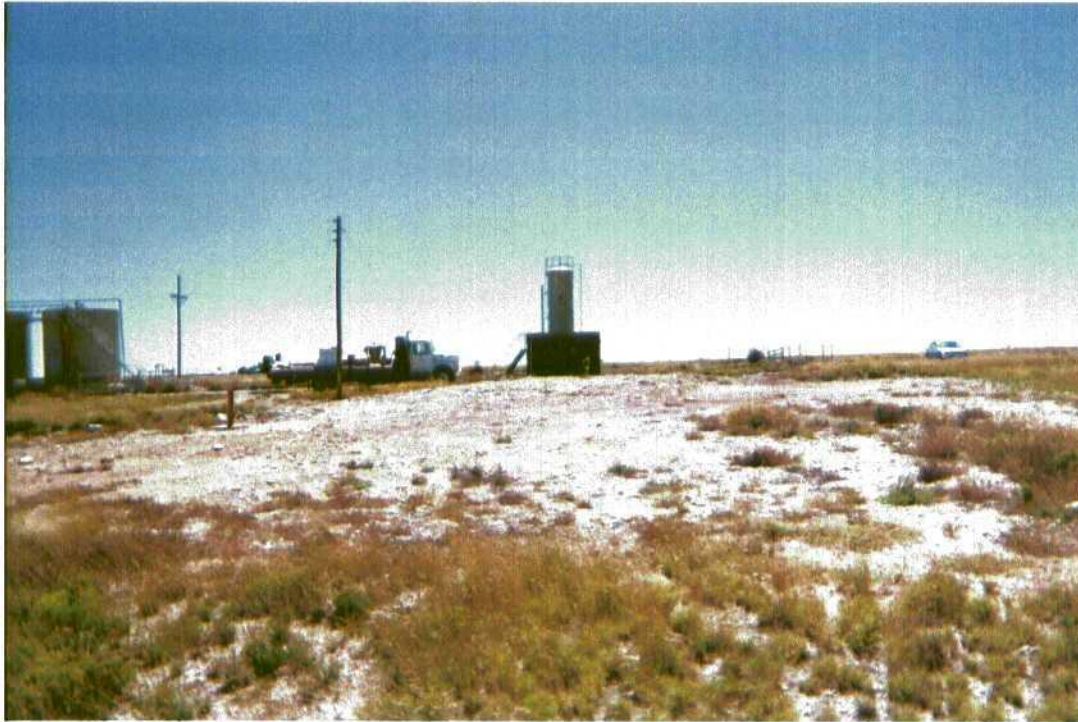
Figure 8 – View across the K-35-1 boot, looking south; (photograph taken October, 2006). The area of impacted vegetation measures approximately 135 ft north/south by 115 ft east/west. See also Figure 5.

Vegetation has been affected over an approximate area of 135 by 115 ft, centered mostly north of the former K-35-1 boot (Figure 8). Nevertheless, it appears that vegetation is gradually becoming reestablished along the margins of this area, suggesting that soil amendments (gypsum and water) would likely be sufficient to effectively restore plant life to its natural state.

2. **Surface ecological restoration.** An area of approximately 135 ft by 115 ft around (mostly north of) the former boot is largely devoid of vegetation (Figures 5 and 8). The most impacted area near the former boot may be partially an effect of earth moving activity and maintenance traffic as much as salt contamination. Nevertheless, in order to determine an appropriate soil remedy to facility re-vegetation, near-surface soil samples will be taken at selected, representative locations and sampled for chlorides. These results will be used develop appropriate soil remedies, which may include soil amendments (likely gypsum), watering, and/or the addition of clean soil where this is warranted. The re-establishment of native vegetation will serve to substantially enhance evapo-transpiration, and to thus limit the downward migration of water and chlorides.
