Re: Variance Request – Freedom 36 State SWD 1 (nRM2014839790)

## Release Notification

| Site Name: Freedom 36 State SWD 1 | Site Type: Battery Pad |

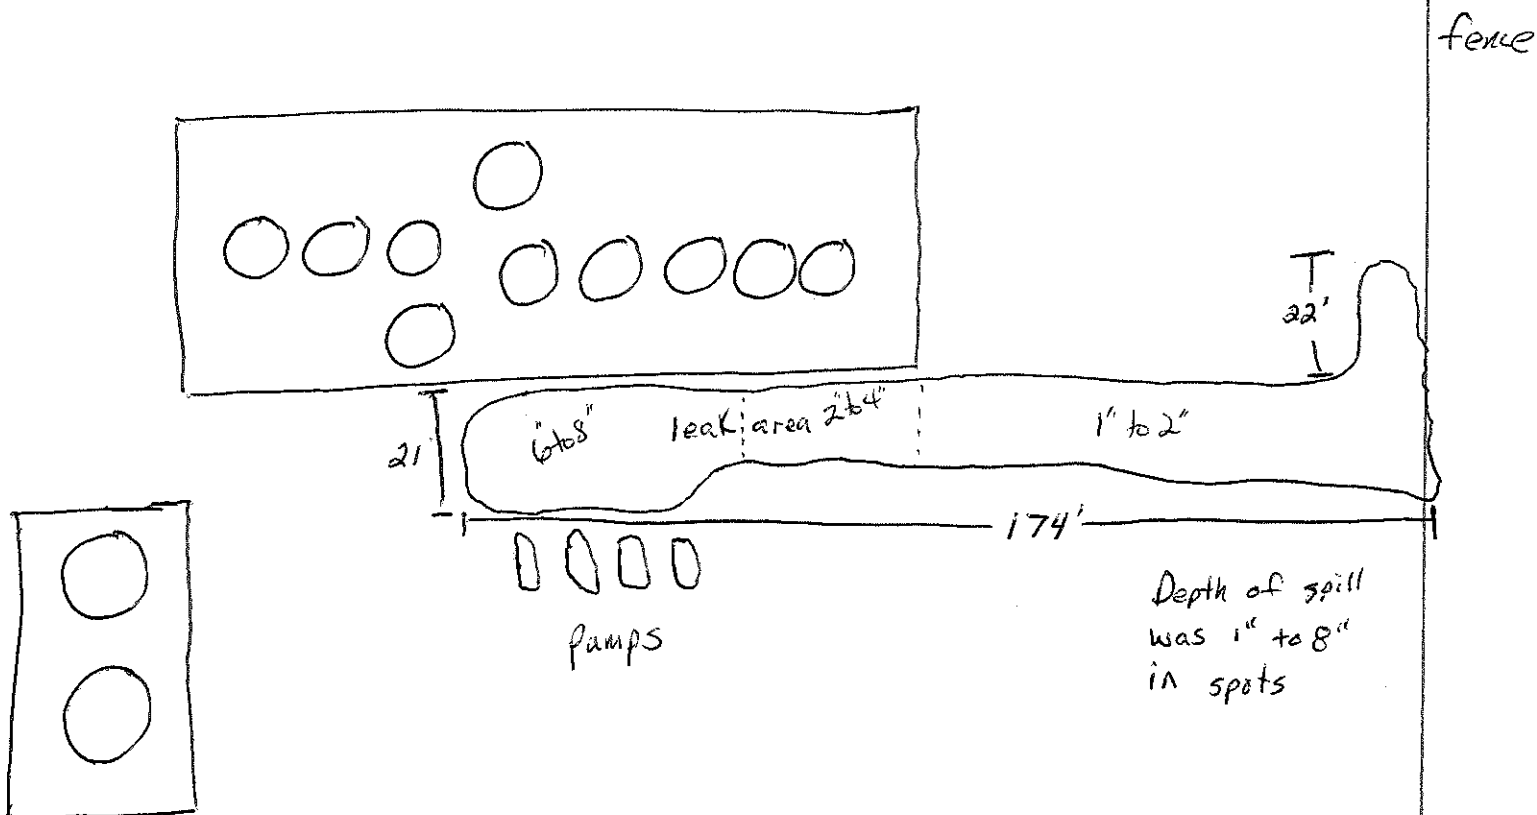
Freedom 36 State I SWD

We found a pin hole in the suction side of charge pump going to the SWD injection pump. We replaced the leaking spoil piece with a plastic coated spoil piece to prevent this from happening again. We released 15 barrels of produced water outside of containment and recovered 10 barrels. We will hydrovac the impacted soil and delineate area to determine pathway forward.

Depth of spill  
was 1" to 8"  
in spots

Cimarex Energy is requesting a deviation on the sampling standard of 200 square feet. We are requesting permission to sample a 400 square foot area to be more representative of the area where the spill occurred. Initial C-141 is included.
