*Amoco production well -  
bad cement job. No cement  
above or below Glorita*

*Amoco disposal well -  
in Glorita.*

Amoco 20N-33E-See 12

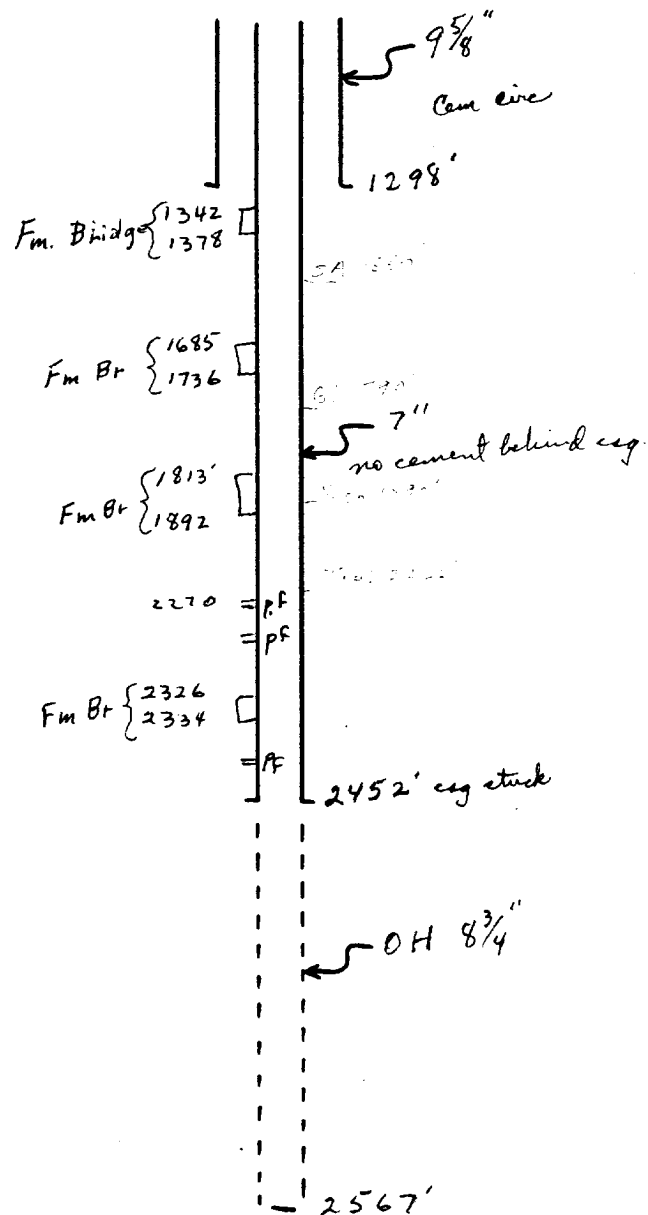
I have been puzzling over this deal -  
have looked at all logs. It is a very strange  
situation of unusual casing, poor cement on prod. cas.  
etc. The squeeze cementing is obviously for  
isolation of Tubb.

My concern is, what might happen when  
massive injection into the Glorieta begins (with  
full scale production). Could pressures at Sec 12,  
20N-33E increase the normal 200-300 psi Glorieta  
to a point that fluids from that zone might move  
up (and maybe down) outside of casing?
