Subject: **Remediation and Closure Report**
Oxy Permian LTD
McMillan 24 State #2 Battery
30-015-32336 2RP-2503

McMillan 24 State 2 Battery
Oxy - NM - South
Eddy County, New Mexico
Figure 1 - Site Plan

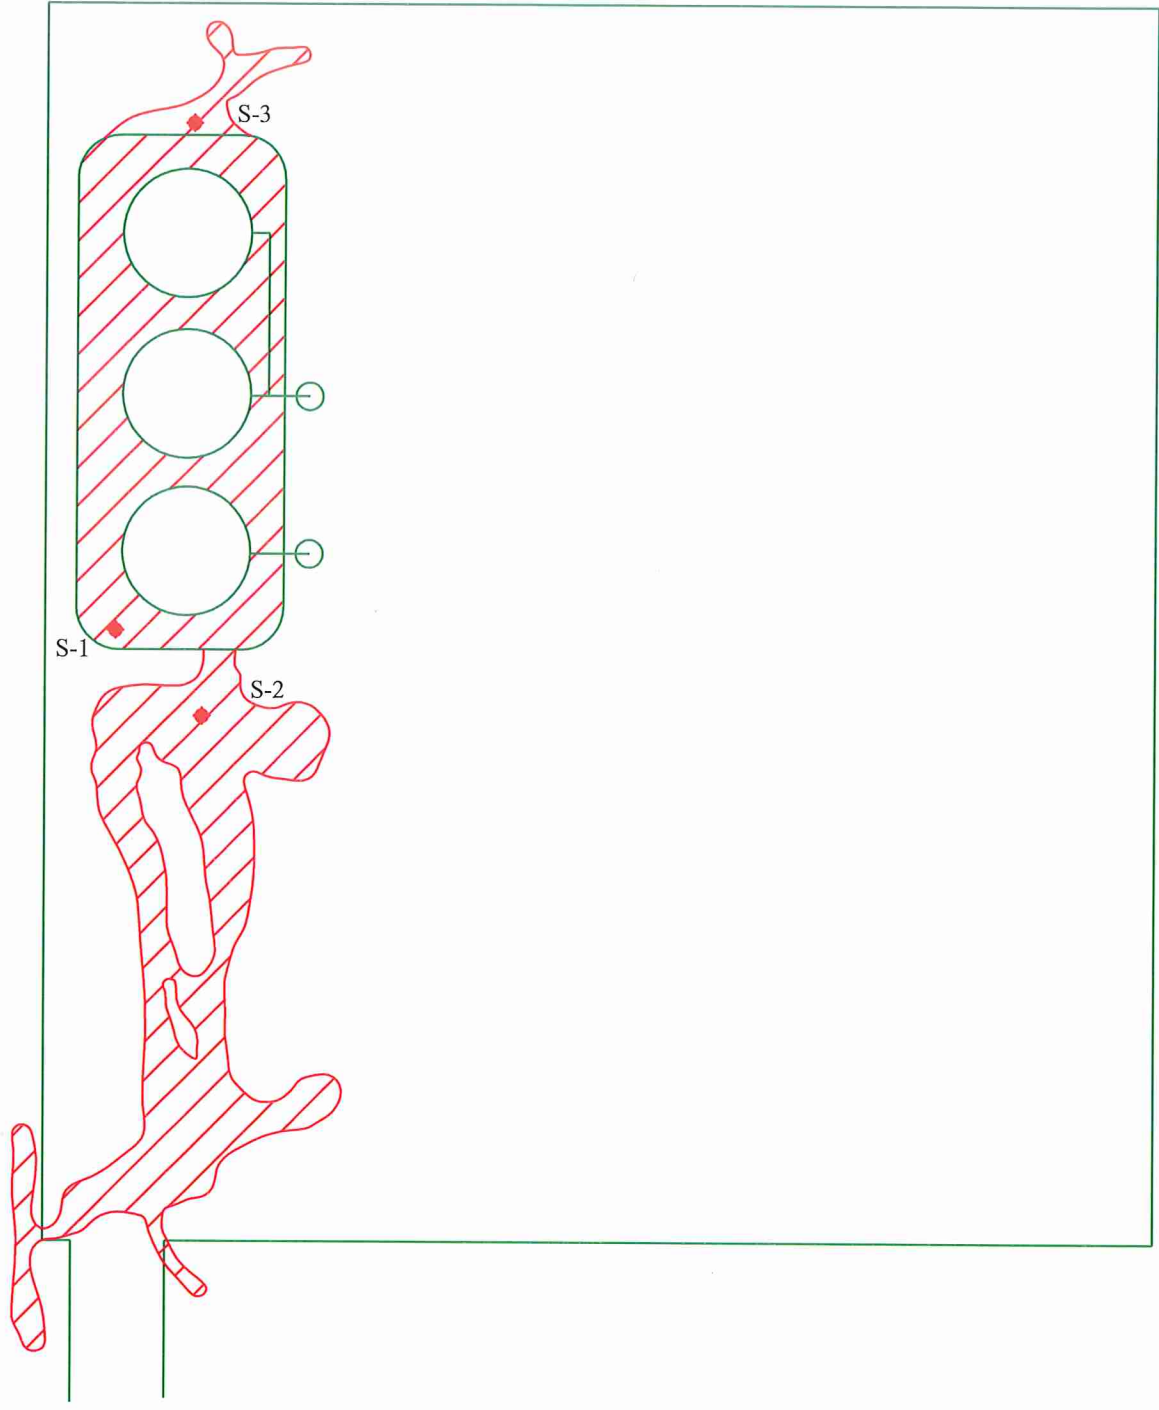
A valve malfunctioned causing the tanks to overflow releasing 400 barrels of oil and 20 barrels of produced water inside the containment of the facility. The release then breached the walls of the containment and flowed south across the location. A vac truck was immediately called to the location and 110 barrels of fluids were recovered. The well was shut-in, the valve was repaired and the facility was put back into service. The area affected was within the facility location pad. The flow path south of the facility on the location measured approximately 165-feet long by 6 to 30 feet at initial breach point. The flow path to the north of the facility measured approximately 20-feet long by 2 to 4 feet wide. See attached site plan in [Appendix I](#).

The impacted area from the south berm, in the vicinity of S-2, down to the lease road was excavated to a depth of 0.5-deep and the impacted soil in the vicinity of S-3 was excavated to a depth of 1.5-feet. The excavated material was hauled to Lea Land, an approved solid waste disposal facility.

The excavated areas were backfilled with new caliche from Lea Land, LLC and the excavated area was re-contoured to match the surrounding location.

The pea gravel inside of the tank battery was removed and excavated to a depth of 0.5-feet deep. The impacted berm behind the center tank (westside) and the north berm of the tank battery was removed and reconstructed with clean caliche backhauled from Lea Land.
