Subject: **Soil Assessment and Remediation Work Plan**  
Devon Energy  
Hackberry 16 SWD No. 1  
API # 30-015-41783, 2RP-3145 & 2RP-3146

Hackberry 16 SWD #1  
Devon Energy Corporation  
Eddy County, New Mexico  
Figure 1 - Site Plan

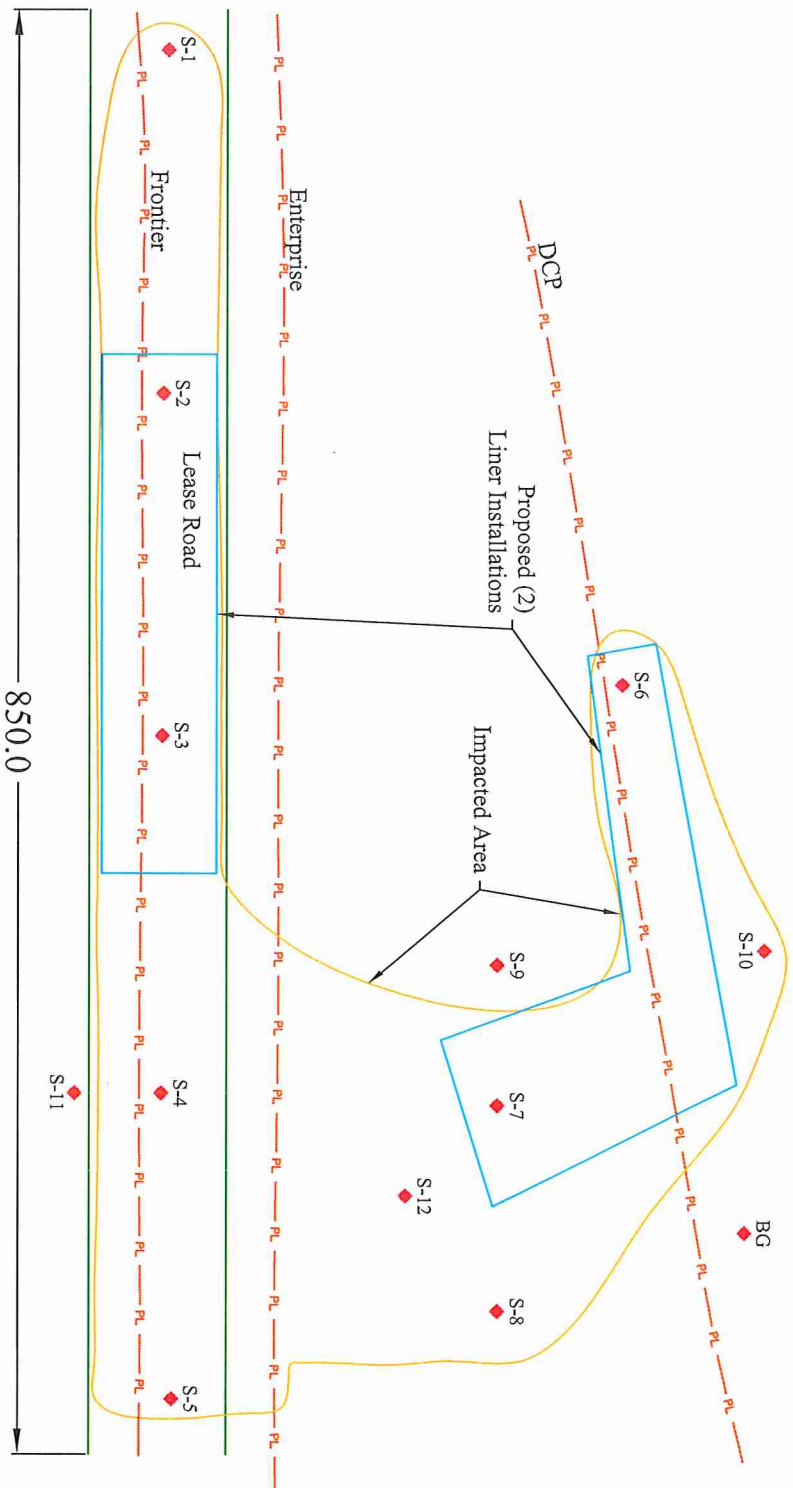
The Hackberry 16 SWD No. 1 is located approximately forty-four (44) miles southeast of Artesia, New Mexico. The legal location for the site is Section 16, Township 19 South and Range 31 East in Eddy County, New Mexico. More specifically the latitude and longitude for the location are 32.653260 North and 103.890311 West. See site map attached in [Appendix I](#).

- The impacted area in the vicinity of sample locations S-1, S-5 and S-8 will be excavated to a depth of 2-feet deep.
- The impacted area in the vicinity of S-10 will be excavated to a depth of 1-foot deep.

- The impacted soil in the area of S-4 will be removed to a 2.5-foot depth and the impacted soil in the vicinity of S-12 will be excavated to a depth of 3.5-feet deep.

- The remaining impacted areas will be removed to a depth of 4-feet below land surface, which include S-2 and S-3 along the lease road and between S-6 and S-7 in the pasture.

- A 20 mil liner will be installed where proposed on the site plan in the 4-foot deep excavation areas.
- The impacted soil around the pipelines will be hand-excavated until the liner can be safely installed below the DCP and Frontier lines.
