### Rice Environmental Consulting & Safety

#### December 4<sup>th</sup>, 2013

#### RE: Corrective Action Plan GPII Energy – Littlefield BO Federal #2 Battery (2RP-1738) UL/A sec. 34 T26S R29E API No. 30-015-24529

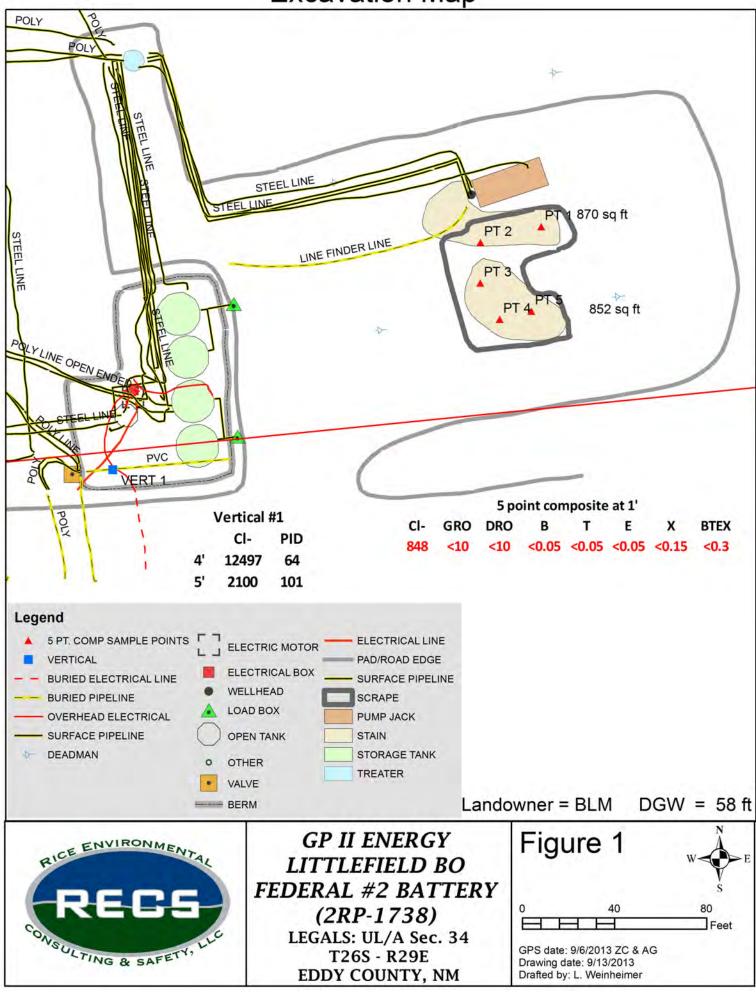
## **Excavation Map**

RECS personnel were on site beginning on September 6<sup>th</sup>, 2013 to assess the site. The stained area on the pad was scraped down to a depth of 1 foot and a 5 point composite of the bottom of the scrape was taken to a commercial laboratory for analysis (Figure 1 and Appendix C). The 5 point composite returned a laboratory chloride reading of 848 mg/kg and Gasoline Range Organics (GRO), Diesel Range Organics (DRO) and BTEX readings of non-detect. Vertical installation was attempted within the bermed battery area but had to be abandoned once an unmarked PVC pipe was discovered. Two samples were taken prior to the vertical being abandoned. The 4 ft sample returned a field chloride result of 12,497 mg/kg and the 5 ft sample returned a field chloride result of 2,100 mg/kg.

The scrape on the pad returned a bottom composite laboratory chloride reading less than 1,000 mg/kg and GRO, DRO and BTEX levels of non-detect. Therefore, the scrape will be backfilled with clean, imported caliche and then contoured to the surrounding location.
