# Frac Water Impoundment Inspection Form

Impoundment Name: Hackberry TW Pond

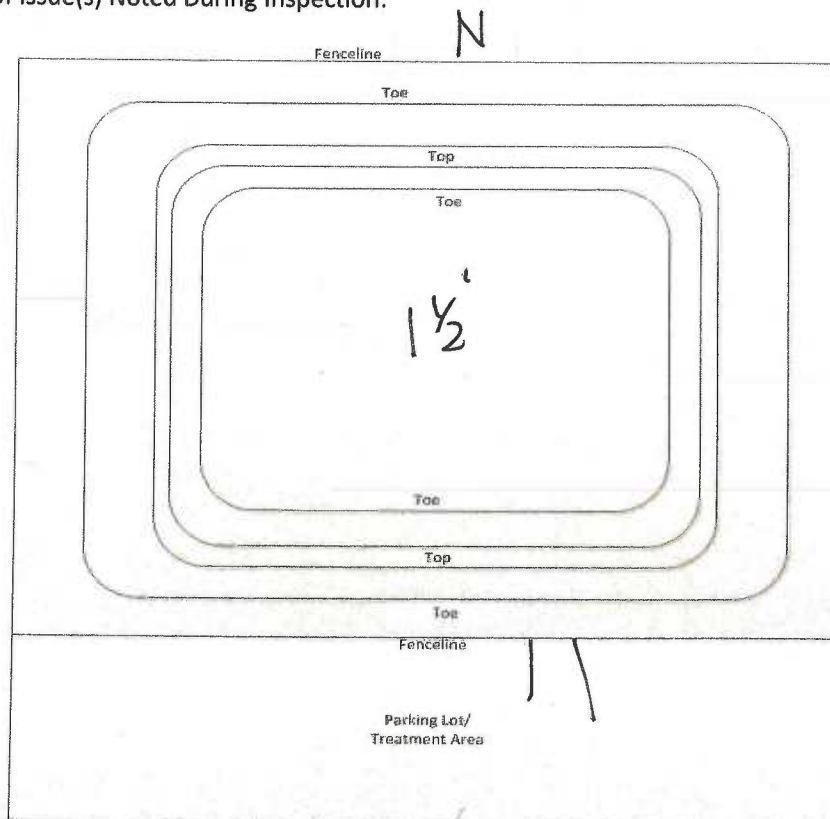
Water has a very reddish tint to it

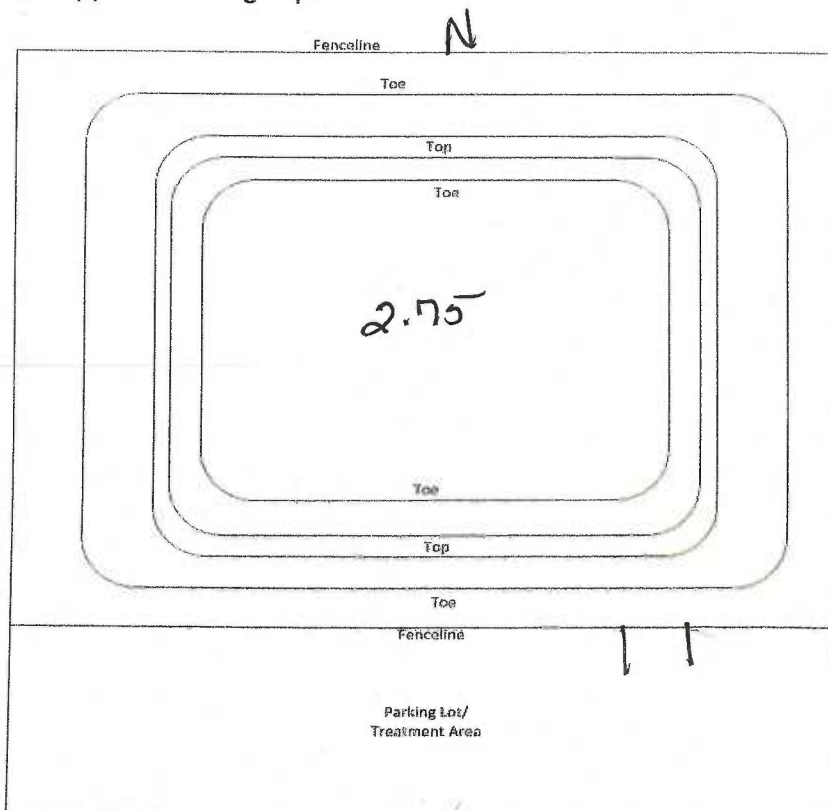
Select still has 10" run flat and roll off containers on berm, miscellaneous 10" fittings and SSal buckets inside and out side of Fence

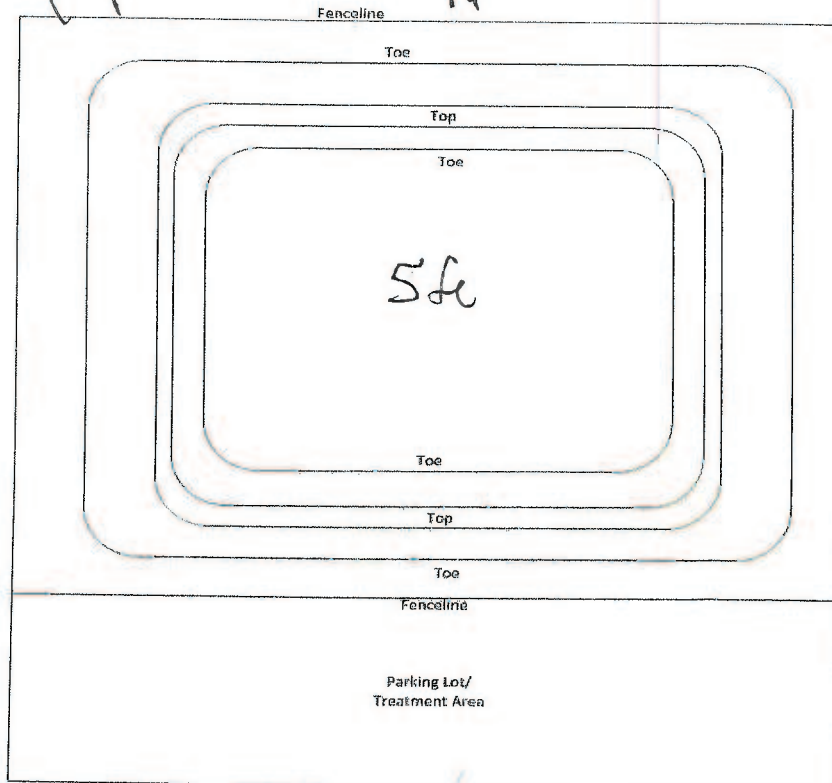
Boil Box not functioning no power 3
