HUNGRY HORSE, LLC

To: Mike Bratcher, New Mexico Oil Conservation Division Dist. II
Reference: Remediation Work Plan
Operator: Devon Energy Production Company
Location: Chimayo 16 St. #3
GPS: 32.1329, -103.9934
Legals: UL. F, Sec. 16, T25S, R29E
NM OCD: 2RP 3412

Release Notification and Corrective Action

Devon Energy Production Company-Chimayo 16 St #3

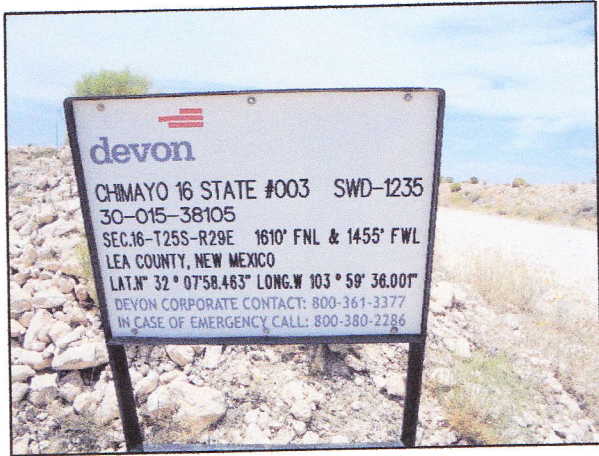
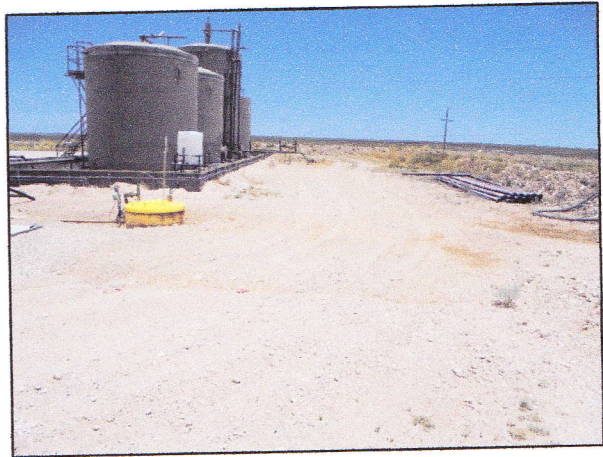
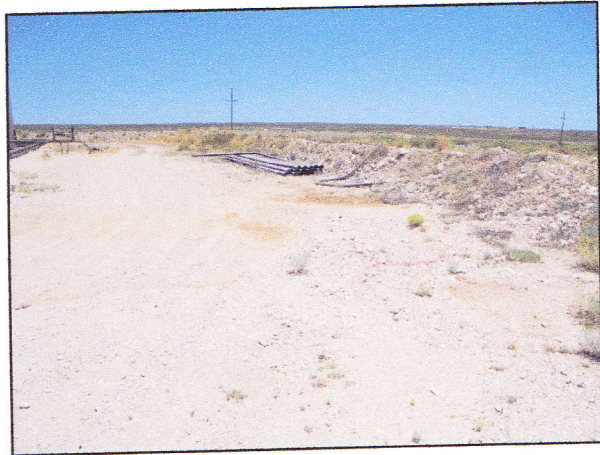
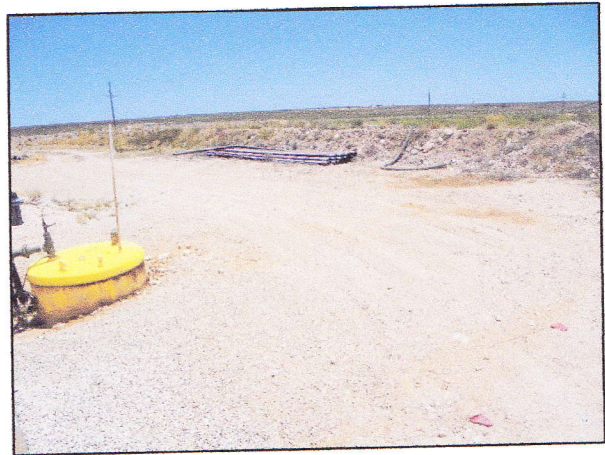
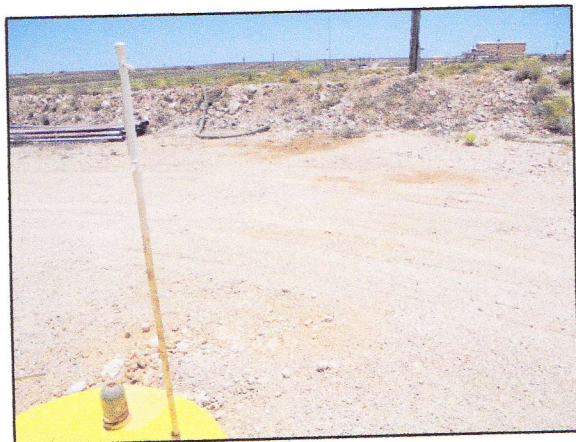
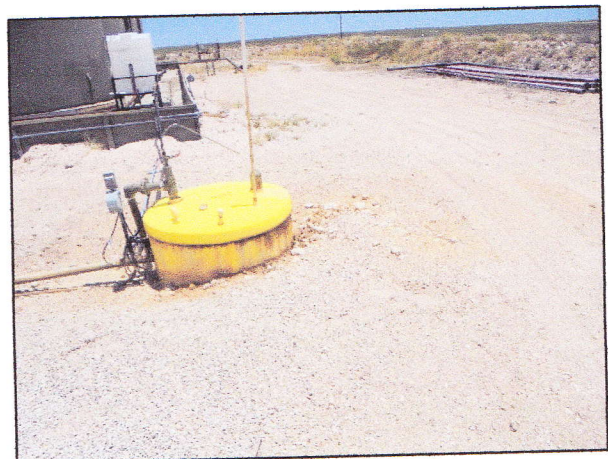
The remediation is the result of a release from a sump tank. All released fluids remained on the location. The impacted area is approximately 25' x 12'.

| Describe Cause of Problem and Remedial Action Taken.* Sump tank overfilled bad check valve, bad check valve allowed produced water from the charge pump to flow back into the sump tank. Isolated the tank by closing valves upstream and downstream of sump tank. | | | | | |
| Describe Area Affected and Cleanup Action Taken.* 7 BBL of Produced water released on a 30 x 50 area all on pad, 7 BBL of Produced water recovered. Vacuum truck was already on location. An environmental agency will be called out for remediation. | | | | | |

With the primary contaminant of concern being chlorides, I plan to use the dig and haul method of remediation. I propose to excavate the impacted area to a depth of 4' BGS and install a 20 mil synthetic liner as a barrier to prevent further downward migration of remaining chlorides. All excavated material will be transported to a division approved disposal facility. The excavated area will be backfilled with fresh caliche, compacted, and brought back to grade.

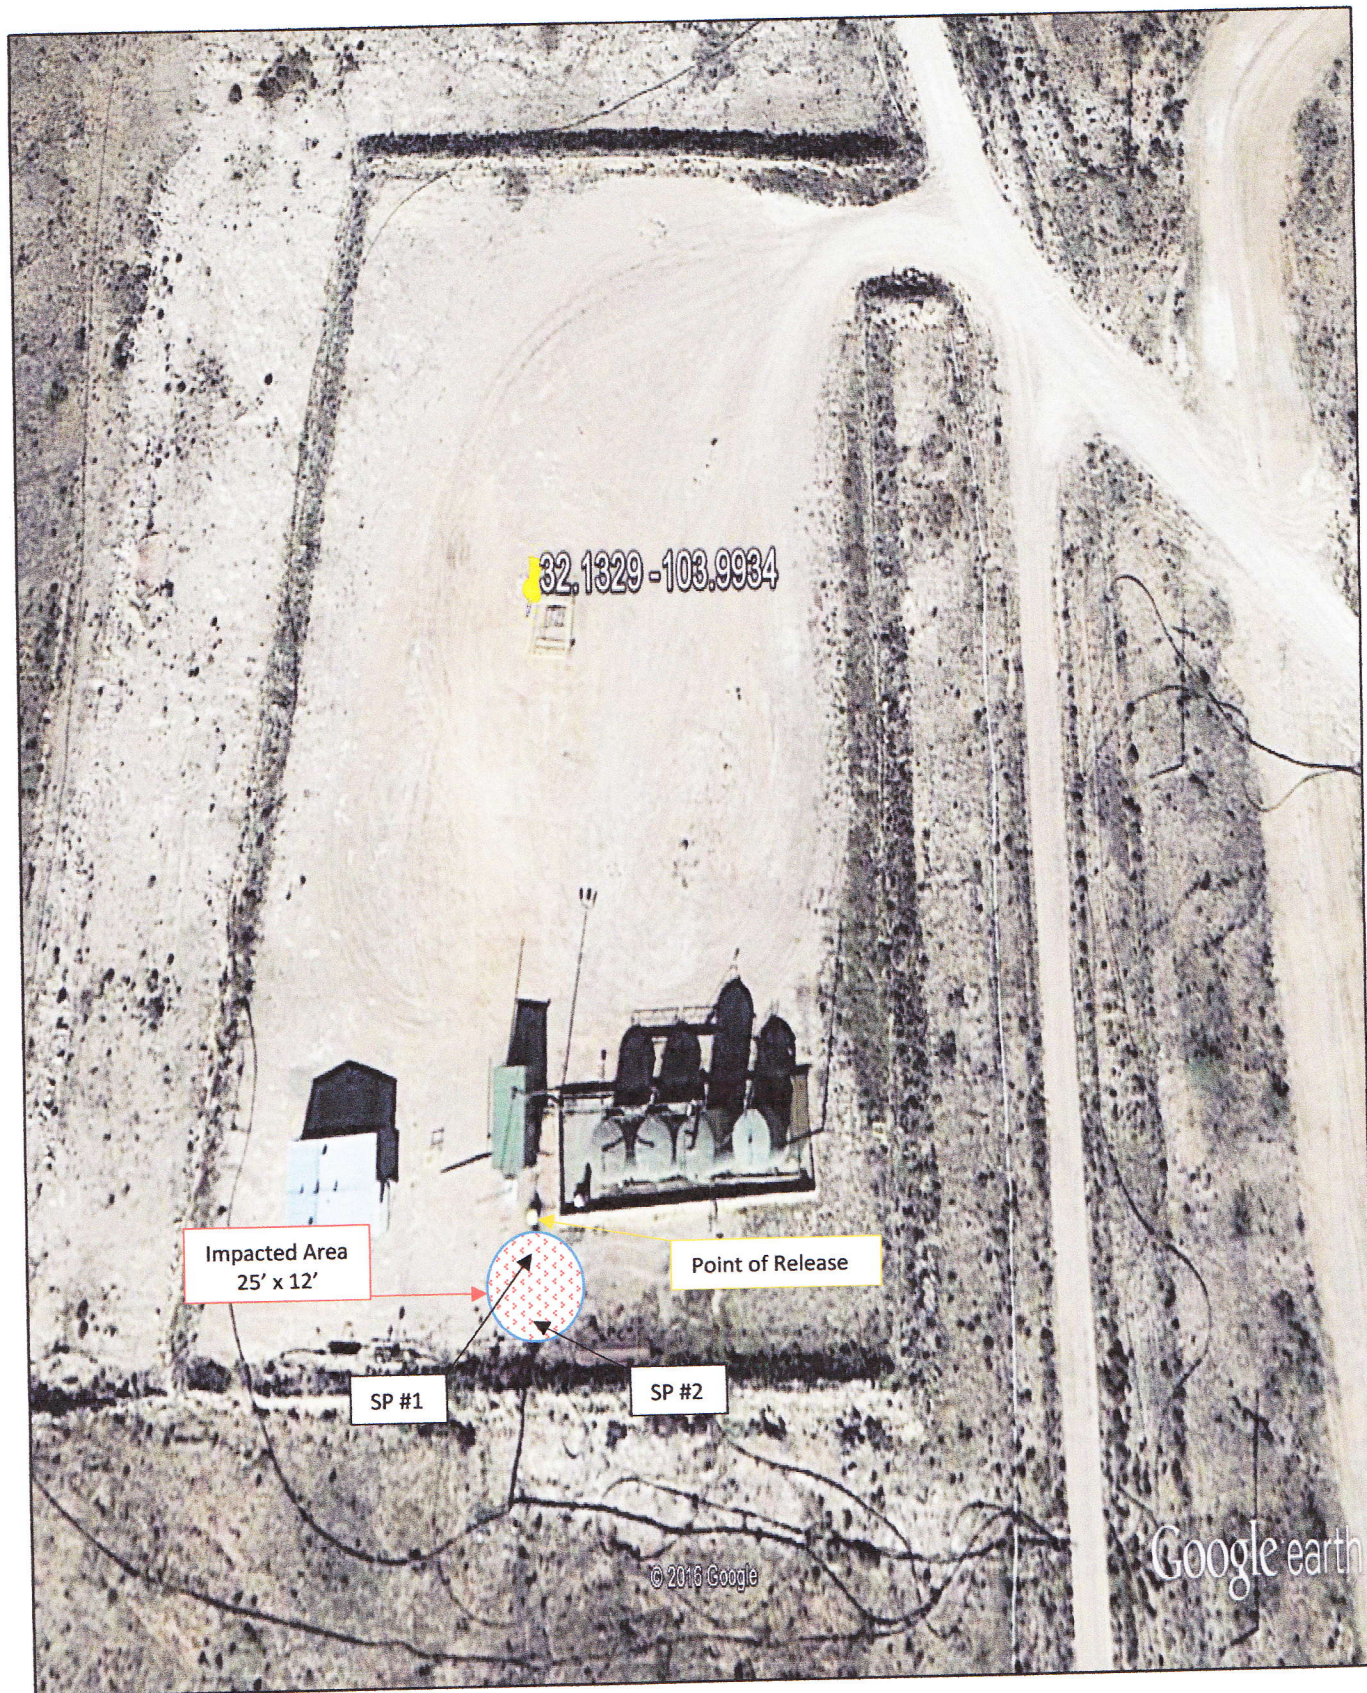
Devon Energy Production Company-Chimayo 16 St. #3

A delineation was conducted using a hand auger, back-hoe, and eventually an excavator. Hard rock was encountered at various depths, more especially at 20' below ground surface (BGS). See attached analytical summary and supporting for results.
