Form C-141 Revised August 8, 2011

Beach Exploration, Inc.

EQU #24 Location Spill Unit C, Sec 11, T-19-S R-29-E

Remediation Plan

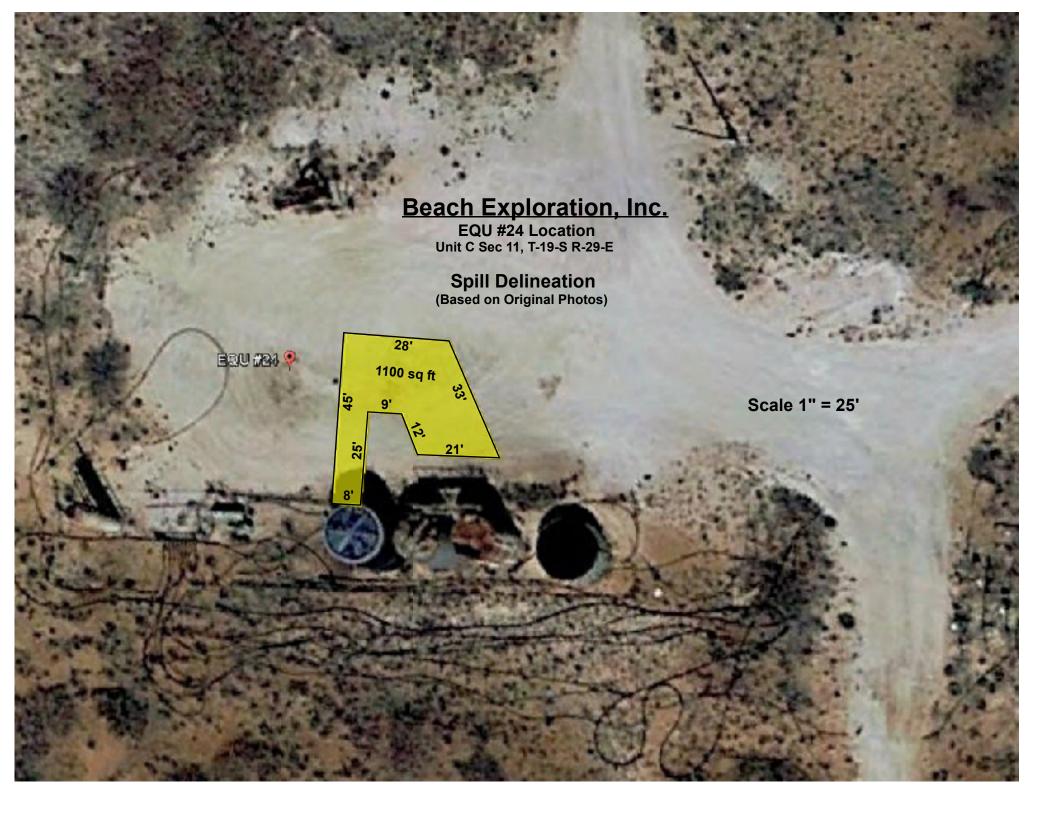
Using Google Earth images, location specifics and the original photos taken on 9-6-16 by Robert Kasuboski with the State Land Office, the area of the spill was delineated (see attached "EQU#24 Spill Size.pdf" and two original photos "EQU#24 9-6-16 pho1.jpeg" and "EQU #24 9-6-16 ph03.jpeg").

CMB Environmental's recommendation, based on the above information, is to remove all stained/saturated material to an approved site and then take a few samples in the excavated area at 3' and 6' to ensure remediation levels are acceptable. The area would then be backfilled with clean material. This recommendation was based on the original spill photos, the delineation of the spill and "Site Assessment" score of "0".
