R. T. HICKS CONSULTANTS, LTD.

RE: Clayton Williams Energy, Inc. – Jenna Com Release 2RP-2458-0

Proposed Remediation Plan

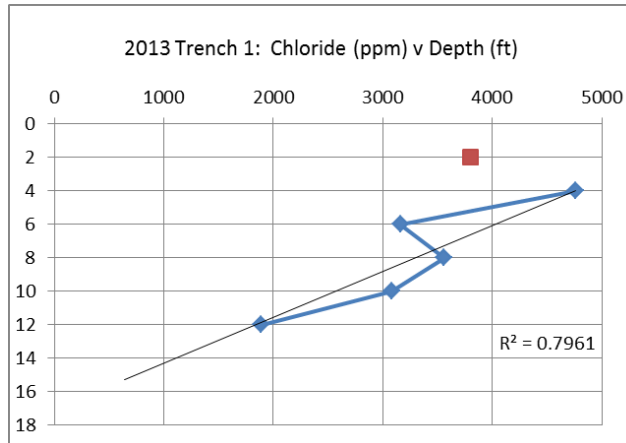
A 2013 trench at the “worst case” location in grid A-2 shows a decline of chloride concentration with depth. We projected the data from 4-12 feet below grade to provide an estimate of the depth where a concentration of 250 mg/kg would be expected. This trendline has a relatively high correlation coefficient of 0.796 and predicts that the 2013 and historic releases penetrated to a depth of about 16 feet.

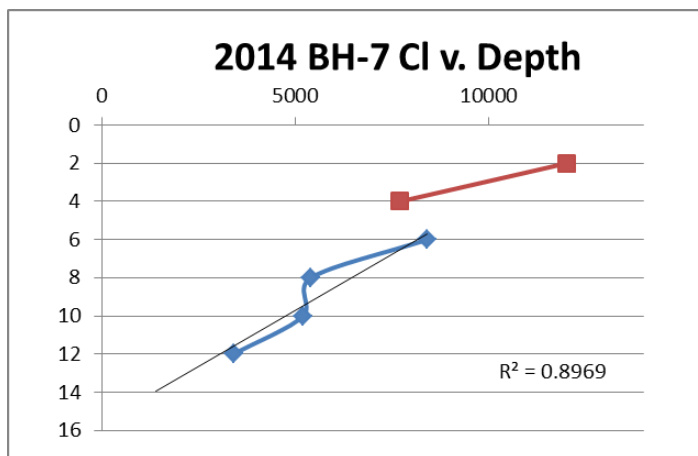
All four trench samples show a decline of chloride with depth. The “worst case” location is plotted in the graphic to the left. Using the data from 6 feet to 12 feet, a simple trend line projection predicts a depth of penetration of about 14 feet. The correlation coefficient of 0.897 is quite good.

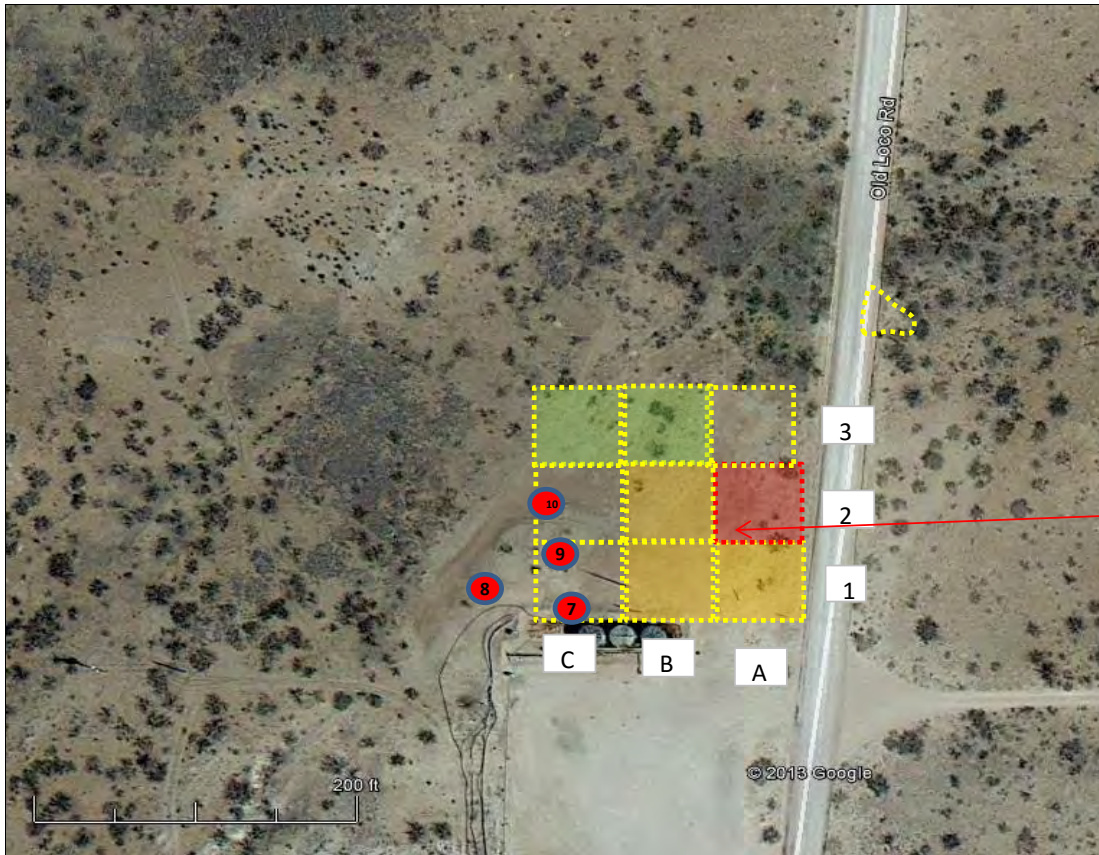
Figure 1 provides the data from the first field program of 2013. These data were included in an October 4, 2013 submission to OCD.

Figure 1 shows the near-surface chloride values that resulted from the 2013 release plus historic releases. The low spot where the 2013 release pooled (Grid A-2), and presumably where legacy releases may also have pooled, showed the highest chloride concentration of 6480 mg/kg. The northwest grid points, furthest from the point of release, are near background conditions.

Also shown on Figure 1 are results of two discrete samples of material removed from the spill footprint to the south side of the location. The chloride concentration of the pile is consistent with the surface concentrations observed in the grid sampling.

As documented by the data from the excavated soil pile, EPA Method 418.1 exaggerates the actual TPH by an order of magnitude. An examination of the laboratory reports show that GRO is not detected in the samples and thus the TPH concentration using Method 8015 is 505 mg/kg for the top of the pile and 454 mg/kg for the bottom of the pile.

2013 Google Earth Image Showing Sampling Locations and Results from 2013 Sampling

The south bioremediation pile will be tilled, contour furrowed and seeded to enhance reduction of concentrations via phytoremediation.

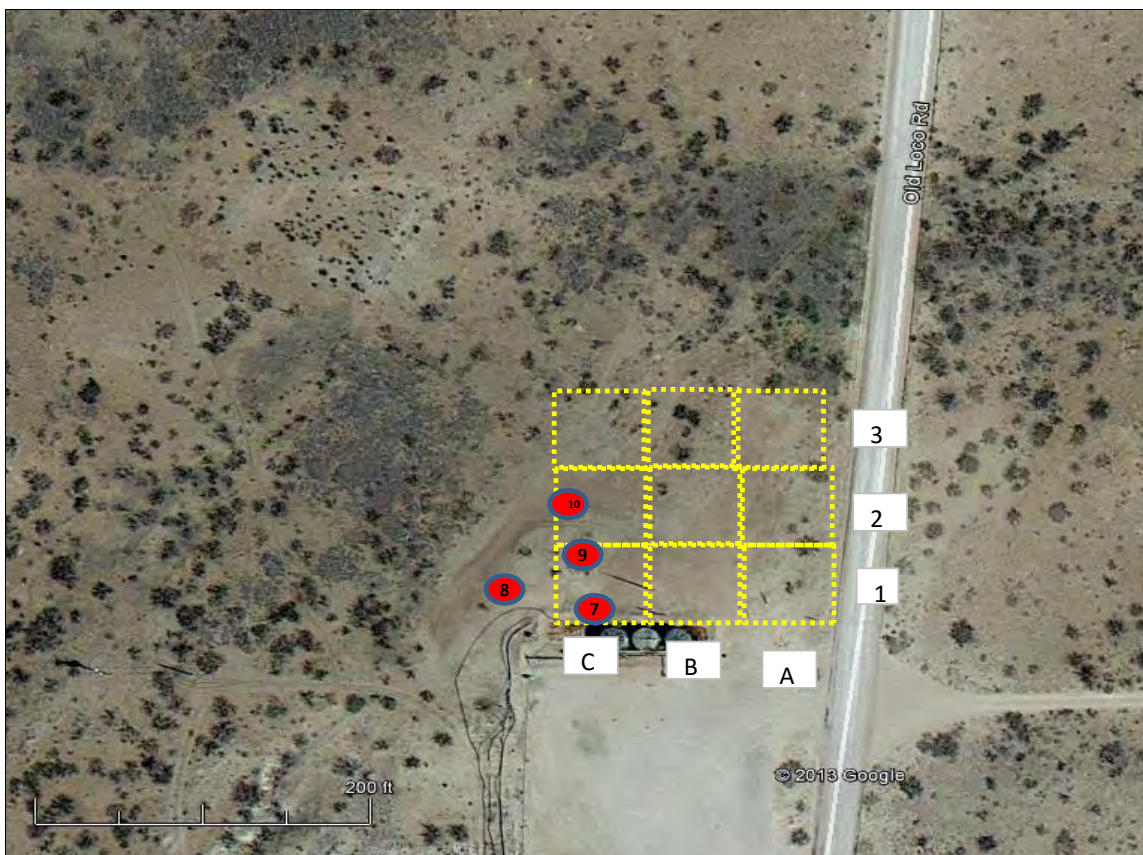
Figure 2 shows the results of a 2014 trench sampling program to characterize the vertical extent of chloride beneath the footprint of a 2014 release, which occurred over the footprint of the 2013 release. Figure 2 also presents the most recent surficial soil sampling conducted in March of 2016.

Figure 2 presents data responding to a 2014 release from the battery. Four deep soil sampling points were obtained using a backhoe from within the footprint of the release.

The 2016 surface samples present a materially different picture than those collected in 2013. Grid A-2

remains an area of pooling. However, since 2014, precipitation runoff has pooled in this area creating a lower chloride concentration, probably due to chloride flushing. Grid B-1 is an area of higher elevation within the release footprint and the value of 3900 mg/kg is

essentially identical to that observed in 2013 (4680 mg/kg). In general, time plus precipitation has reduced the chloride concentrations by an order of magnitude wherever infiltration of precipitation occurs.

Data from the south soil bioremediation cell tell a similar story of chloride flushing plus reduction of hydrocarbons over time. In 2016, we collected samples from three locations from depths of 0-6 inches in order to gain some insight about the success of the remedy proposed to OCD in 2013. Chloride and hydrocarbon concentrations of the near-surface material are one order of magnitude less than that observed in 2013.

R.T. Hicks Consultants Albuquerque, NM	2013 Google Earth Image Showing Sampling Locations and Results from 2014 and 2016 Sampling	Figure 2
	Clayton Williams - Jenna Com	Apr-16

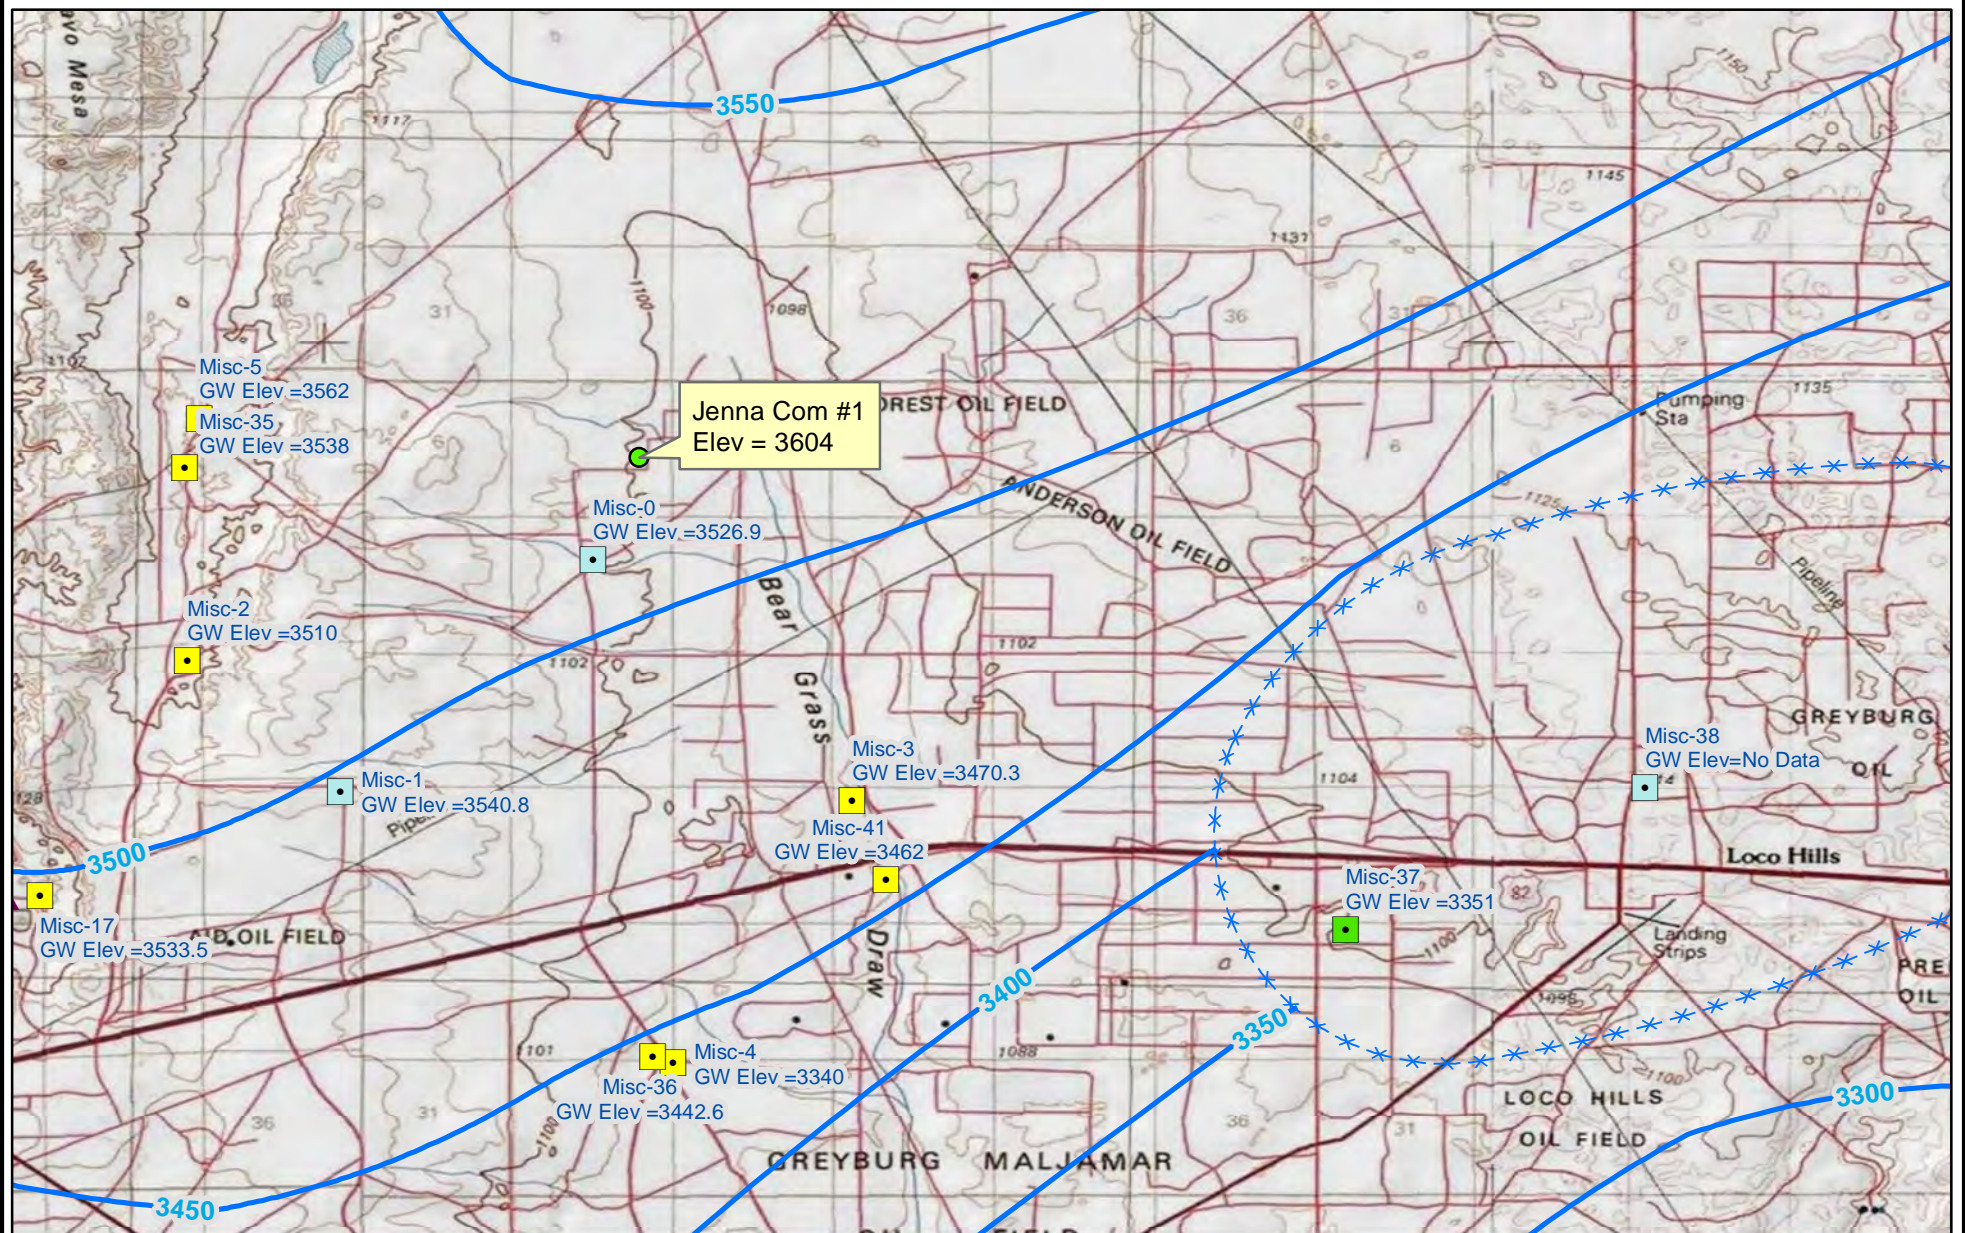
Figure 3
April 2016

Figure 3 shows the elevation of the groundwater surface in the general area plotted on a topographic map with metric contour lines. Beneath the site, the potentiometric surface is about 3530 feet above sea level. Given the 3604 surface elevation of the Jenna Com #1 well, the depth to groundwater is $(3604 - 3530 =) 74$ feet.

Groundwater Elevation	
Southwest Royalties - Jenna Com #1

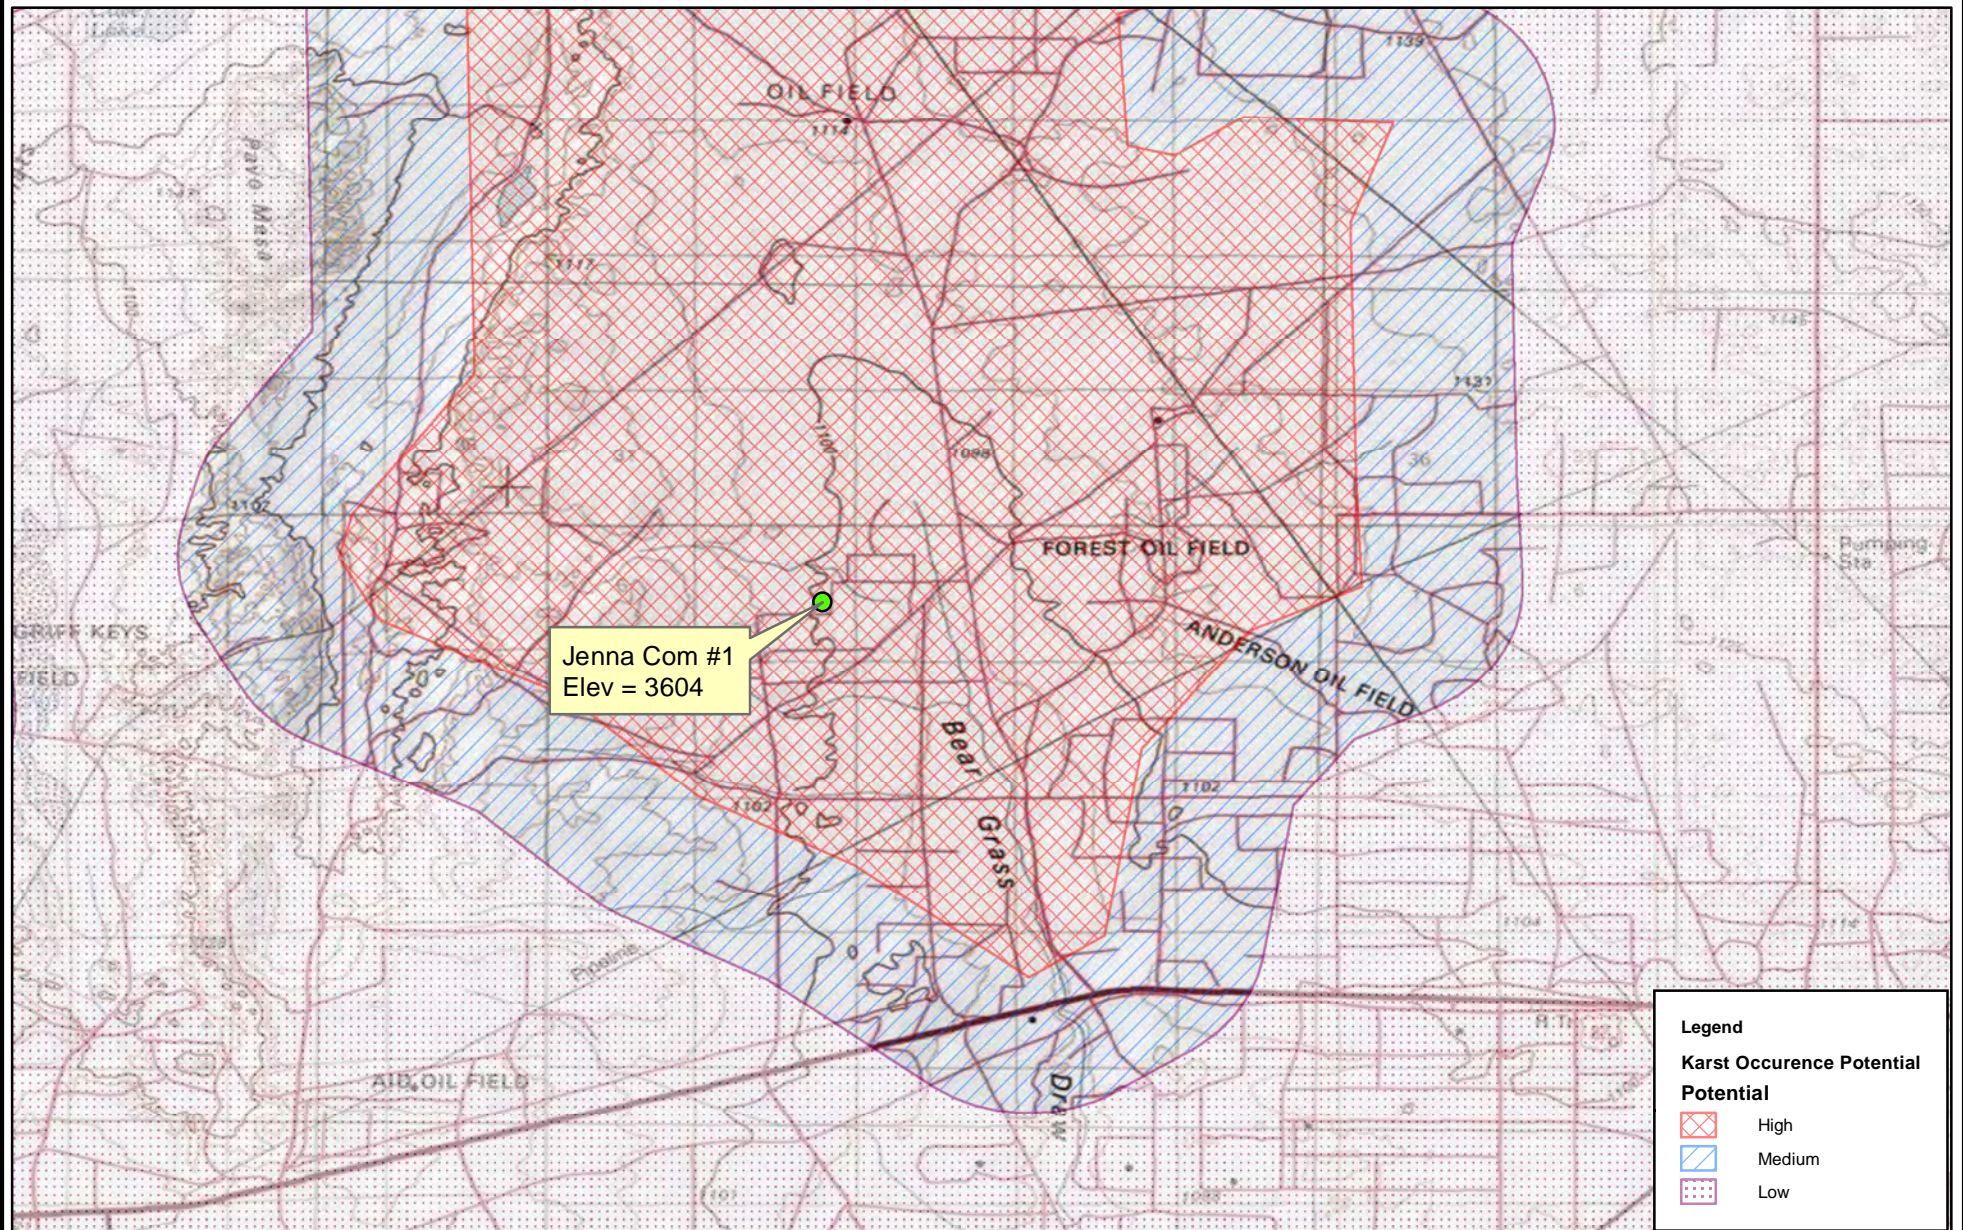
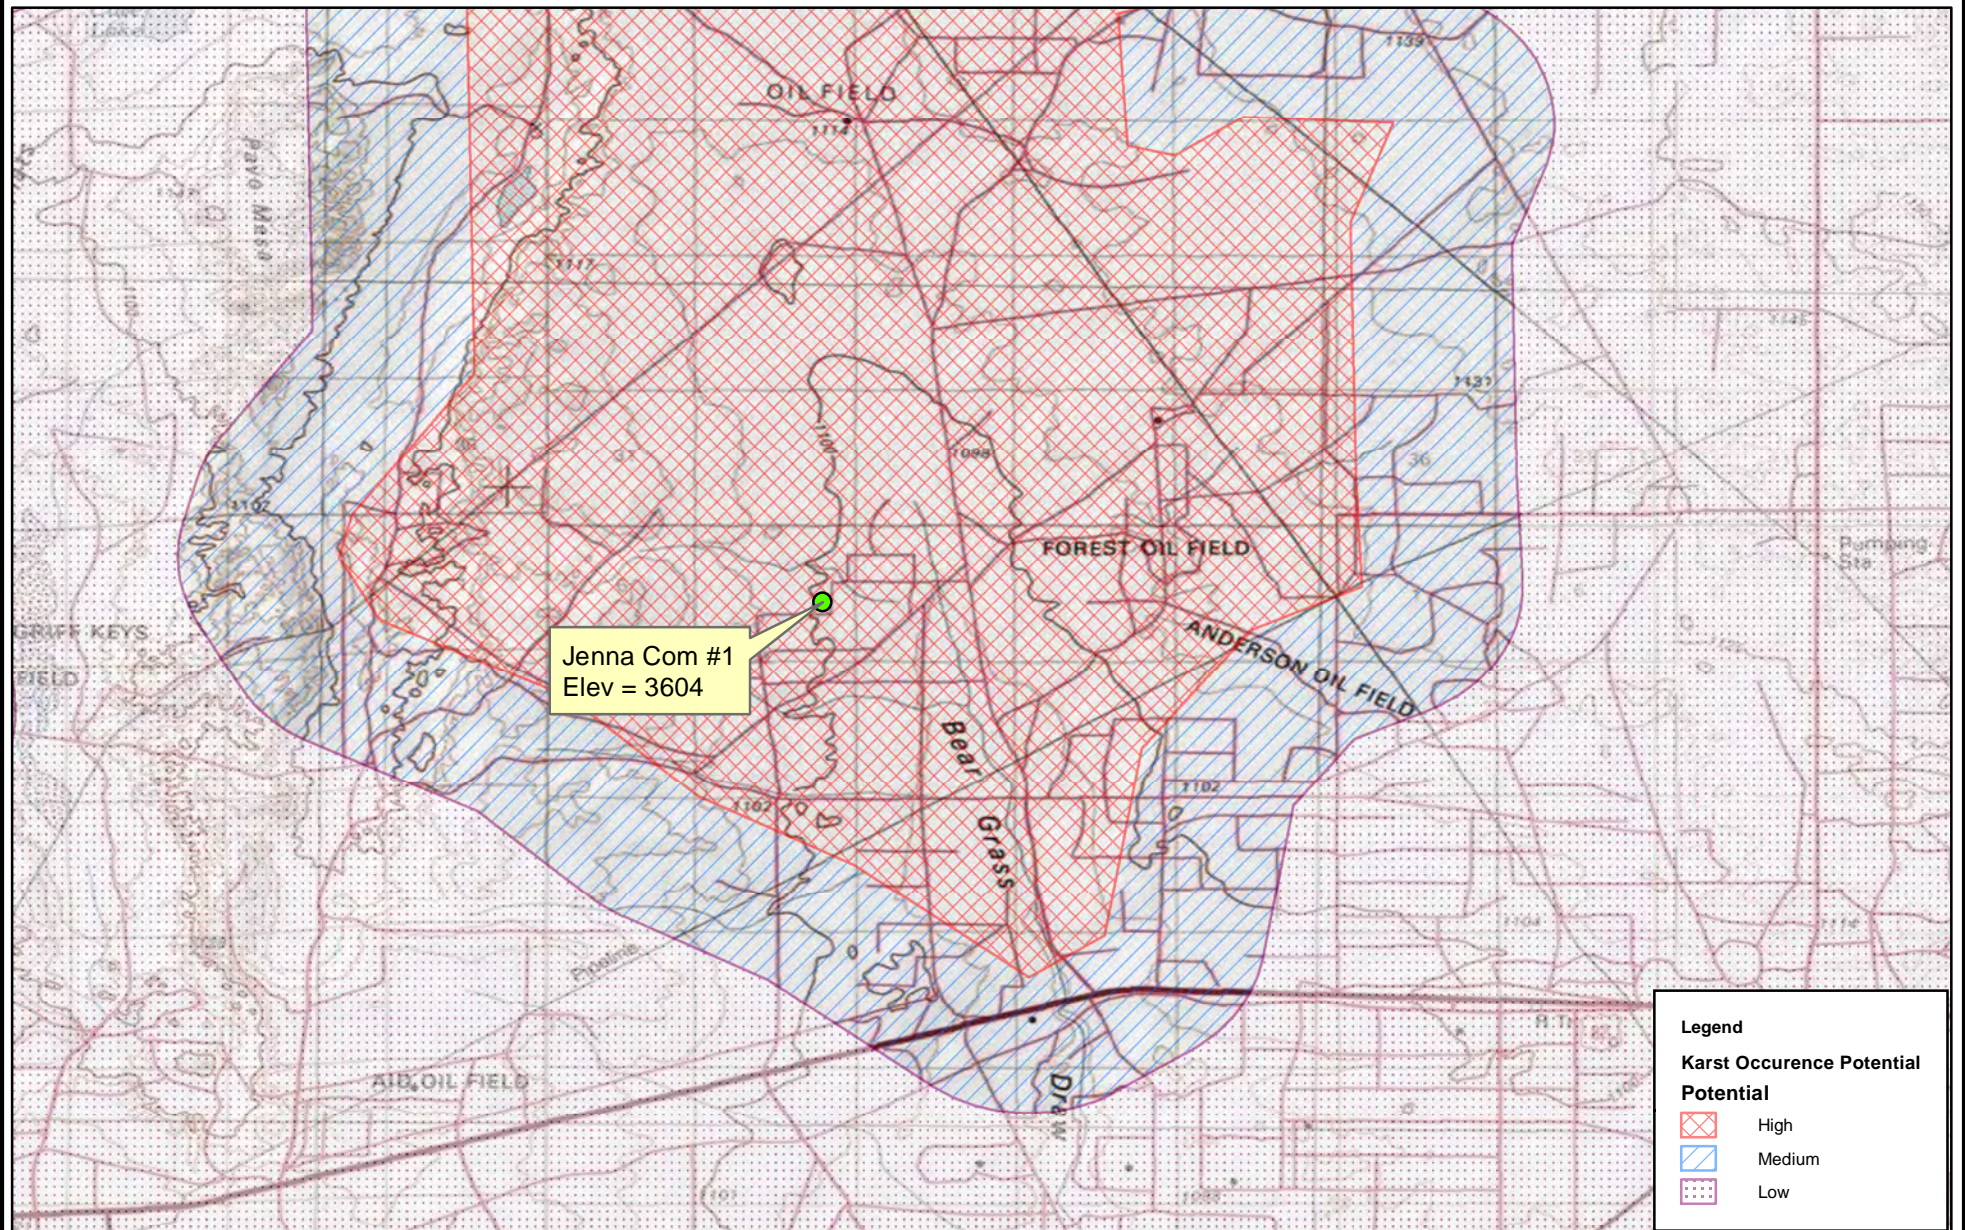
Figure 5 shows a somewhat surprising interpretation of karst potential of this area. We are not surprised that the area to the west of the Jenna site, due east of the Turkey Track Ranch HQ, is mapped as high karst. You may remember we observed sinkholes in the area that was previously mapped by BLM as low karst and we may have brought this finding to the attention of BLM. The area near the Jenna Com #1, however, shows no signs of sinkholes, fissures or solution features or unstable ground. Although we will take a closer look during the next field event, such voids actually result in higher attenuation of unsaturated transport to groundwater. Thus, any subsurface voids that are not apparent at the surface is a good thing with respect to our proposed remedy.

BLM Karst Potential Map

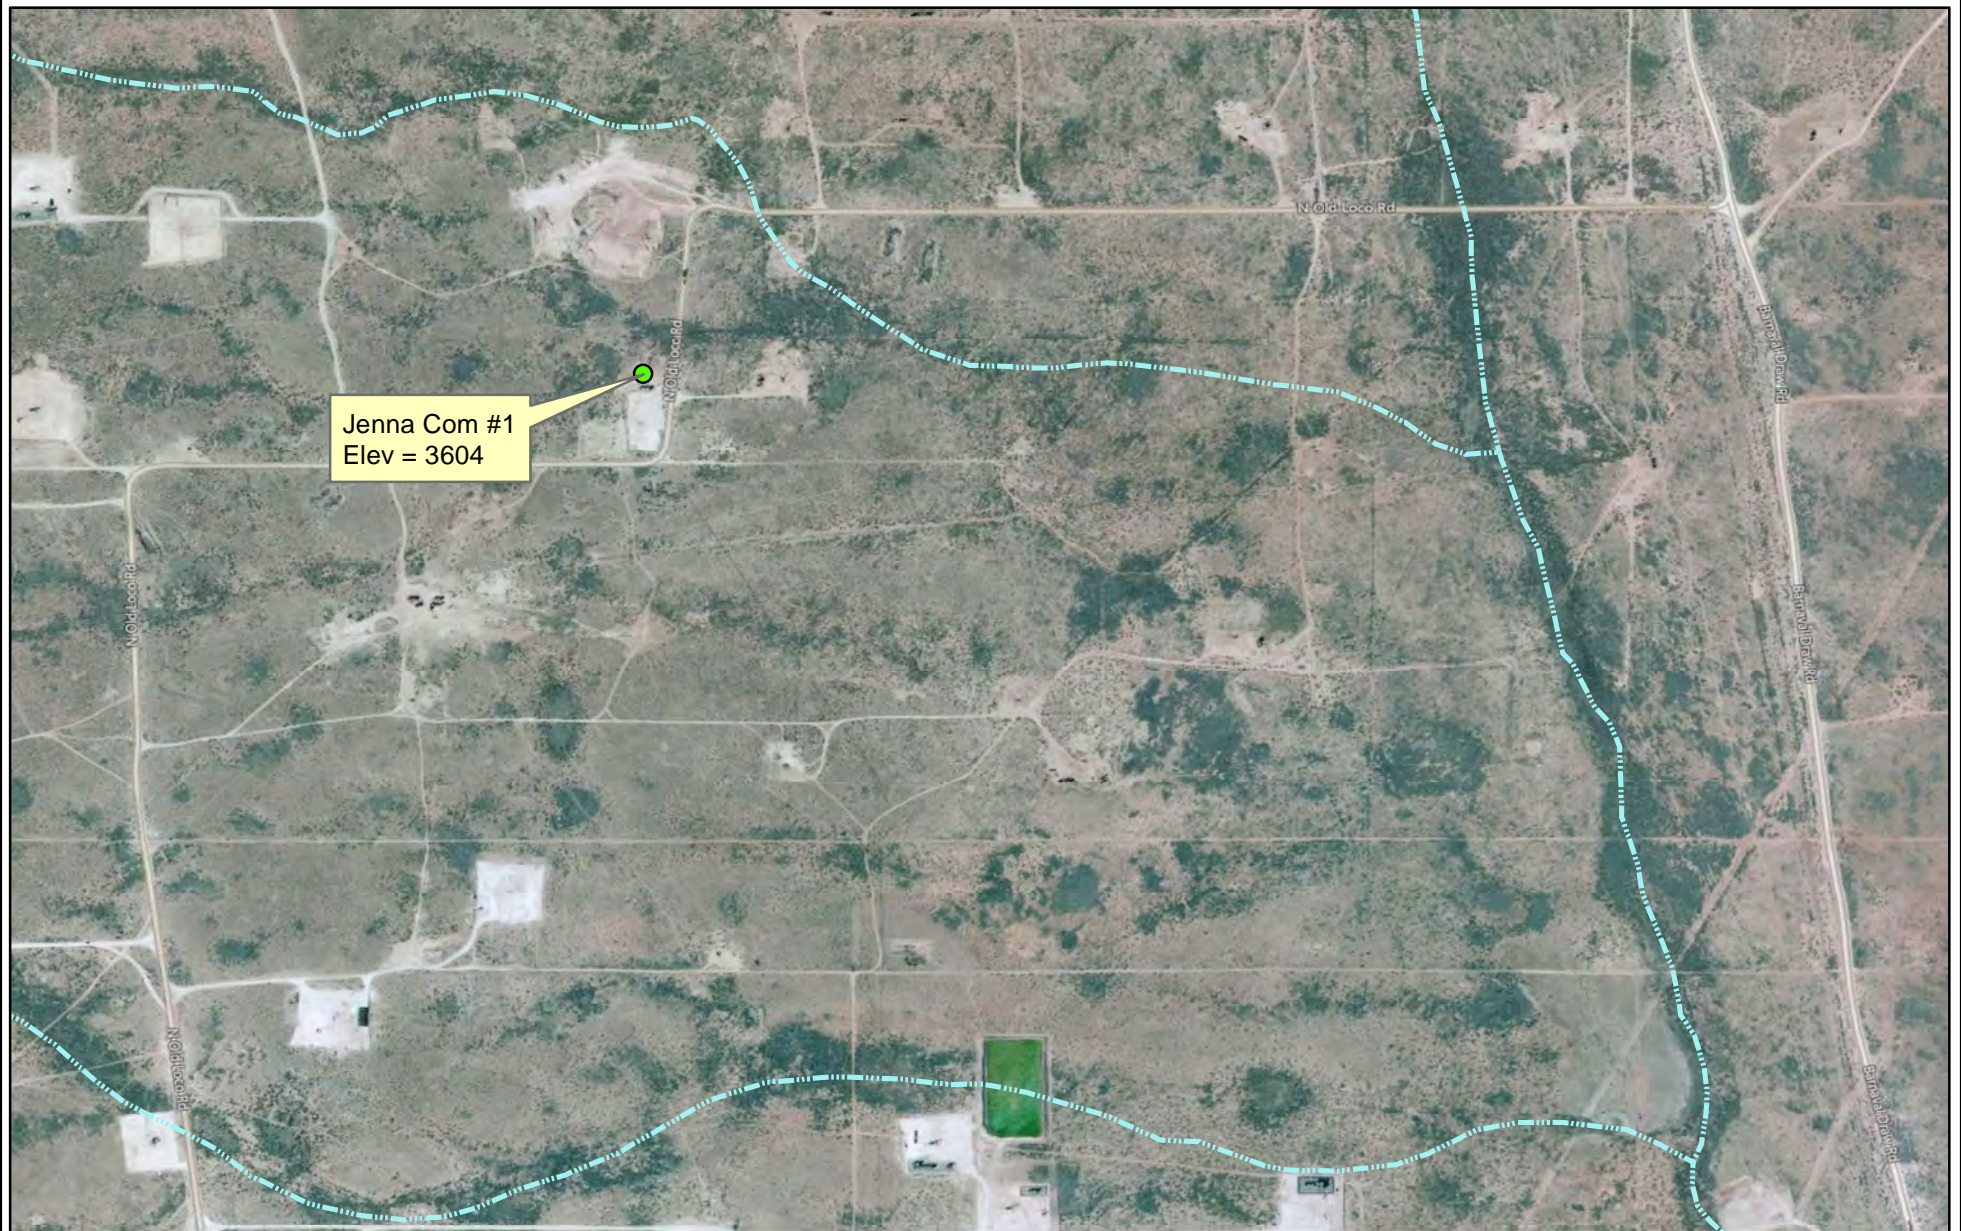
Figure 4

Nearby surface water features are depicted in Figure 4. The closest mapped intermittent stream is about 900 feet to the northeast. While a small swale exists due north of the spill footprint, a watercourse with a defined bed and bank does not exist in this grassy low spot. We also checked our system and found no nearby mapped wetlands.

Nearby Surface Water
