2RP-4655 Coyote #1 Battery DELINEATION PLAN Produced Water Spill Eddy County, New Mexico

LAI Project No. 17-0175-40

April 10, 2018

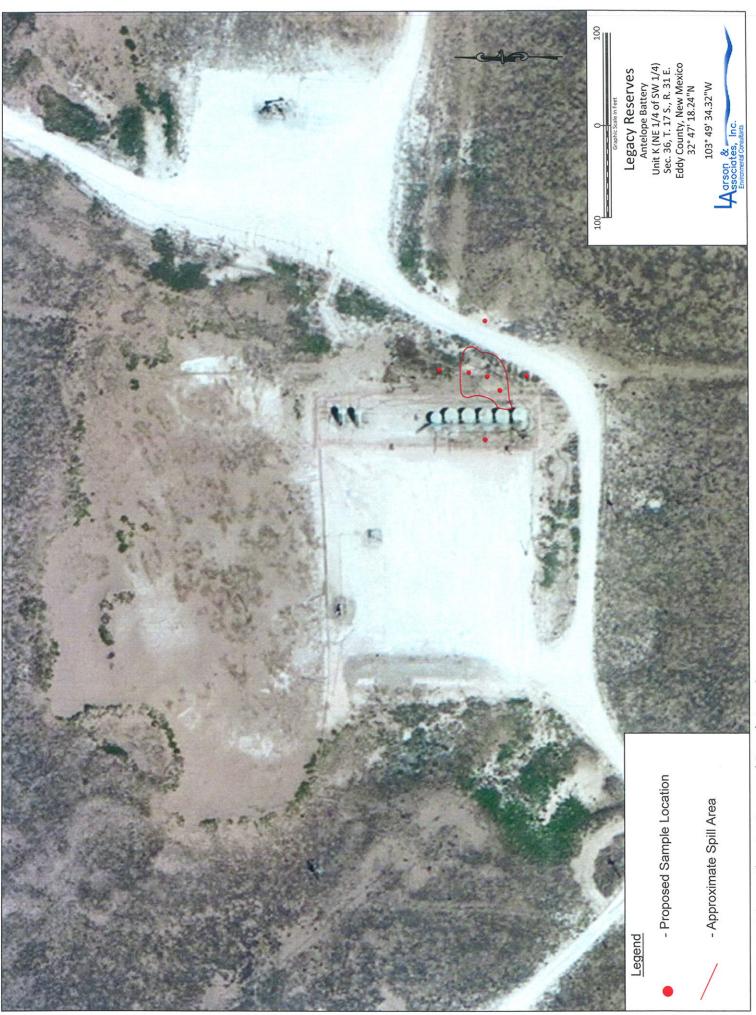
Figure 2 - Aerial Map Showing Proposed Sample Location

LAI proposes to collect soil samples at three (3) locations within the spill area. The samples will be collected at 1 foot intervals to approximately 4 feet bgs and 2 foot intervals to approximately 12 feet bgs using direct push technology (DPT) depending on subsurface conditions. Additional samples will be collected in each cardinal direction (north, south, east and west) of the spill area at the same depth intervals for horizontal delineation. The soil samples will be delivered under preservation and chain of custody to Xenco Laboratories (Xenco) in Midland, Texas. The upper samples (0 to 1 foot) will be analyzed for BTEX (sum of benzene, toluene, ethylbenzene and xylene), TPH (total petroleum hydrocarbons) including gasoline range organics (GRO), diesel range organics (DRO) and oil range organics (ORO) by EPA SW-846 Methods 8021B and 8015M. All samples will be analyzed for chloride by EPA SW-846 Method 300. Pending laboratory results, further delineation will be performed to achieve the RRALs. Appendix B presents photographs.

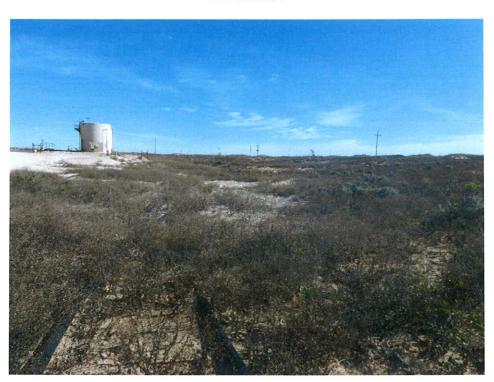
On an unknown date between approximately 6 and 7 barrels (bbl) of produced water were released. The released fluids pooled in the pasture to the southwest of the Site. The pasture show distressed vegetation as well as standing salt on the surface. The initial C-141 was submitted on January 3, 2018 and assigned remediation permit number 2RP-4655. Appendix A presents the initial C-141.

Spill Area Viewing East, November 21, 2017

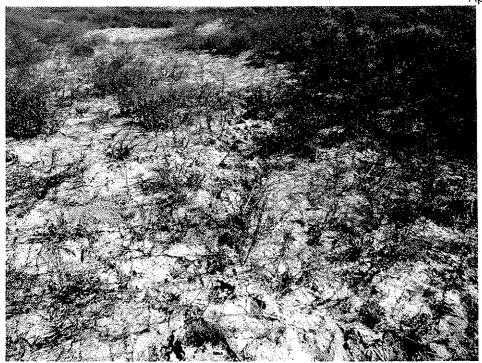
Spill Viewing East, November 21, 2017
