**RE: Containment Liner Inspection
2RP-5682
Tucker Draw 9 4 Federal Com #005H
Eddy County, New Mexico**

ATTACHMENT 1: PHOTOGRAPHIC LOG

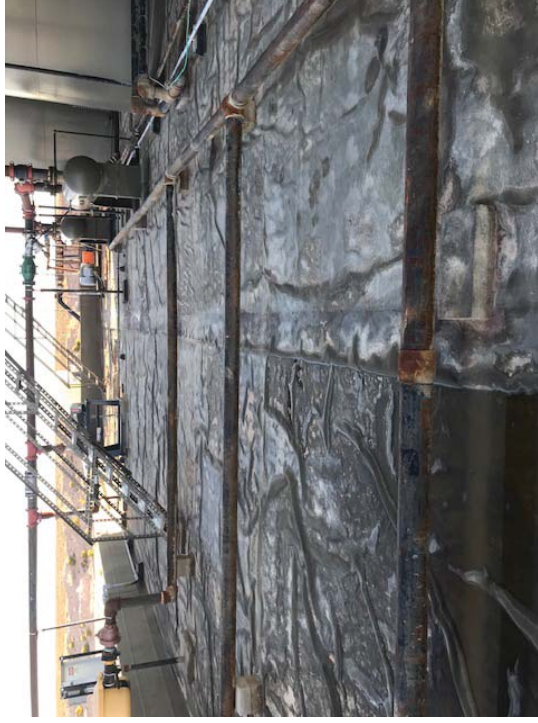
Photograph 1: View east of liner.

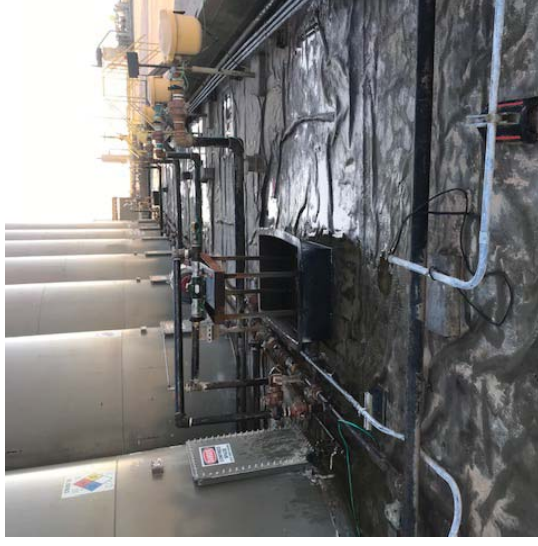
Photograph 2: View west of liner.

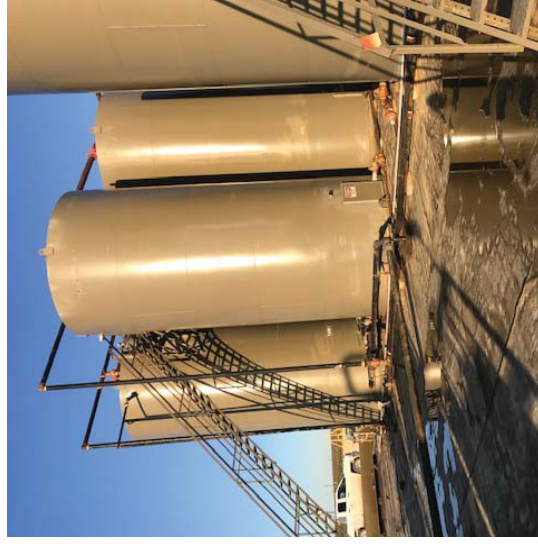
Photograph 3: View northeast of liner.

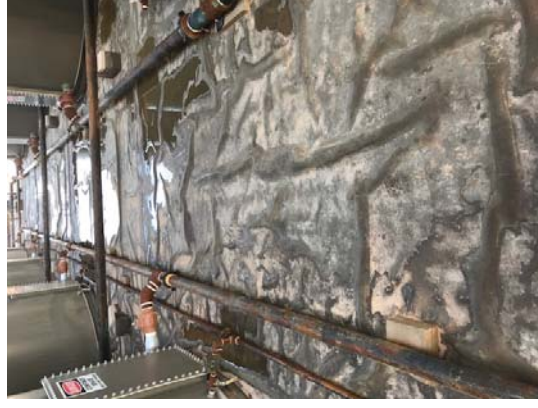
Photograph 4: Cleaned liner.
