Souder, Miller & Associates ♦ 201 S. Halagueno St. ♦ Carlsbad, NM 88220  
(575) 689-7040

August 6, 2020

SMA #5E29133, BG59

**RE: LINER INSPECTION REPORT  
FLAGLER 8 CENTRAL TANK BATTERY 1**

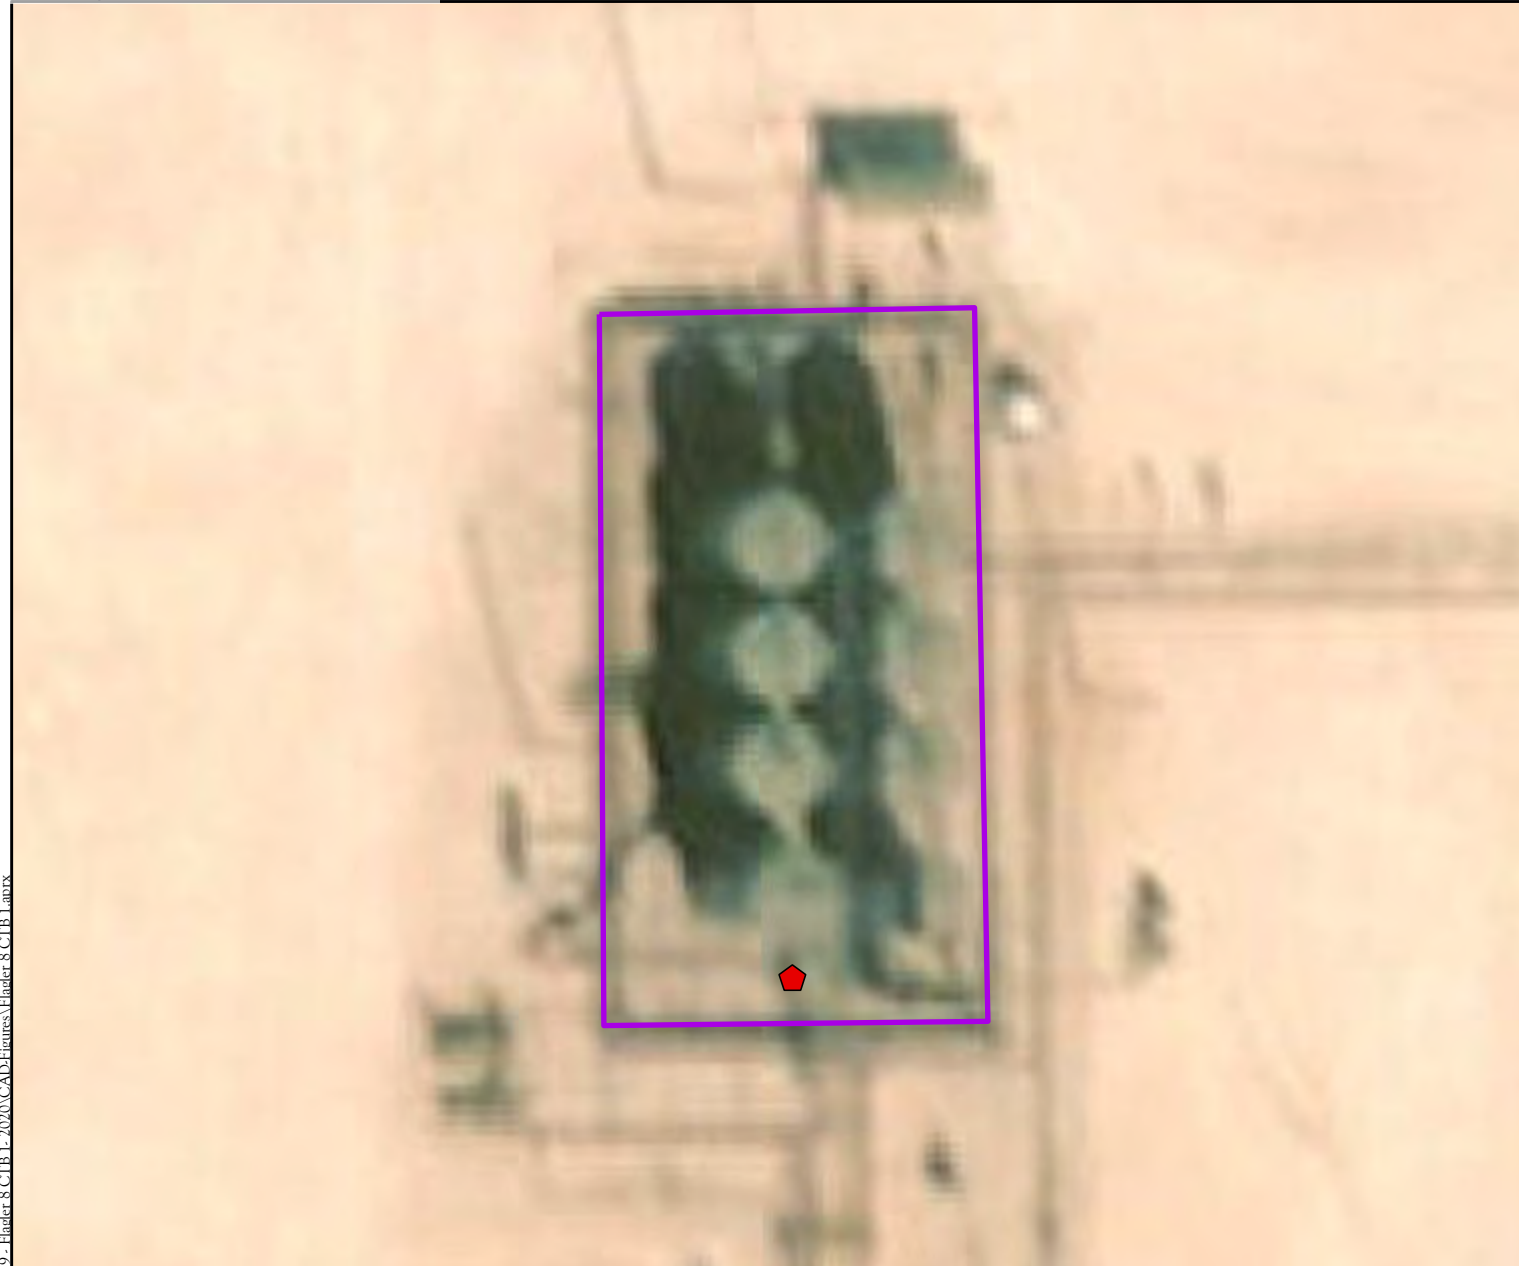
Based upon New Mexico Office of the State Engineer (NMOSE) depth to groundwater in the area is estimated to be 90 feet below grade surface (bgs). There are no water sources within ½-mile of the location, according to the NMOSE and USGS water well databases ([https://gis.ose.state.nm.us/gisapps/ose\\_pod\\_locations/](https://gis.ose.state.nm.us/gisapps/ose_pod_locations/); accessed July 29, 2020; Appendix C). The nearest significant watercourse is an unnamed intermittent stream, located approximately 10,603 feet to the east/northeast. Figures 1 and 2 show the release location and surrounding hydrologic features. Figure 3 shows the location of the facility and the release.

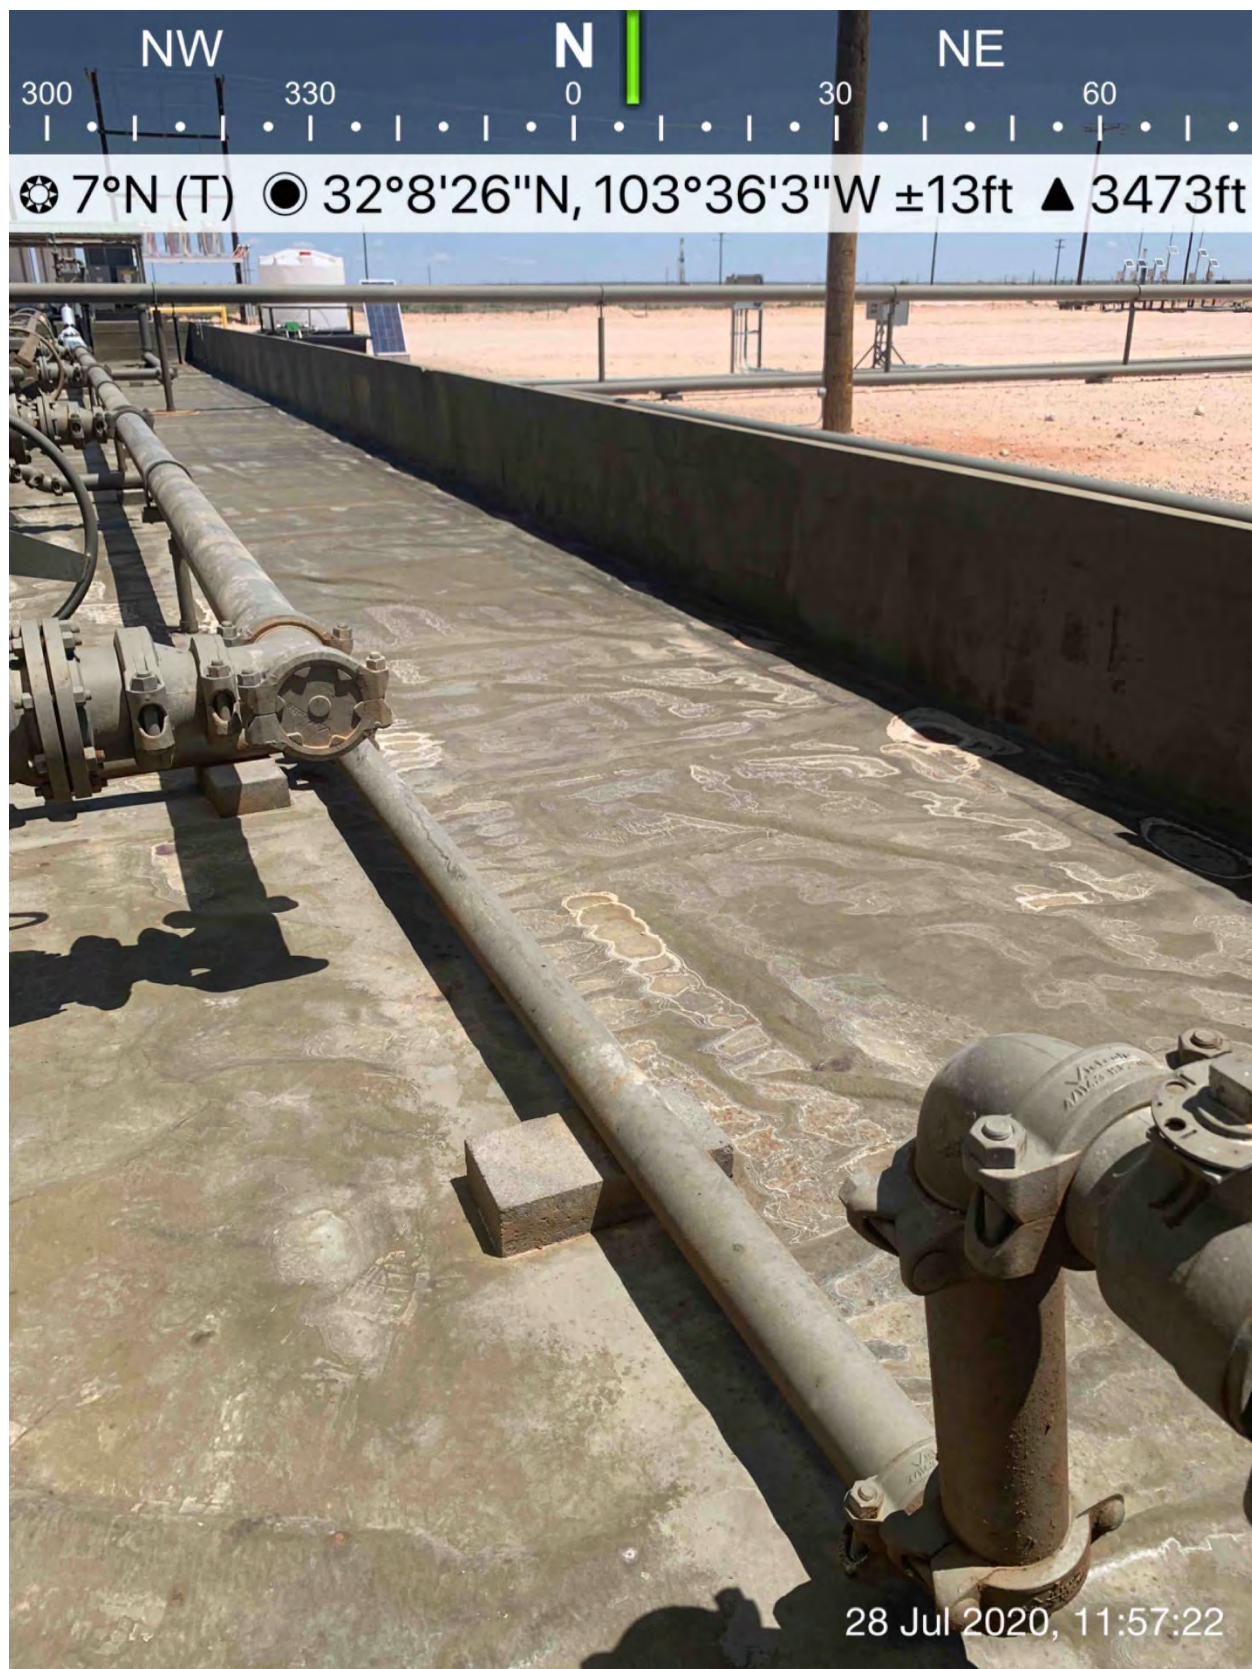
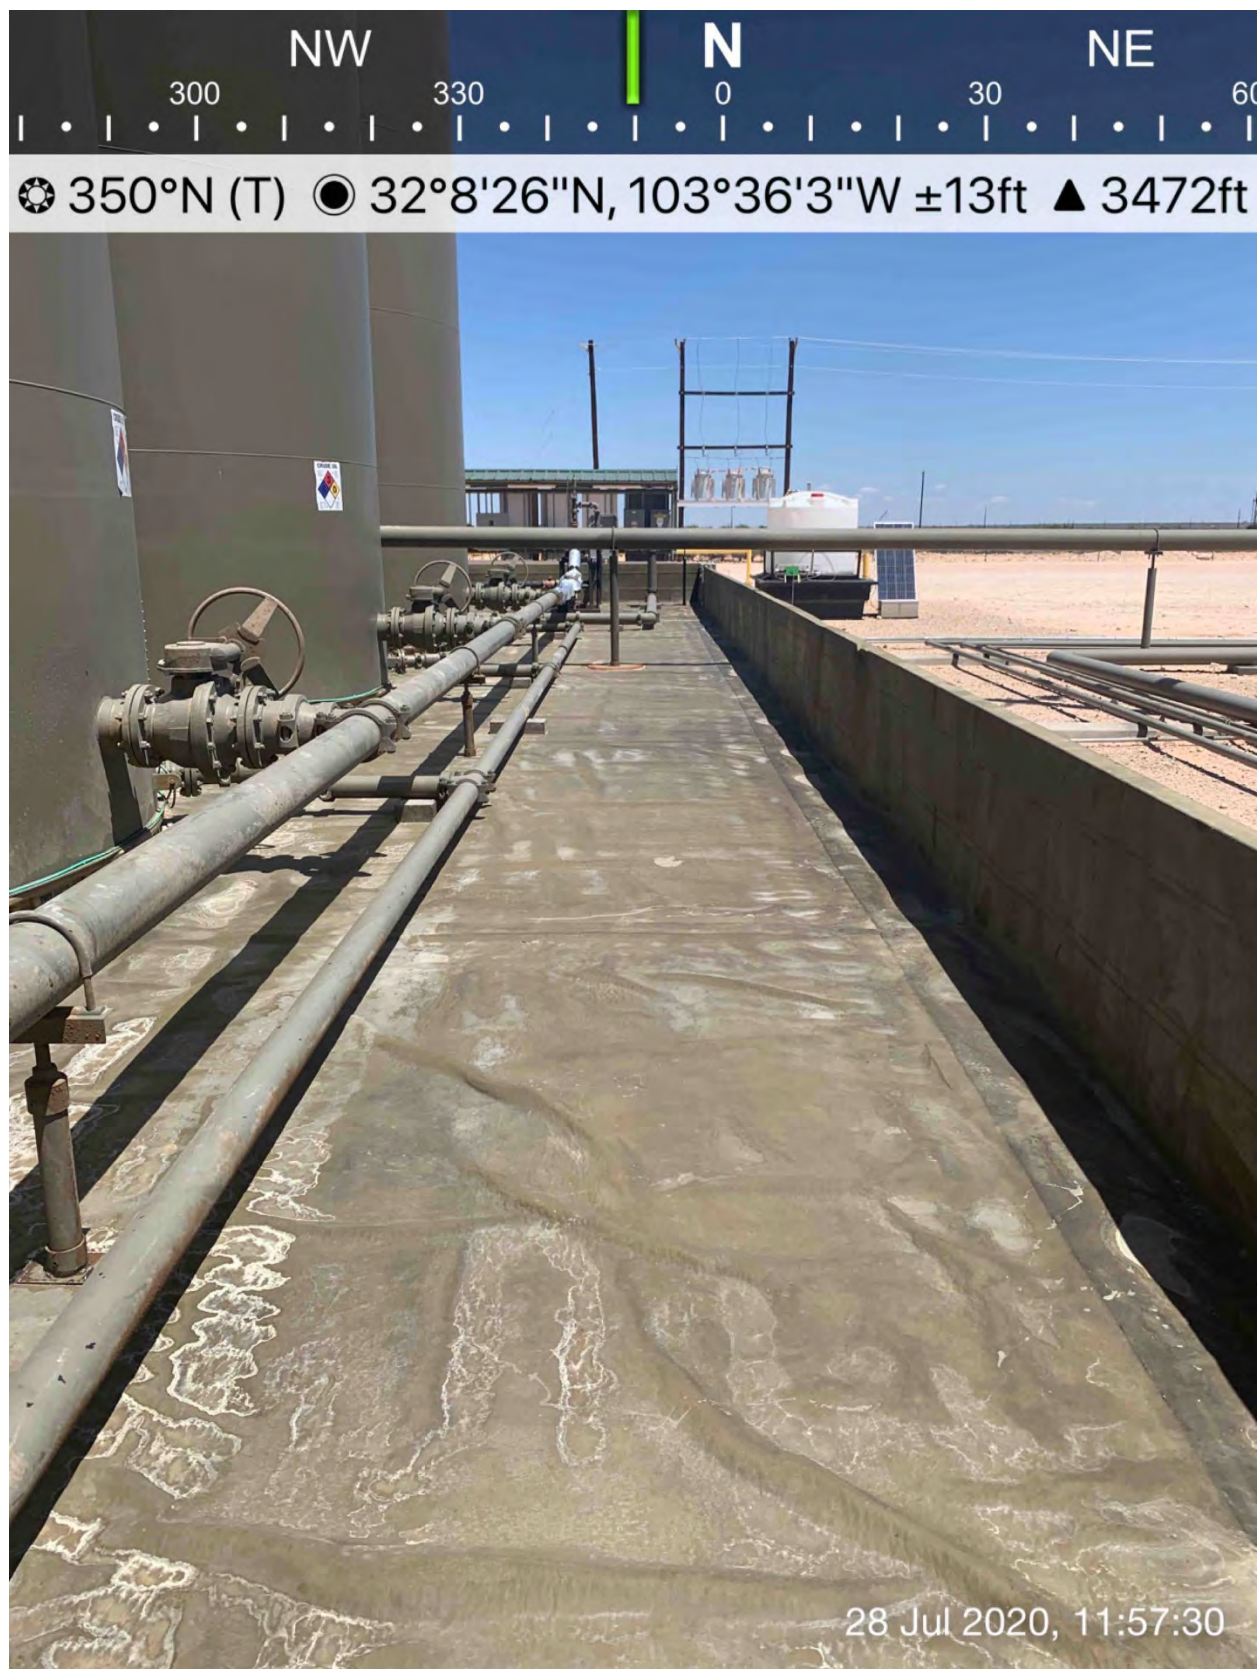
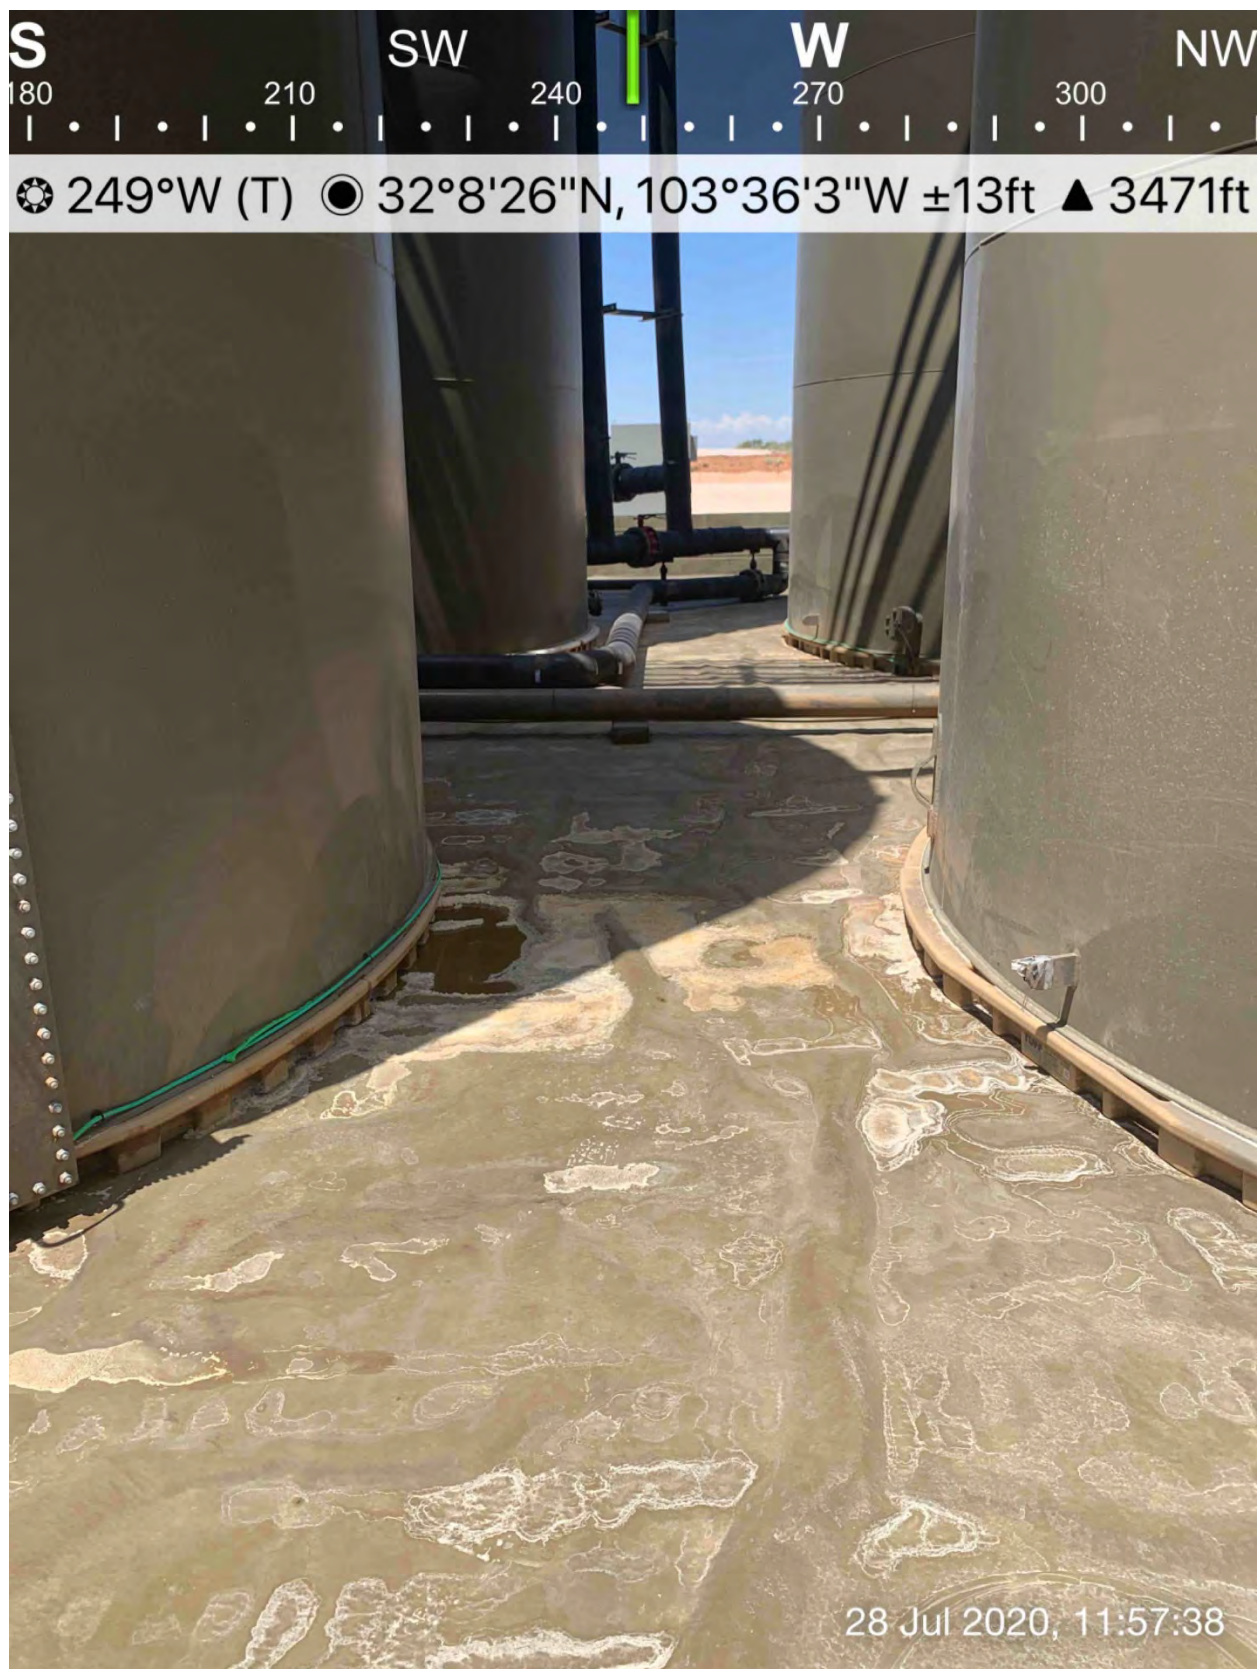
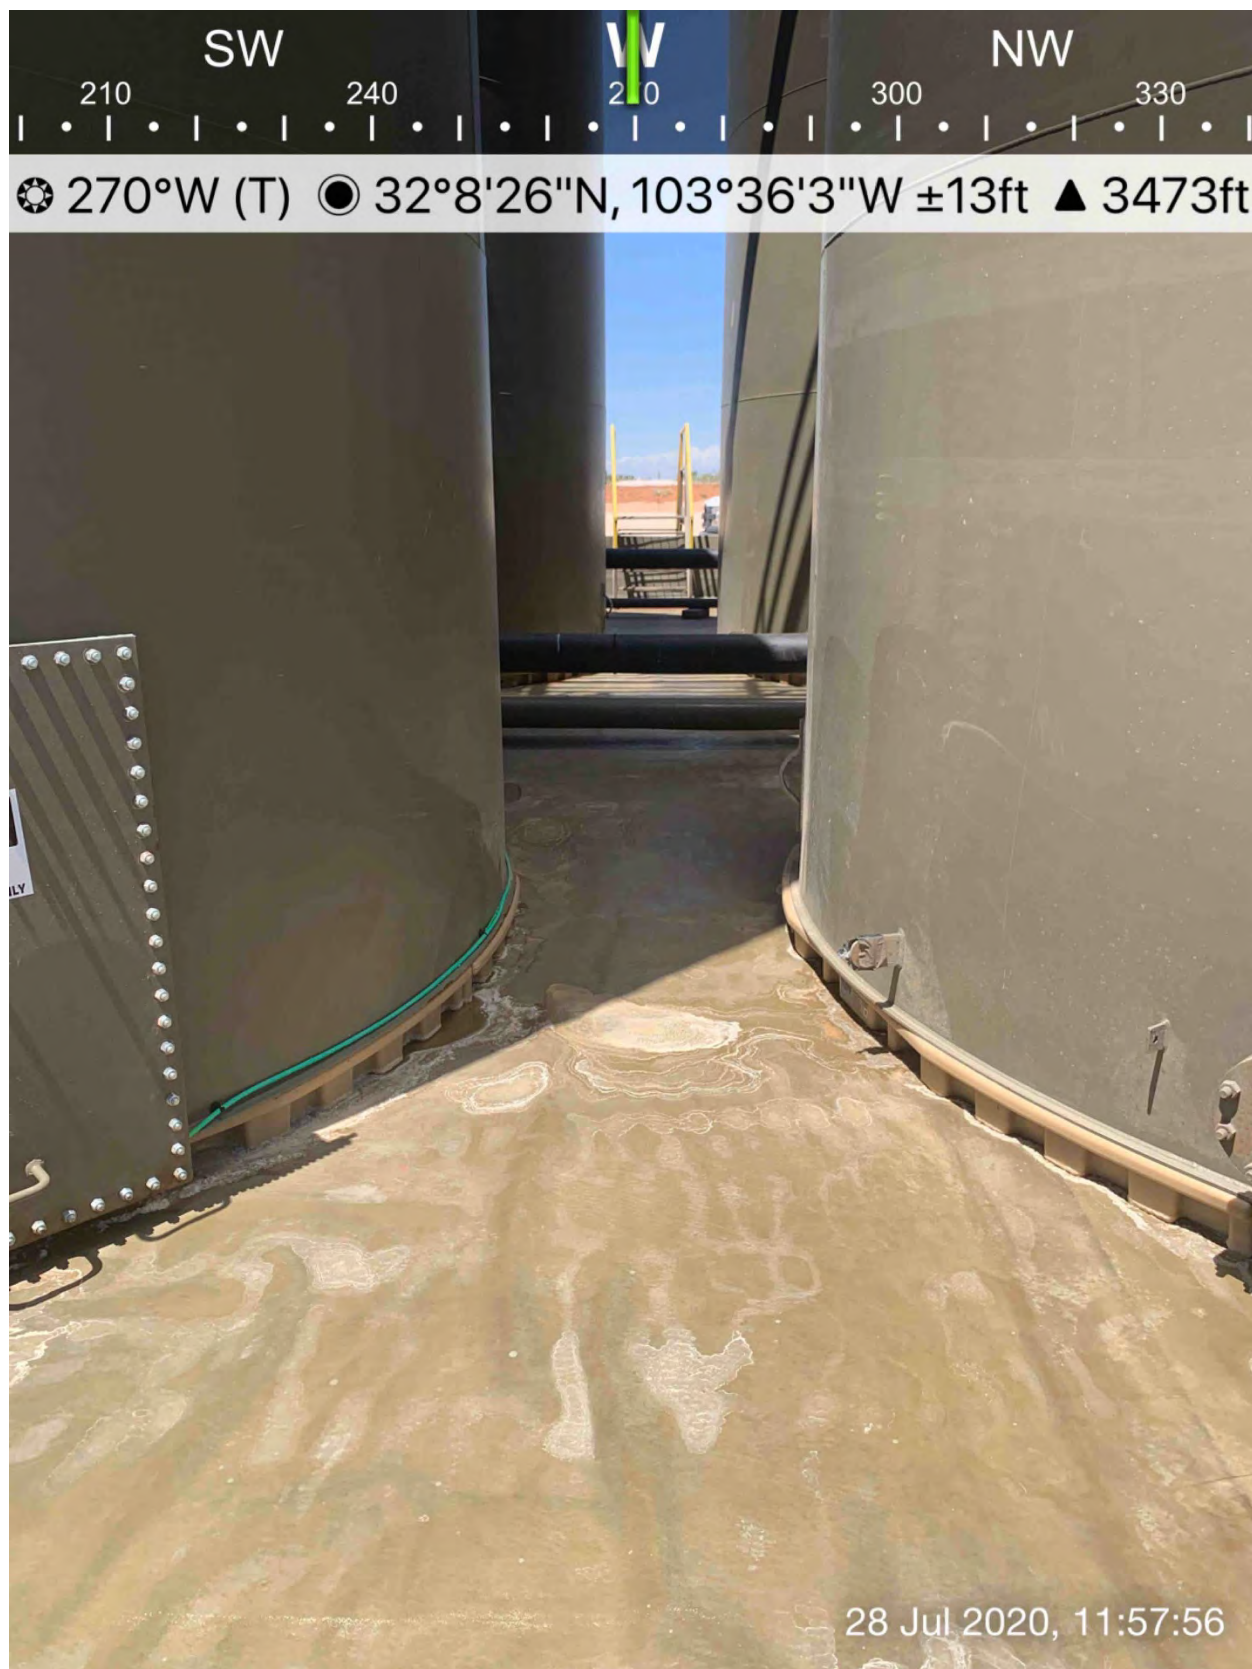
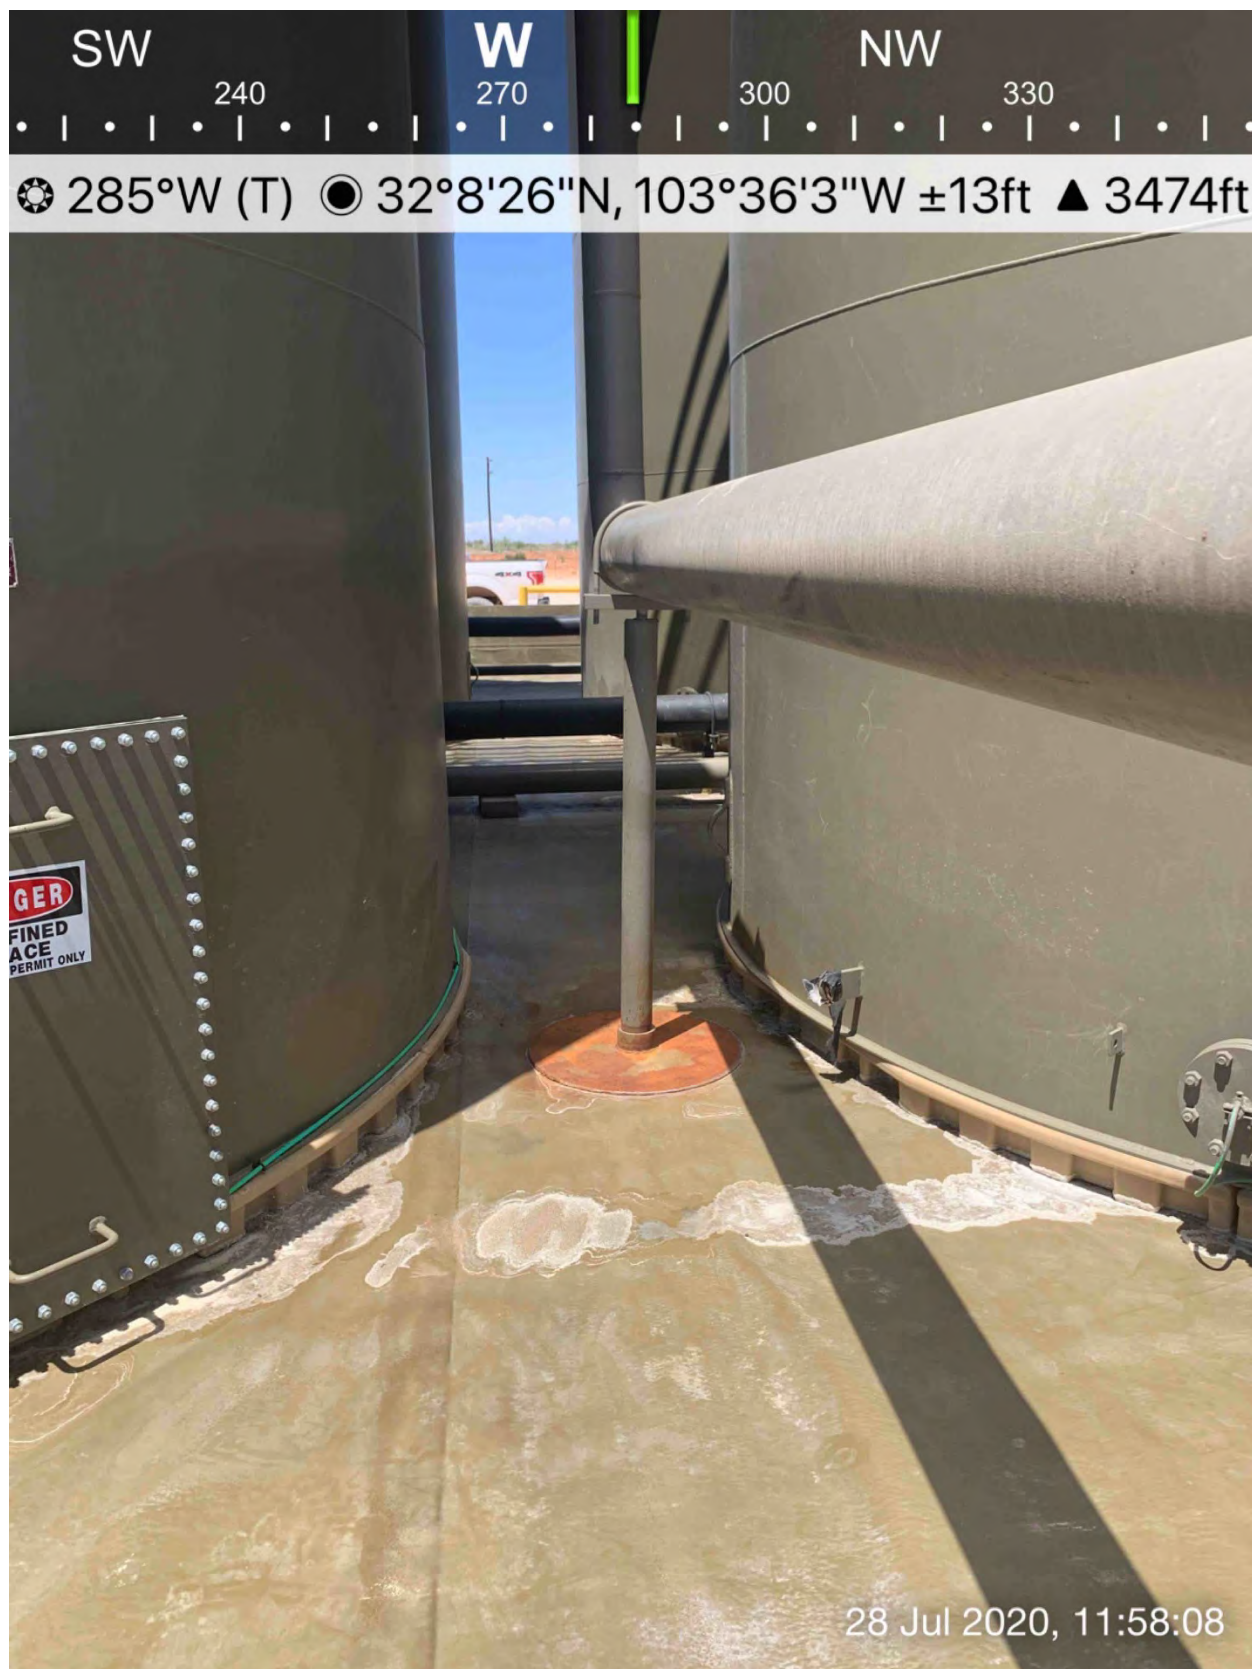
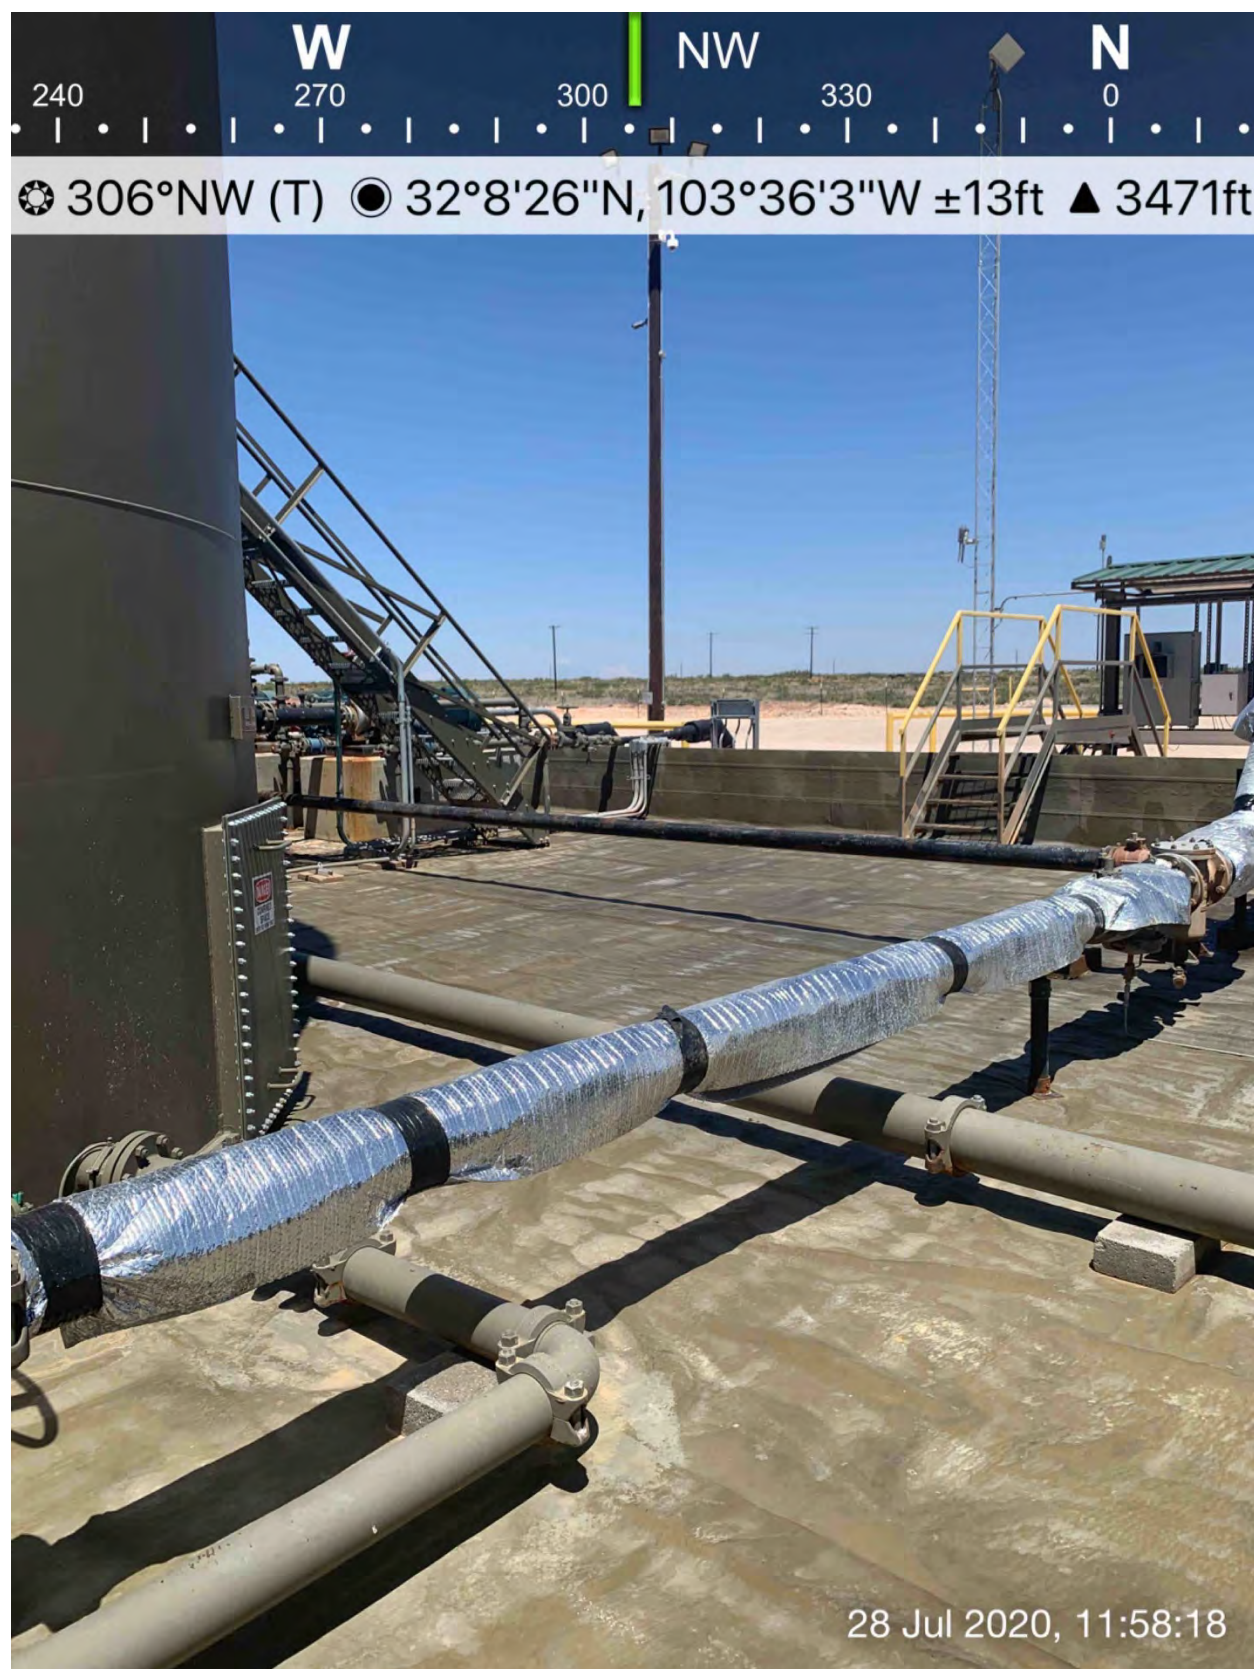
**Appendix A**  
**PHOTO LOG & FIELD NOTES**

At the request of Devon, SMA conducted a liner integrity inspection per the requirements of 19.15.29.11.A(5)(a) NMAC. NMOCD was notified on July 27, 2020 that the liner inspection was to occur. After a thorough visual inspection of the liner within the tank battery containment, the liner appeared to be intact and had the ability to contain the leak in question and will continue to do so. The valve from which the release occurred was identified, and SMA verified that the release did not occur outside of the lined containment. A photo log and field notes of the inspection is included in Appendix A.

SMA recommends no further action for this release.
