Summary of Reclamation Activities

Former Rocky Arroyo Gas Well Site
Sec 4, T22S, R22E
Eddy County, New Mexico

Prepared for: ConocoPhillips

07/18/2014 • 085637 • Report No. 2

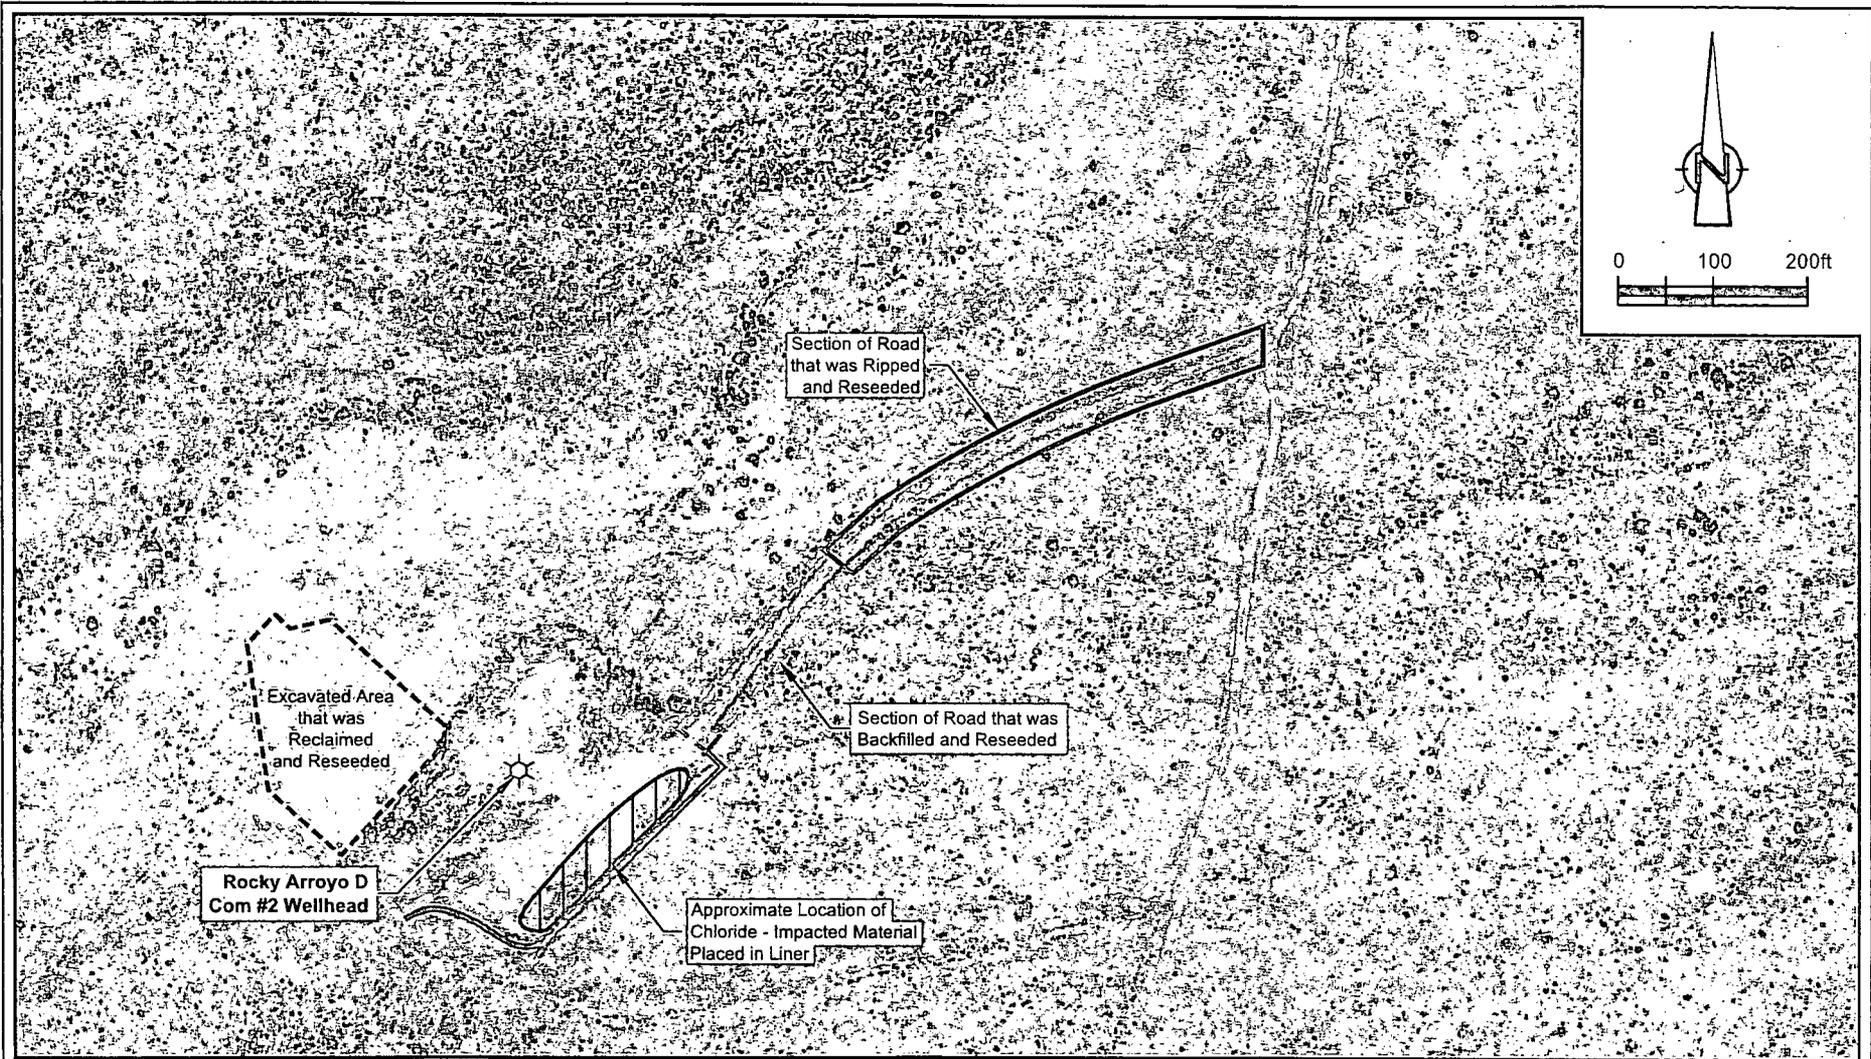
Figure 2
 SITE MAP
 ROCKY ARROYO SITE
 EDDY COUNTY, NEW MEXICO
ConocoPhillips Company

The working pad occupied approximately 1.55 acres. It appeared that the pad was hewn out of the rock slope where the well was located. This created a cut wall that was approximately 20 feet high on the south side of the pad (see Figure 2). The spoils from the cut were pushed to the north to create the pad. The height of the cut wall varies from ground surface where it intersects the slope to approximately 20 feet above the pad surface.

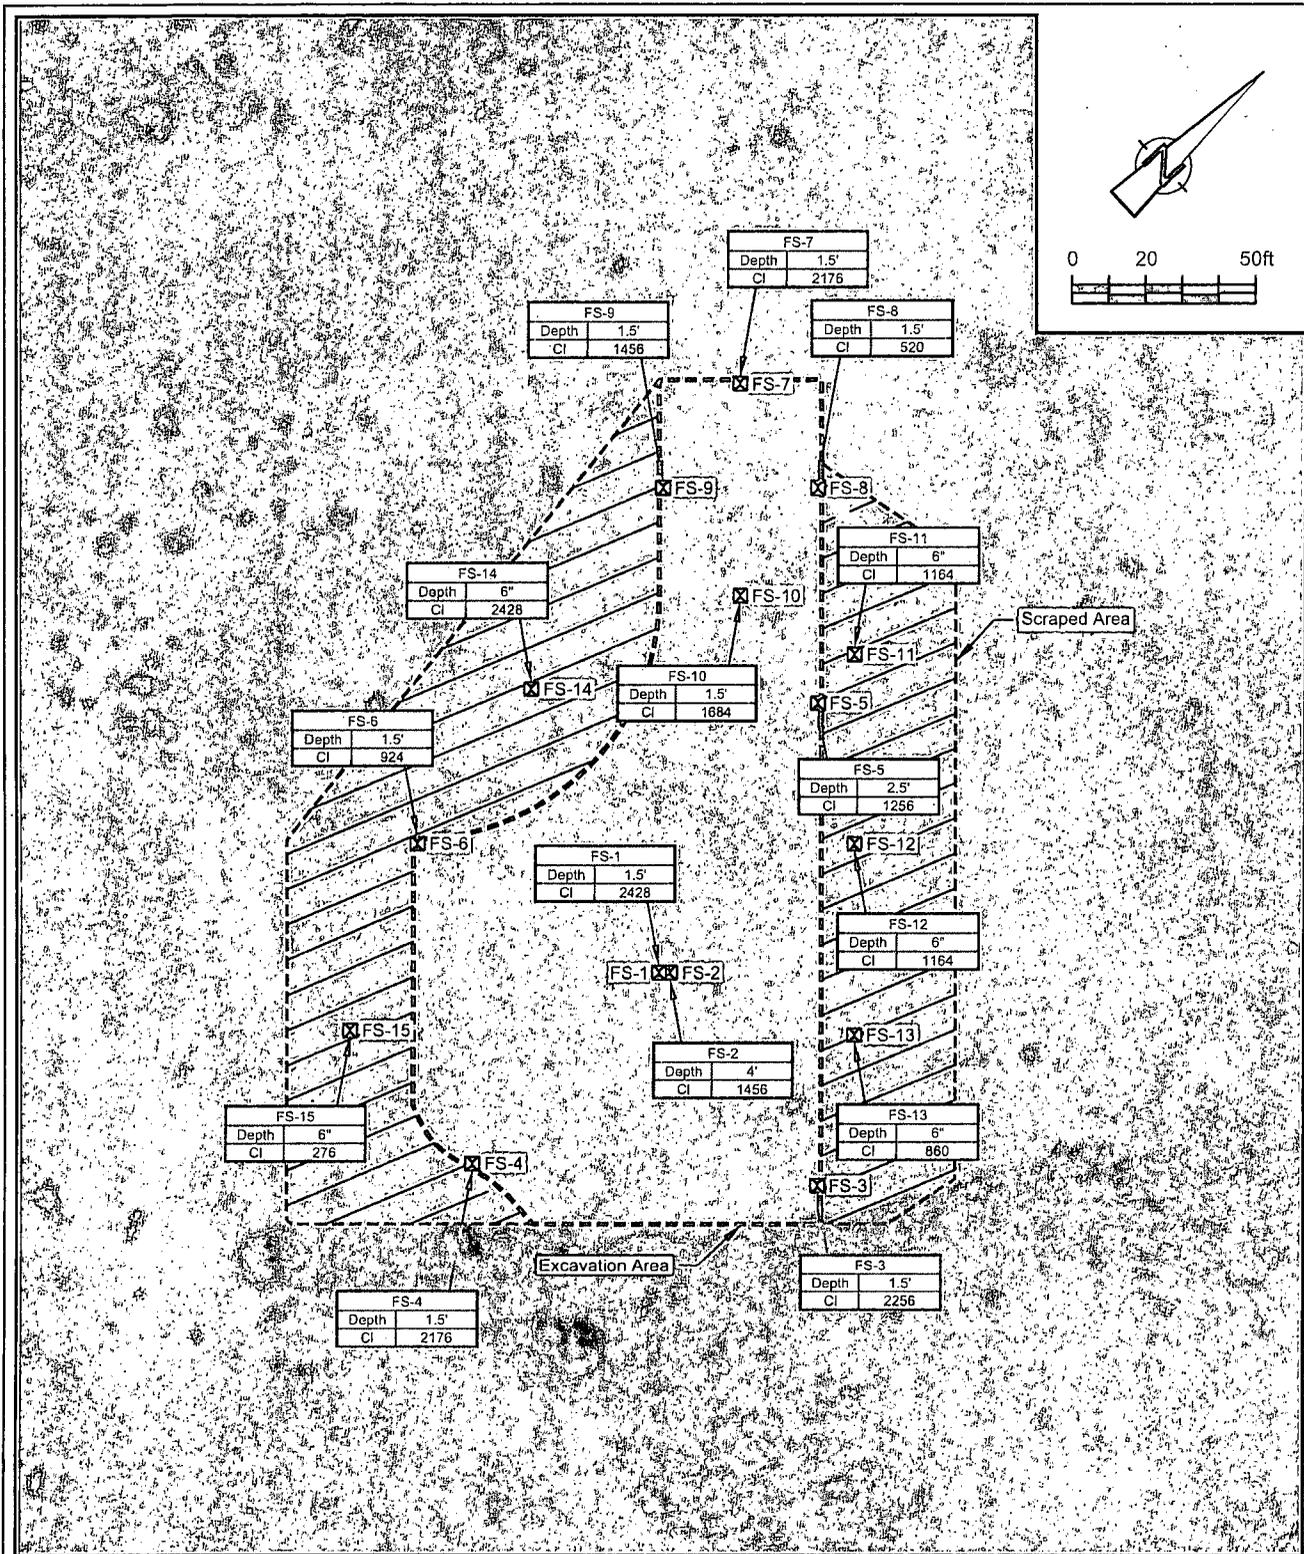
Figure 3
 PIT AREA EXCAVATION MAP
 ROCKY ARROYO SITE
 EDDY COUNTY, NEW MEXICO
 ConocoPhillips Company

Once all the necessary excavation was complete, soil samples from various locations throughout the excavated area (see Figure 3) were collected and field-screened for chlorides using Hach chloride test strips. None of the soil samples returned field screening results that exceeded 2,500 milligrams per kilogram for chlorides.

Reclamation activities began on April 30, 2014. The fine material from the top of the pad next to the cut wall was scraped and stockpiled for later use. The unvegetated portion of the former pit (see Figure 3) was excavated to approximately 18 inches below ground surface (bgs). A 20 mil liner was placed on the pad adjacent to, and partially up the side of the cut wall. Edges of the liner were overlapped a minimum of 24 inches to create a continuous liner. The excavated pit material was then placed on top of the liner, adjacent to the cut wall.

After the initially agreed upon area had been excavated, Mr. Whitlock with the BLM visited the site and it was decided that the excavation needed to be expanded in order to encompass the associated brine-impacted areas. Additionally, the African Rue, an invasive weed, would need to be sprayed with weed killer. The impacted areas, mainly to the north of the former pit, were excavated to approximately 18 inches bgs. The impacted areas on the perimeter of the former pit were scraped to approximately 6 inches bgs.
