UNITED OIL & MINERALS, INC

9/15/99

WELL NAME: NORTH BENSON QUEEN UNIT #7
LEGAL: 2310' FNL & 660' FEL SEC 28, T18S, R30E
EDDY COUNTY, NEW MEXICO

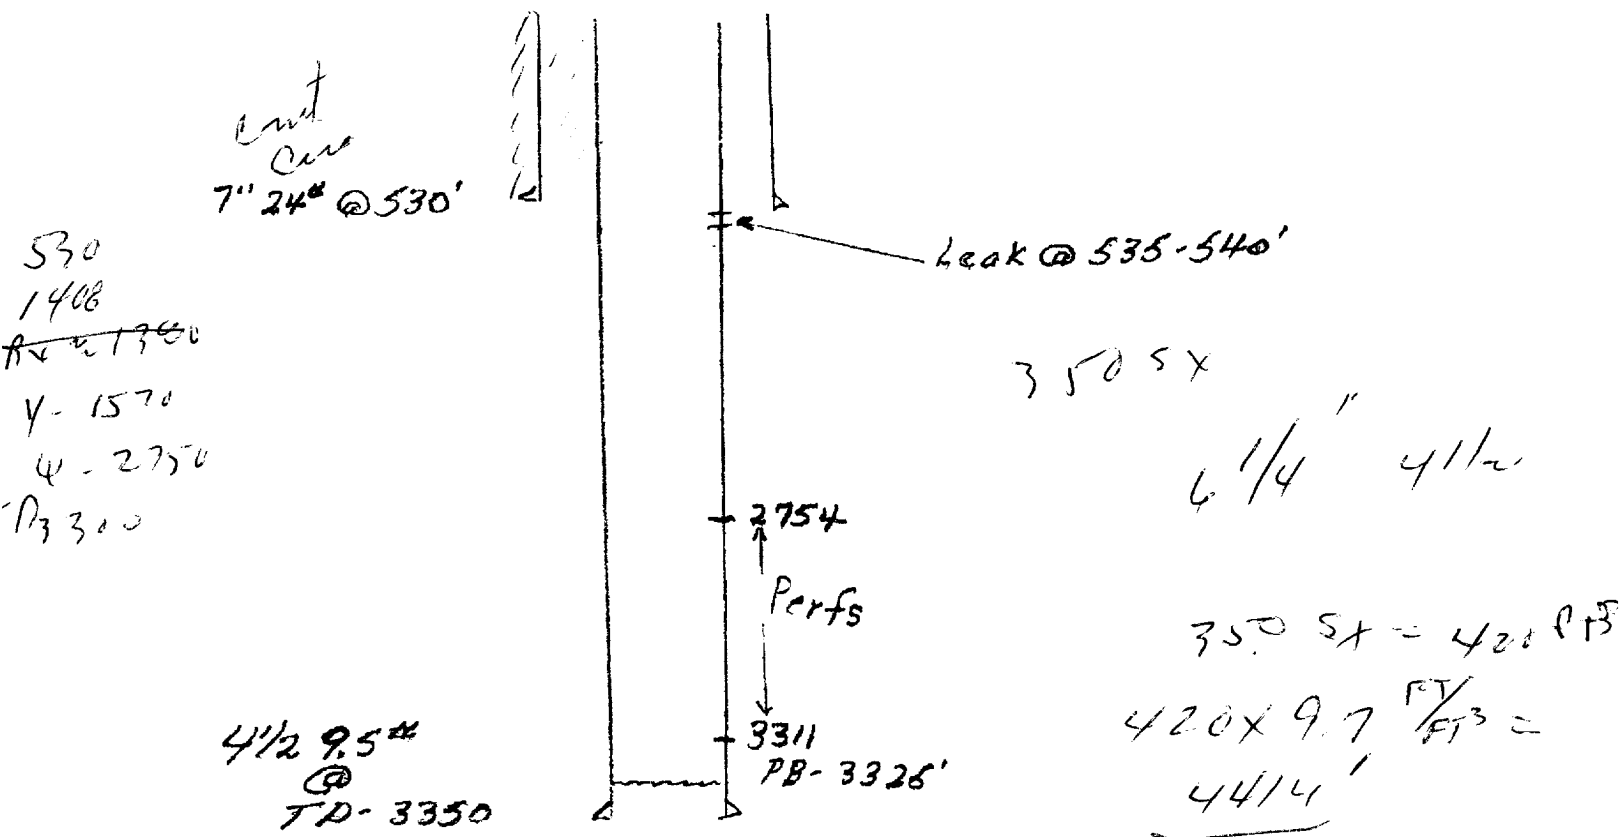
CASING DETAIL: 7" 24# SET @ 530'. CEMENT CIRCULATED
4 1/2" 9.5# SET @ 3350'. CEMENTED W/ 350 SXS. CALCULATED TO CIRCULATE

DETAIL: A CASING LEAK WAS FOUND FROM 500' TO 561'. THE LEAK HAS BEEN
SQUEEZED THREE TIMES AS OF THIS WRITING. DETAILS AS FOLLOWS:

SQUEEZE#1: PUMPED 150 SXS CLASS C + 2% CACL. CEMENT CIRCULATED TO SURFACE
DRILLED OUT. HAD 21/48BPM @ 250PSI LEAK AFTER SQUEEZE.

SQUEEZE#2: PUMPED 200SXS THIXOTROPIC "H" + 200 SXS "C" W/2% CACL
DRILLED OUT & HAD 0.1BPM @ 350PSI LEAK AFTER SQUEEZE.

SQUEEZE#3: SPOTTED 50 SXS "C" LOW FLUID LOSS CEMENT & SQUEEZED.
DRILLED HARD CEMENT TO 535', FELL THRU TO 540', DRILLED HARD CEMENT
TO 561'. TESTED W/ 18BPM @ 350PSI & BUILDING. WILL FLOW BACK PUMPIN
VOLUME. TOOK 10 BBLs TO BUILD 350PSI.
