# PRESSURE LOG\*

Field Report No. 11327 C  
Instrument: J-069

LLANO, INC.  
LEAVITT COM.#1; EDDY COUNTY, NEW MEXICO  
TEST #1; 9012' TO 9208'  
LOCATION: SEC.13-T18S-R26E

FIELD REPORT #11327 C

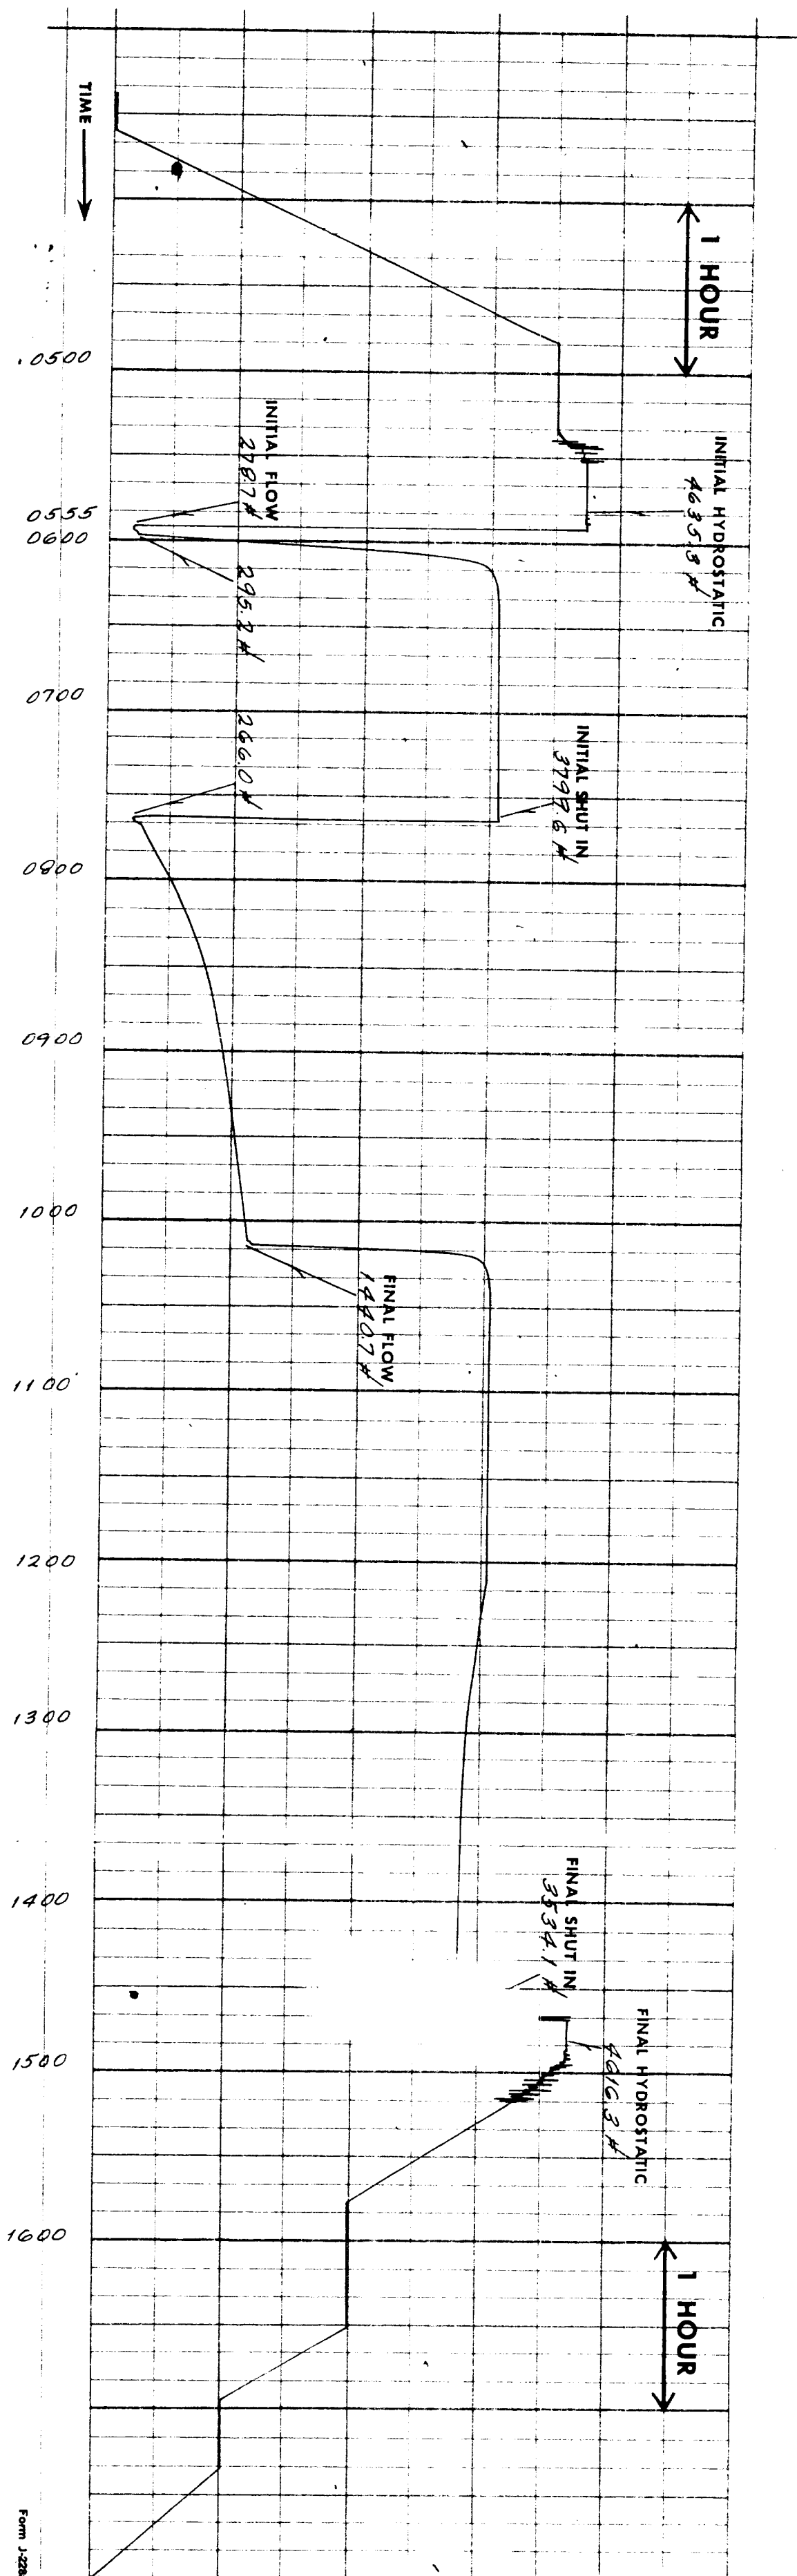
Depth 9196 ft.

\* a continuous tracing of the original chart
