# WELLBORE DIAGRAM

## PARKWAY DELAWARE UNIT #508

API # : 30-015-30029  
 SPUD: 1/01/98  
 COMP: 1/98  
 INITIAL FORM: DELAWARE "C"

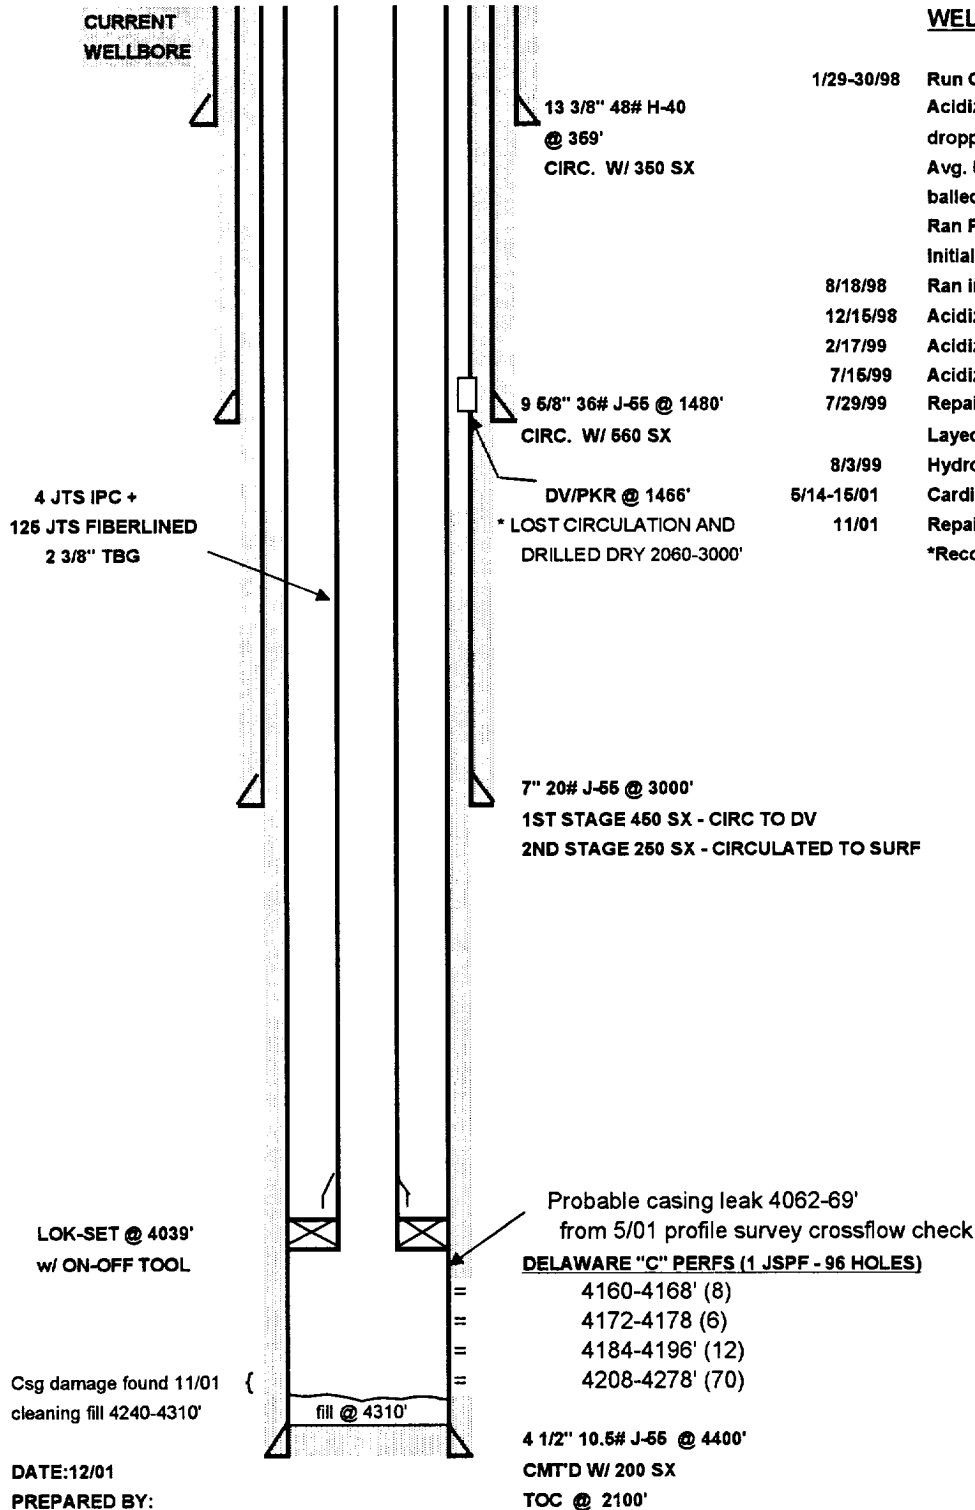
1/29-30/98 Run GR/CBL/CCL and Perforate  
 Acidized w/ 2600g 15% HCl  
 dropping 150 BS's throughout  
 Avg. 5.5 BPM @ 250-3000 psi  
 balled out with 106 balls  
 Ran Pkr & Fiberlined Injection Tubing  
 Initial Rate :~300 BWPD @ 300 psi  
 8/18/98 Ran injection profile survey  
 12/15/98 Acidize w/ 1000g 15%HCl  
 2/17/99 Acidize w/ 1600g 15%HCl  
 7/16/99 Acidize w/ 1000g 15%HCl  
 7/29/99 Repair tbg leak - did not find hole  
 Layed down and replaced inserts  
 8/3/99 Hydrotest in - ok.  
 5/14-15/01 Cardinal Surveys Injection Profile & SI Temp.  
 11/01 Repair tbg leak, clean out fill 4240-4310'  
 \*Recovered ~8' x 2" piece of 4 1/2" csg\*
