ORIGINAL WELL CONDITIONS

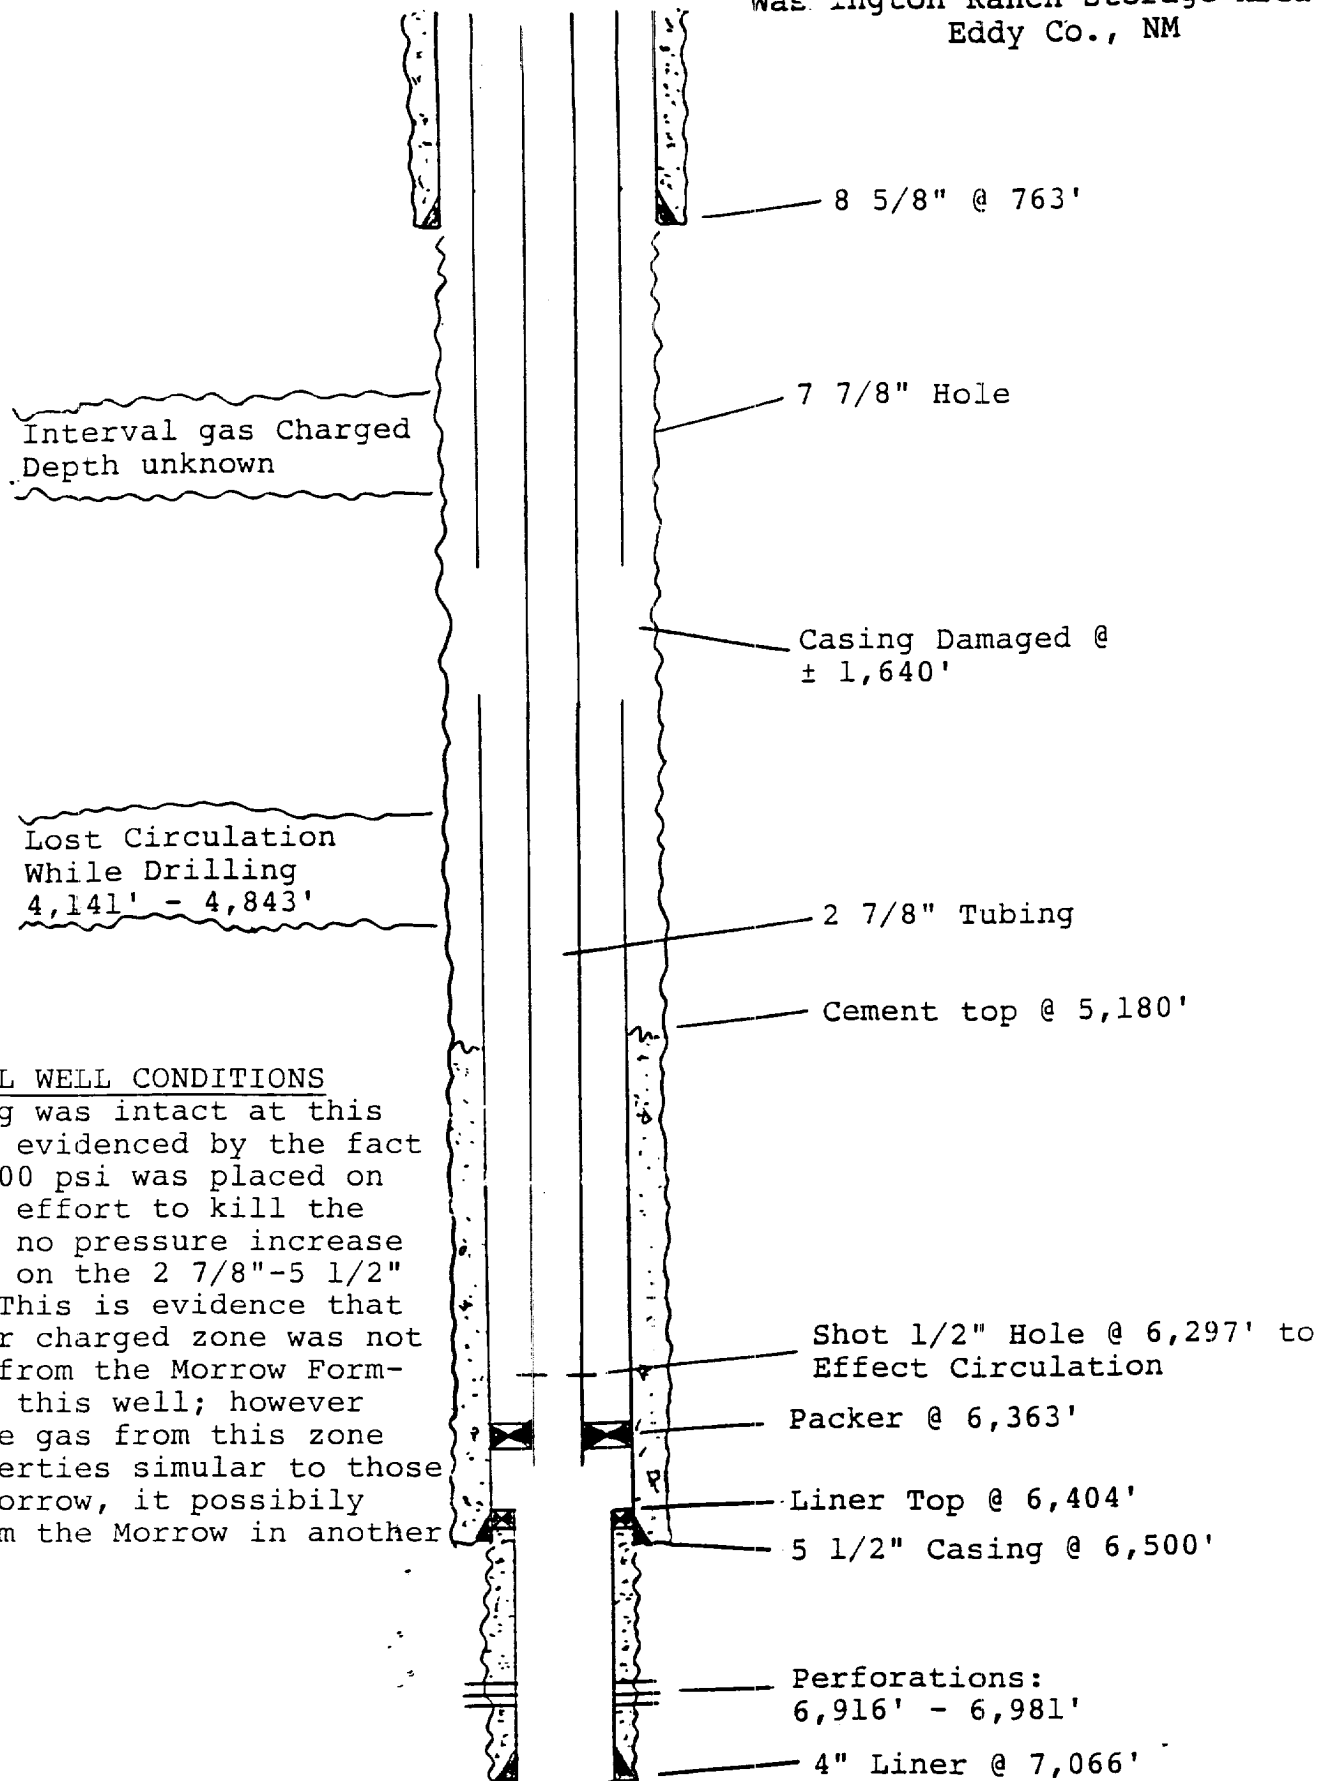
Tubing was intact at this point as evidenced by the fact that 1,400 psi was placed on it in an effort to kill the well and no pressure increase occurred on the 2 7/8"-5 1/2" annulus. This is evidence that the upper charged zone was not charged from the Morrow Formation in this well; however since the gas from this zone had properties similar to those of the Morrow, it possibly came from the Morrow in another well.

FIGURE #1. Well conditions on March 3, 1995, when workover commenced.
