From: Jim Foster [mailto:jim@teamtimberwolf.com]
Sent: Friday, July 12, 2019 1:28 PM
To: Thomas, Leigh <l1thomas@blm.gov>; 'Abiodun Adelaye' <aadeloye@blm.gov>; John Kendall <j01kenda@blm.gov>
Cc: Jennifer Deal <jdeal@hilcorp.com>; Matt Henderson <mhenderson@hilcorp.com>; Ryan Mersmann <ryan@teamtimberwolf.com>; James McNutt <james@teamtimberwolf.com>; Clay Morris <clay@teamtimberwolf.com>
Subject: [EXTERNAL] Hilcorp's Kaufman No. 1 - Weekly Update for week of 7/8/19

Figure
Wetland Map

Wetland Delineation

Kaufman No. 1 Release (SE1/4 NE1/4, Sec. 33, T31N, R13W)
Hilcorp Energy Company
San Juan County, New Mexico

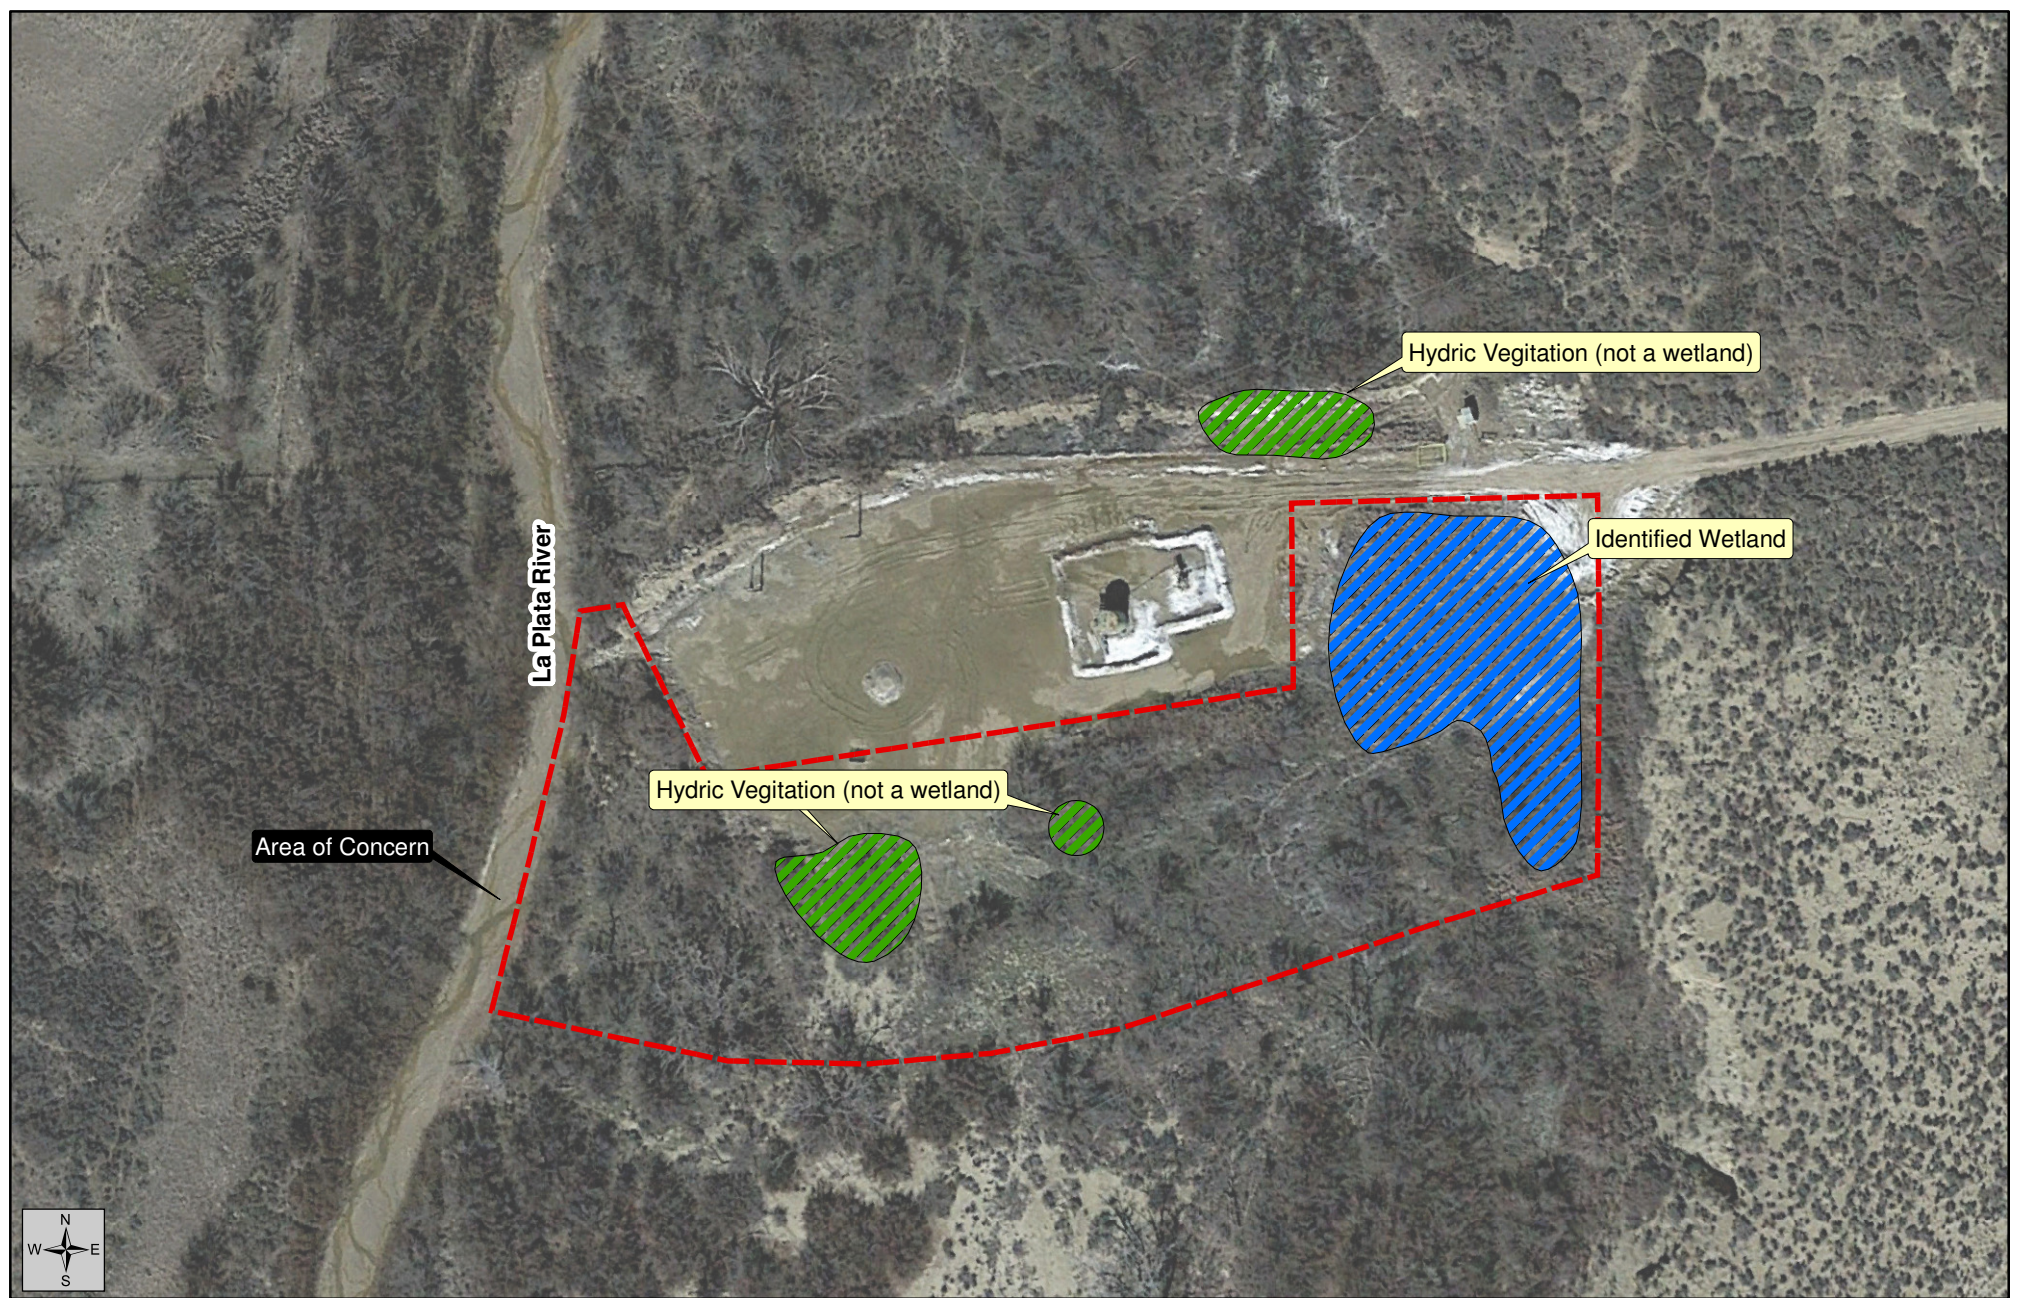
On 7/2/19, Timberwolf conducted a wetland investigation. The attached map depicts the bounds of the investigation and identified features. One wetland was observed east of the Site and 3 areas of hydric vegetation (non-wetland) are located north and south of the Site.

Per the Army Corp of Engineer's request, a wetland investigation was conducted at the Site on 7/2/19. The investigation area encompassed the same area of concern (AOC) as the archeological survey. The investigation revealed one wetland, located immediately east of the well pad. A map depicting the AOC and wetland boundary is being prepared and will be delivered as soon as available. The wetland investigation report is scheduled to be completed by 7/19/19.
