From: Jennifer Deal <jdeal@hilcorp.com>
Sent: Monday, July 22, 2019 12:21 PM
To: Smith, Cory, EMNRD
Subject: [EXT] FW: [EXTERNAL] Hilcorp's Kaufman No. 1 - Weekly Update for week of 7/15/19
Attachments: Kaufman Receptor Survey.pdf

Receptor Survey

Kaufman No. 1 Release (SE1/4 NE1/4, Sec. 33, T31N, R13W)
Hilcorp Energy Company
San Juan County, New Mexico

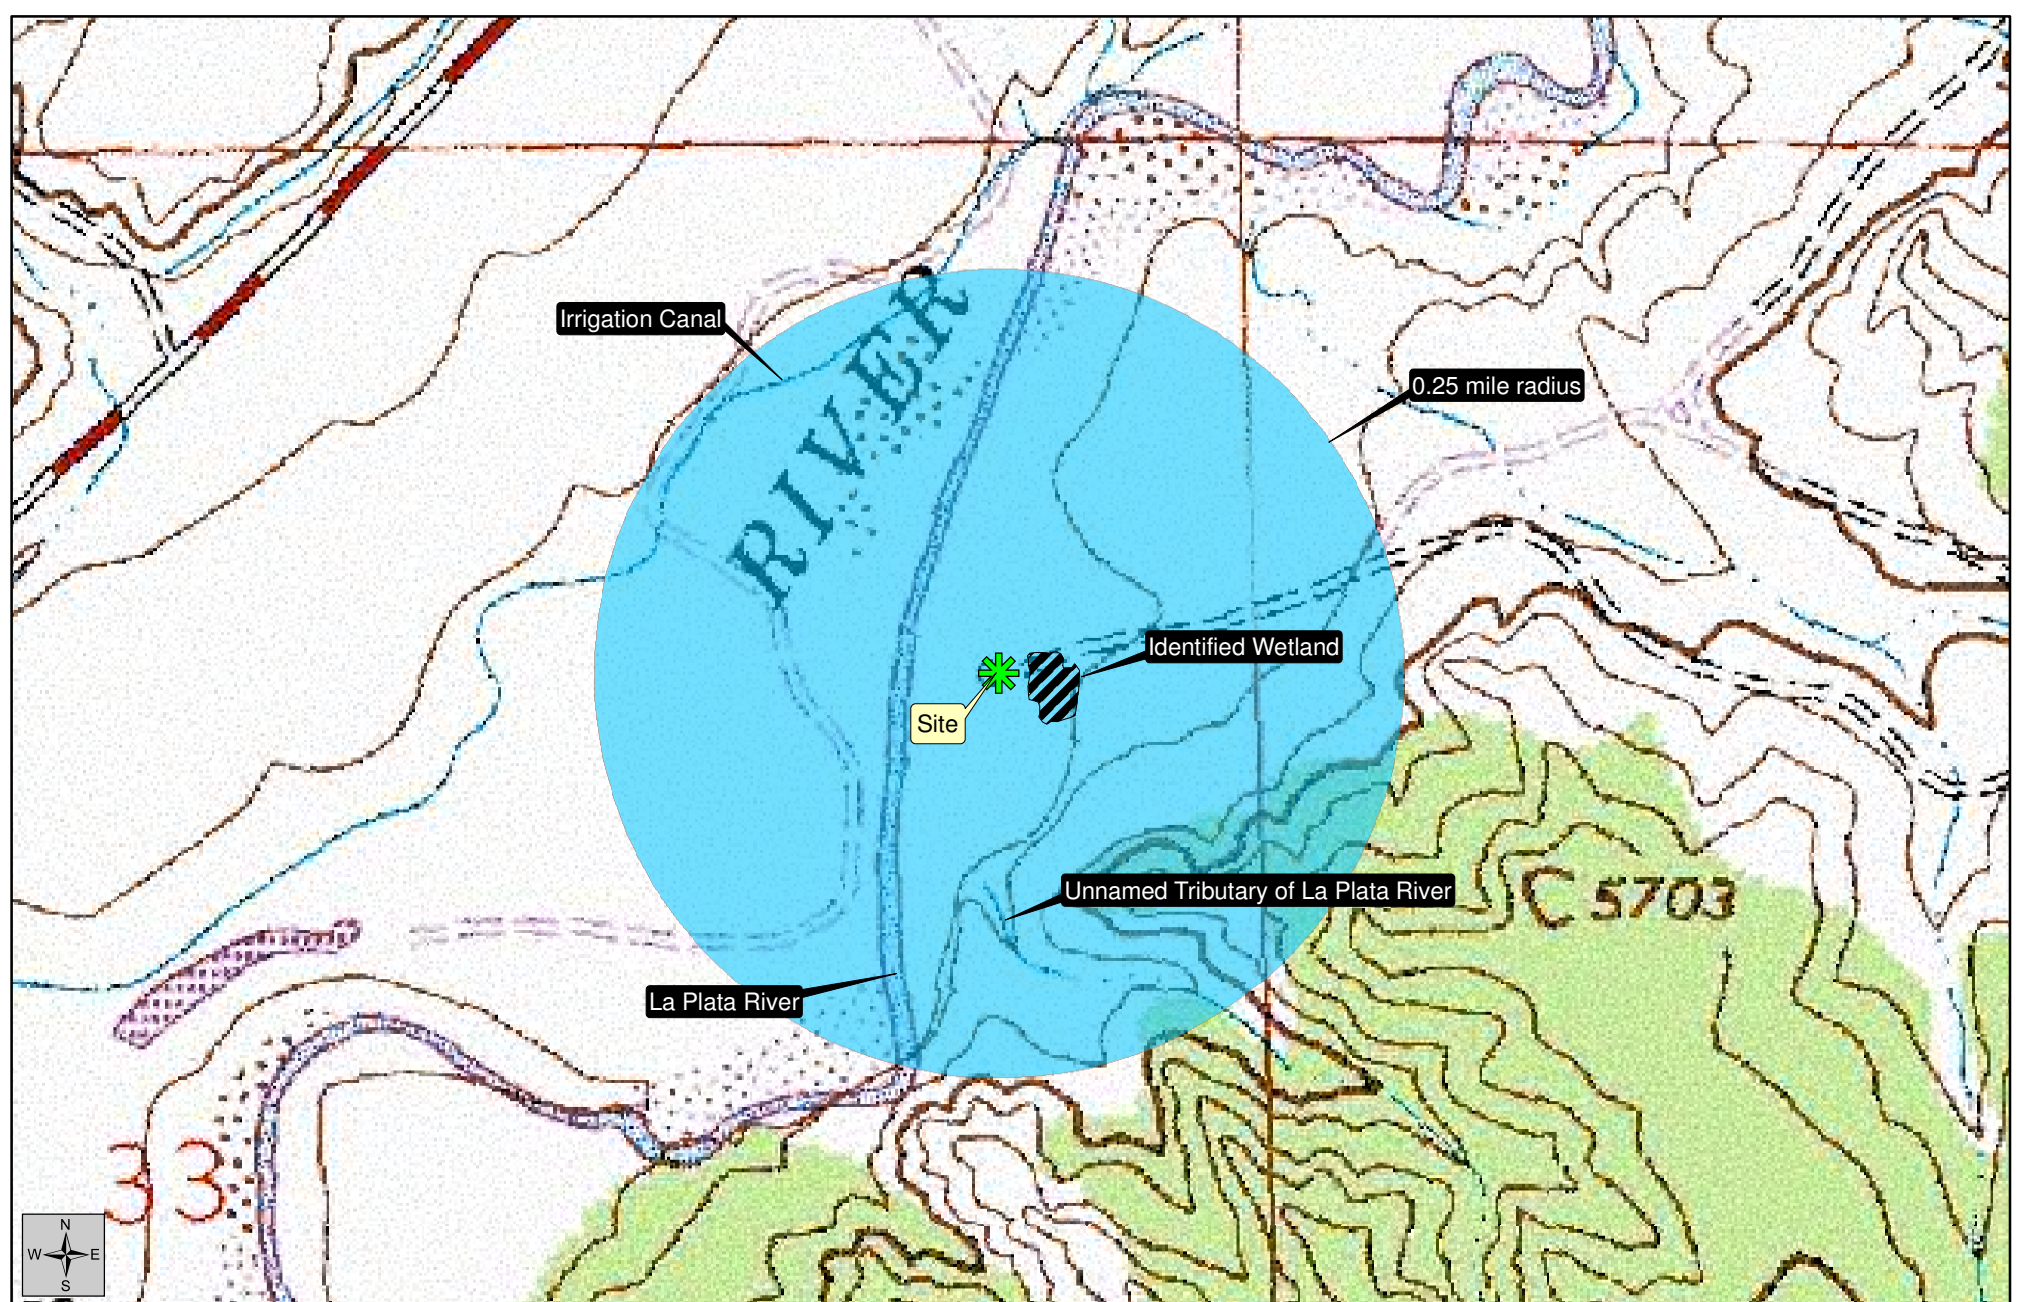
Figure
Topographic Map

Four sensitive features were identified within a one-quarter mile radius of the Site. These include: one wetland, the La Plata River, an unnamed tributary of the La Plata River, and an irrigation canal. Also, 19 water wells were identified within a one-mile radius of the Site; all wells are domestic supply wells. Figures depicting the location of sensitive features and water wells are attached. Also, within the attached document is a table that provides well location, well type, and depth (if available).

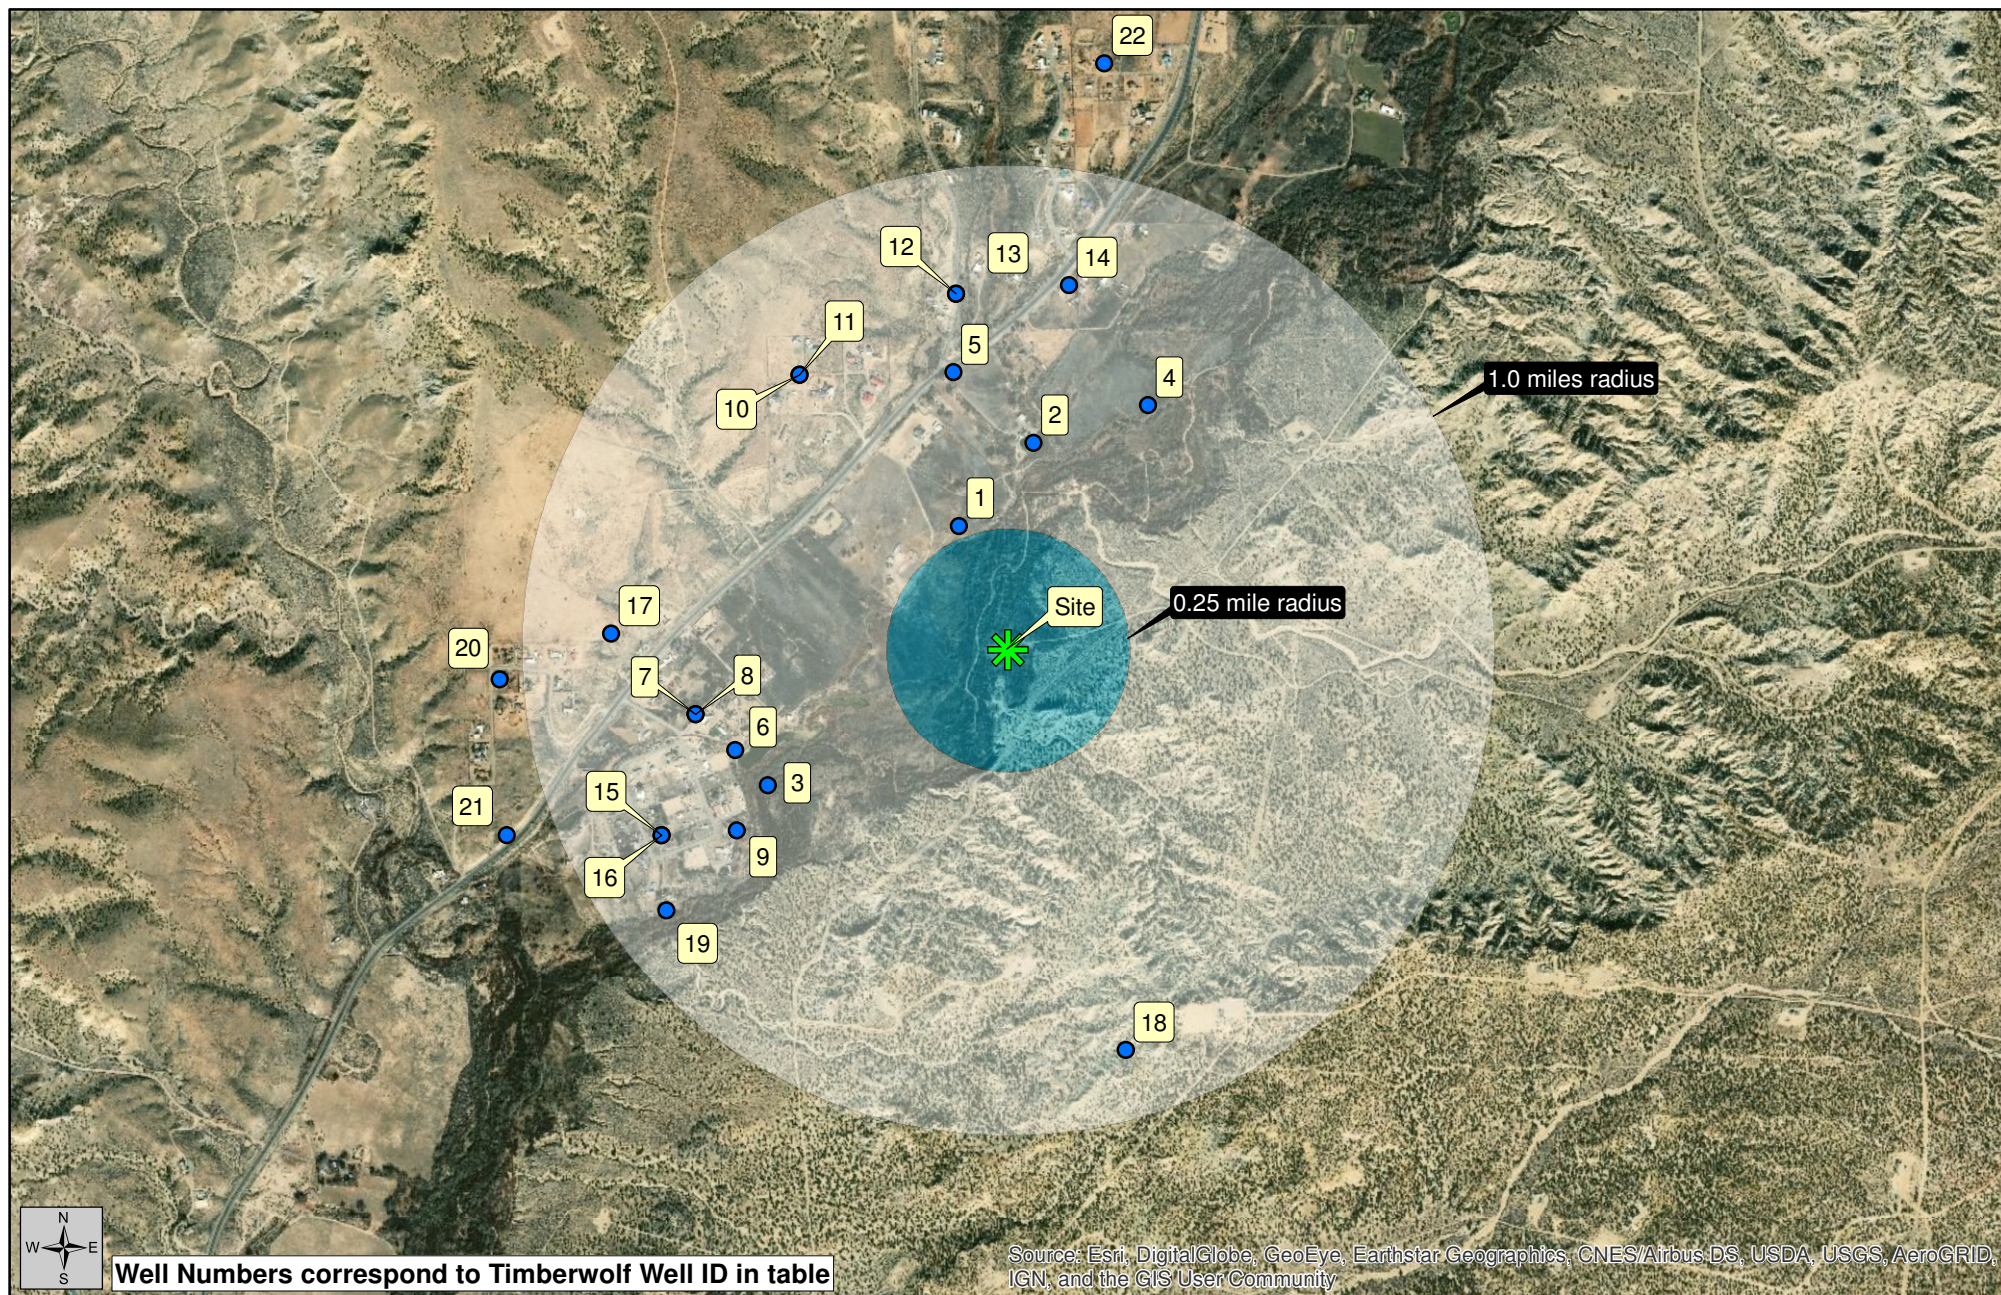
Figure
Water Well Location Map

Review of public records revealed 18 domestic water supply wells within a 1-mile radius of the Site. The closest water well is approximately 0.22 miles north-northwest of the Site.
