From: Jennifer Deal <jdeal@hilcorp.com>
Sent: Monday, July 29, 2019 10:41 AM
To: Smith, Cory, EMNRD
Subject: [EXT] FW: [EXTERNAL] Hilcorp's Kaufman No. 1 - Weekly Update for week of 7/22/19
Attachments: Kaufman No. 1 (Figure 2Q19_potentiometric).pdf; Kaufman No. 1 (Figure ecologicalriskassessmenttt).pdf

Figure
Ecological Risk Assessment

Kaufman No. 1 Release (SE1/4 NE1/4, Sec. 33, T31N, R13W)
Hilcorp Energy Company
San Juan County, New Mexico

Figure
2Q19 Potentiometric
Surface Map

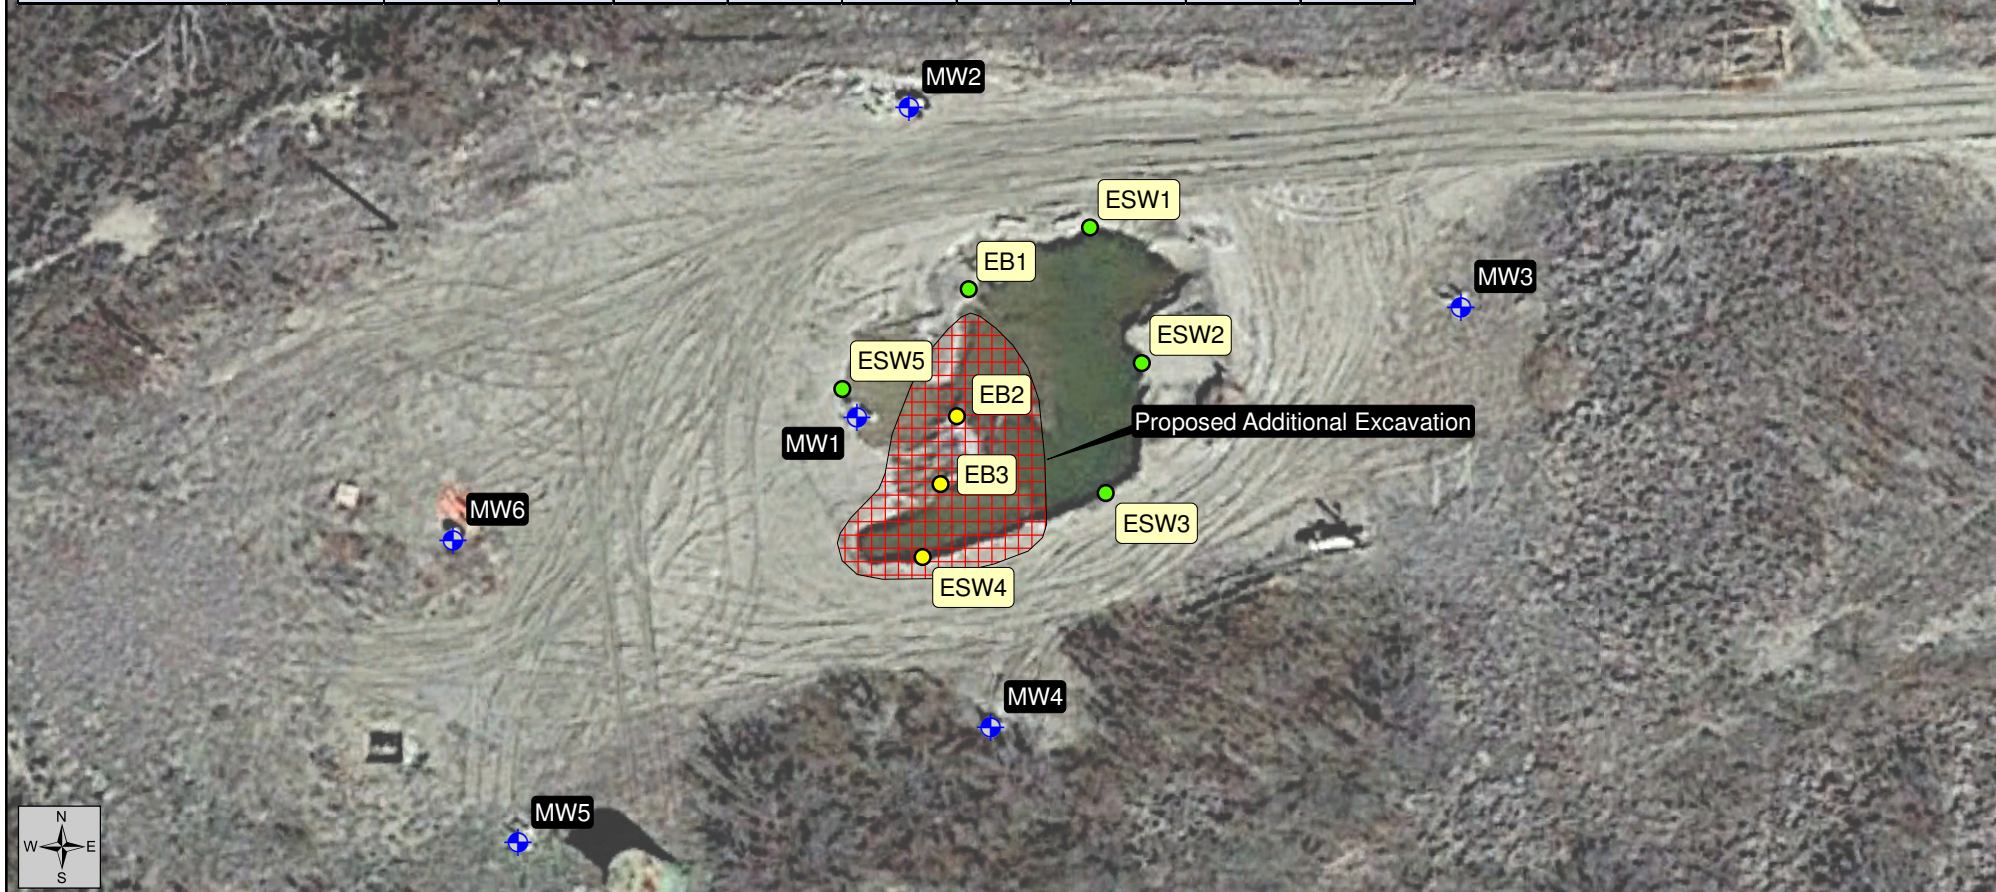
The ecological assessment (Section 6.4 of the Stage 1 abatement plan) was conducted to determine if soil at the Site pose a risk to the Southwestern willow flycatcher. Soil samples were collected from the upper 2 ft of the excavation base and sidewalls. The assessment revealed that soil in the western portion of the excavation exceeded the protective concentration limits (PCL) for the Southwestern willow flycatcher. To mitigate the ecological risk, soil will be excavated for off-site disposal. Findings of the risk assessment and proposed excavation area are presented in the attached figure.

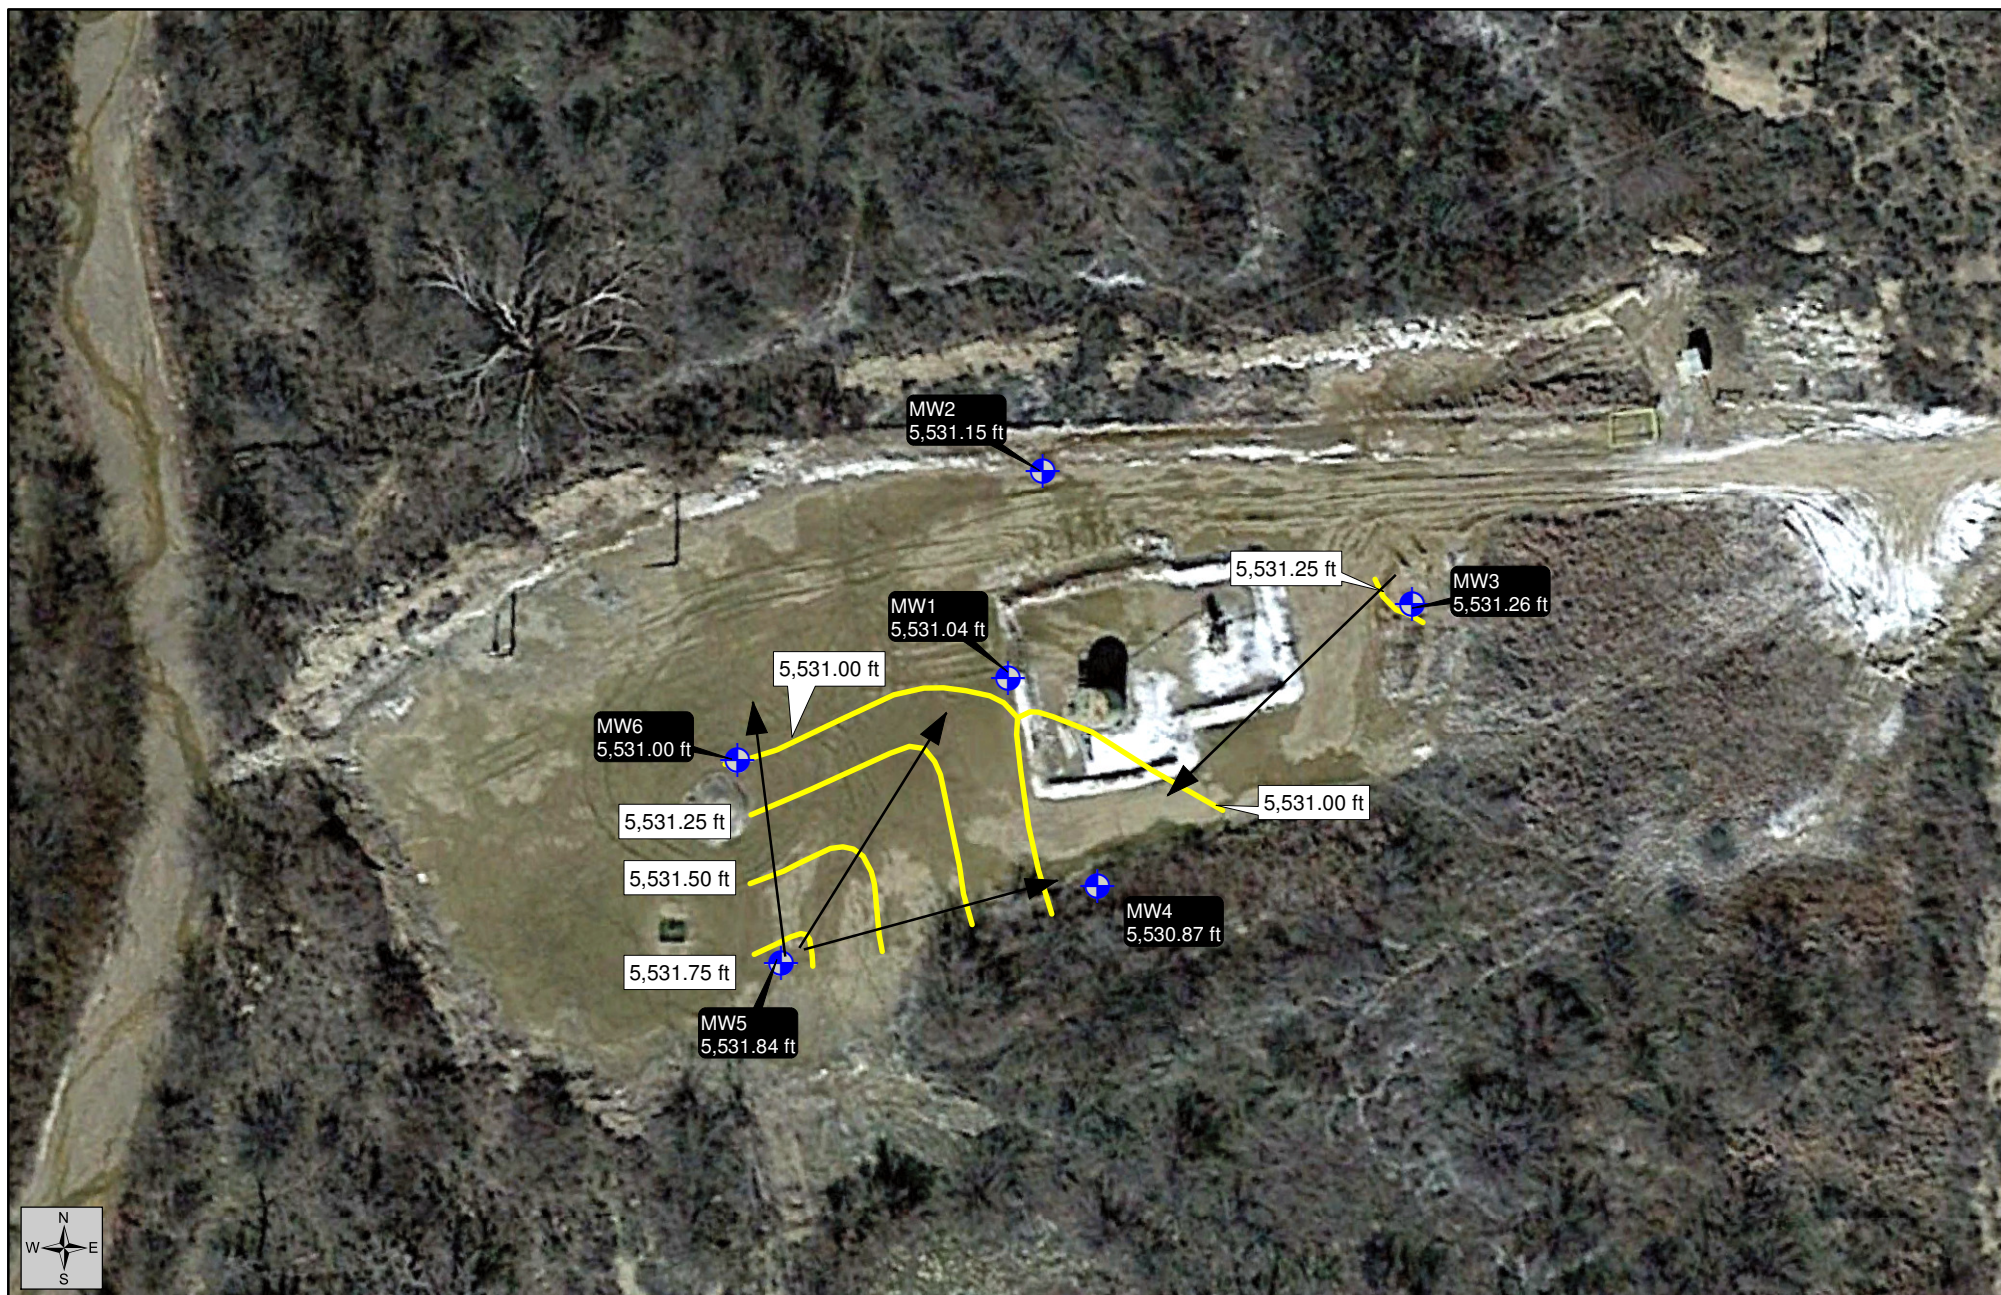
During the additional groundwater assessment (Section 5 of the Stage 1 abatement plan), potentiometric surface elevations were collected for groundwater in each monitor well. The attached potentiometric surface map reveals groundwater is moving towards the excavation.
