PIT REMEDIATION AND CLOSURE REPORT

30-045-12174

Operator: ConocoPhillips

Well Name: Farmington C Com 1

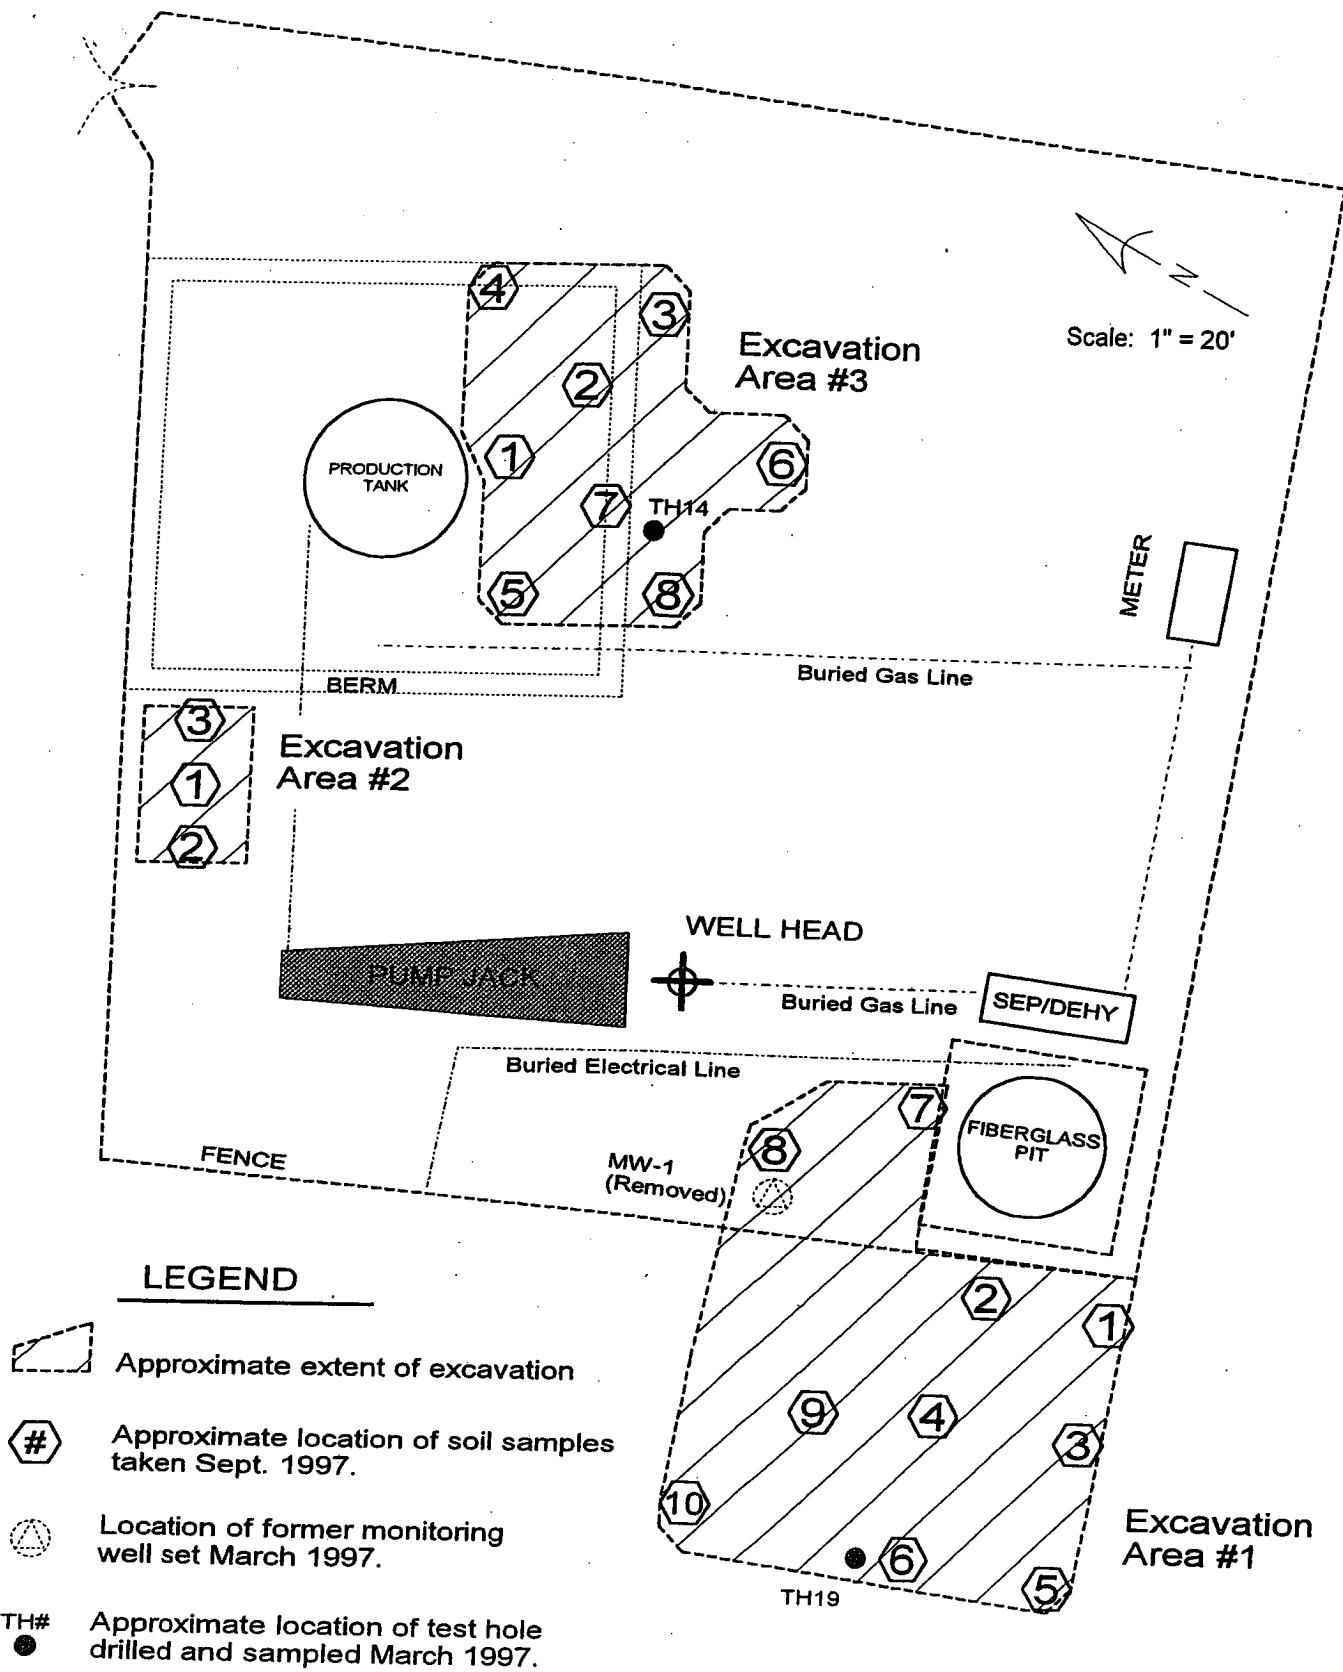
FIGURE: A-1

SITE SKETCH

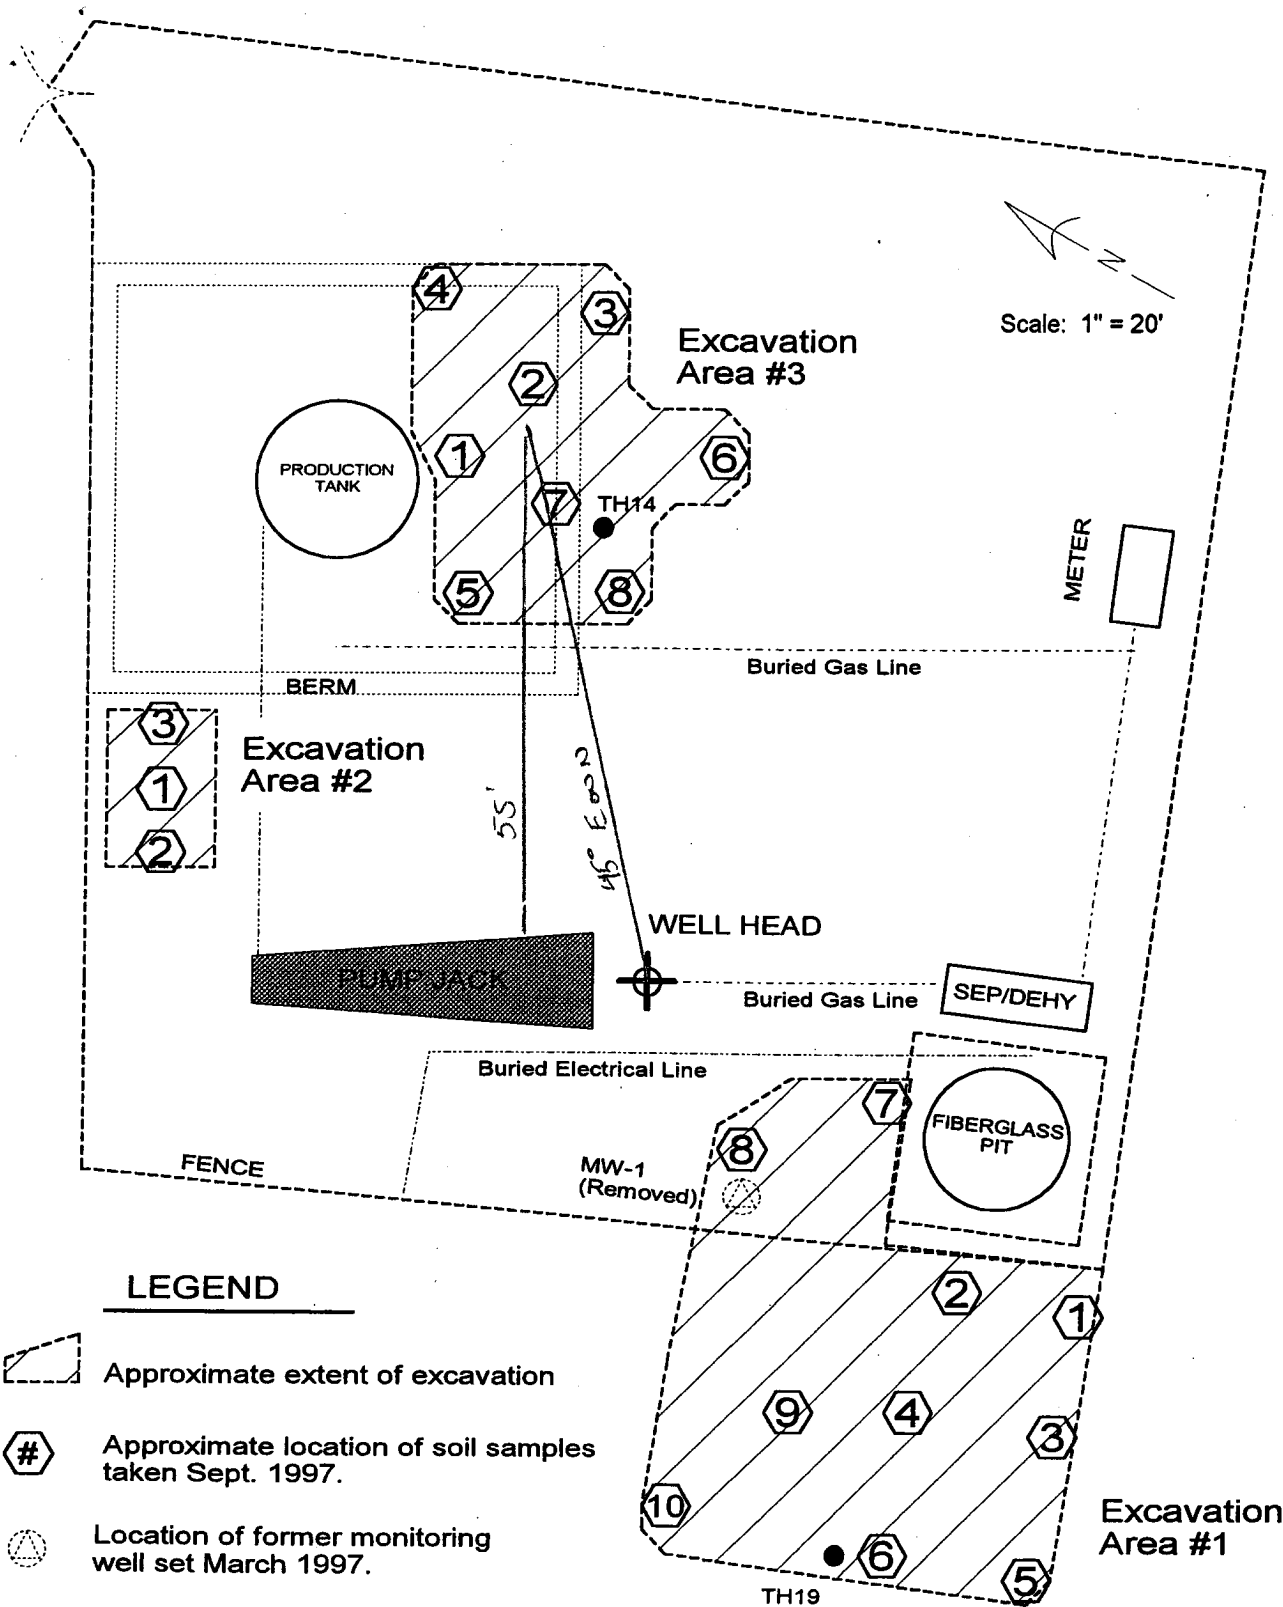
FARMINGTON "C" COM #1 Unit L, S15, T29W, R13W SAN JUAN BASIN, NM		SITE SKETCH
