Pit or Below-Grade Tank Registration or Closure

Operator: Merrion Oil & Gas Telephone: (505)324-5326 e-mail address: cdinning@merrion.bz
Address: 610 Reilly Ave., Farmington, NM 87401
Facility or well name: Canada Mesa 3 API #: 30-039-20632 U/L or Qtr/Qtr ne/ne Sec 14 T 24N R 6W
County: Rio Arriba Latitude _____ Longitude _____ NAD: 1927 ☐ 1983 ☐ Surface Owner Federal ☒ State ☐ Private ☐ Indian ☐

**Merrion Oil & Gas
Canada Mesa No. 3
UL A, Sec 14, T24N, R6W
Rio Arriba County, New Mexico
Pit Closure Summary**

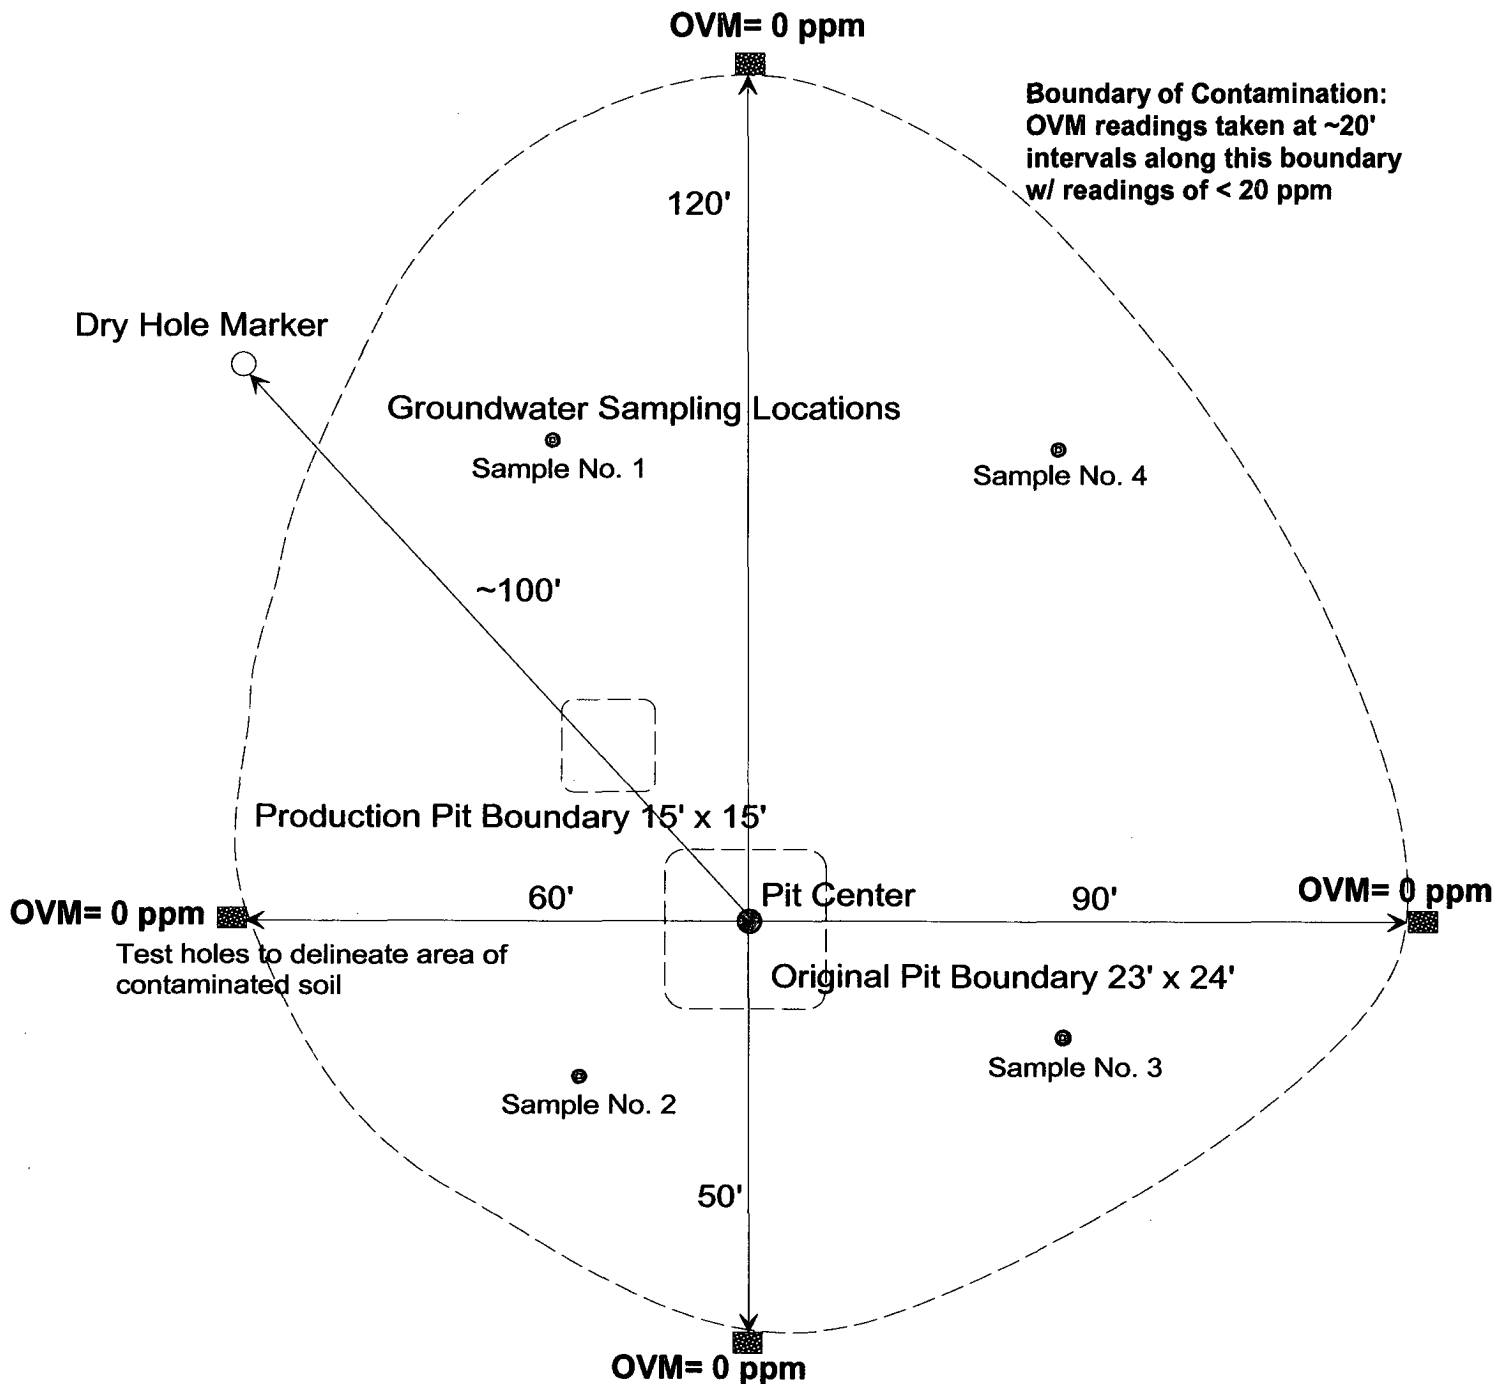
**Merrion Oil & Gas
Canada Mesa No. 3
Pit Closure, Site Sketch**

- ❖ Remove contaminated soil in segments
 - As planned, the soil was removed in sections, moving out radially from the center of the existing pit. The attached site diagram shows the location of the test holes that were excavated to determine the extent of the soil contamination. The excavation contractor, Moss Excavation, initially moved out approximately 100' in each direction to find clean soil. He then moved toward the center of the pit from the clean soil continuing to dig test holes at 10' intervals until he hit contaminated soil. This was sufficient in each direction except the north, toward Largo Wash. This was the apparent direction of groundwater flow, and hydrocarbon flow from the pit. The soil was contaminated 100' to the north, so he moved out approximately 40 additional feet and worked back toward the pit in 10' intervals until he hit contaminated soil. The diagram shows the approximate shape of the contamination in the soil.

- ❖ Close segments based on OVM readings
 - We required OVM readings of 100 ppm prior to the backfilling of any section of the pit with clean soil. These readings were taken at 20' intervals along the approximate boundary noted on the attached diagram. The excavation and testing continued until all the contaminated soil was removed, and portions of the
