Site Name: Lybrook A12-2306 01H	Site Type: Tank Battery
Date Release Discovered: 7/28/2018	API# (if applicable): 30-039-31219

Cause of Release: Lightning Strike

RE: CONFIRMATION SAMPLING DOCUMENTATION FOR THE LYBROOK A12 2306 01H UNIT A WELL SITE, RIO ARRIBA COUNTY, NEW MEXICO

**SITE PHOTOGRAPHY
SPILL ASSESSMENT AND CLOSURE REPORT
ENCANA OIL AND GAS INC.
LYBROOK A12 2306 01H UNIT A
PROJECT NUMBER 11195-0228
AUGUST 2018**

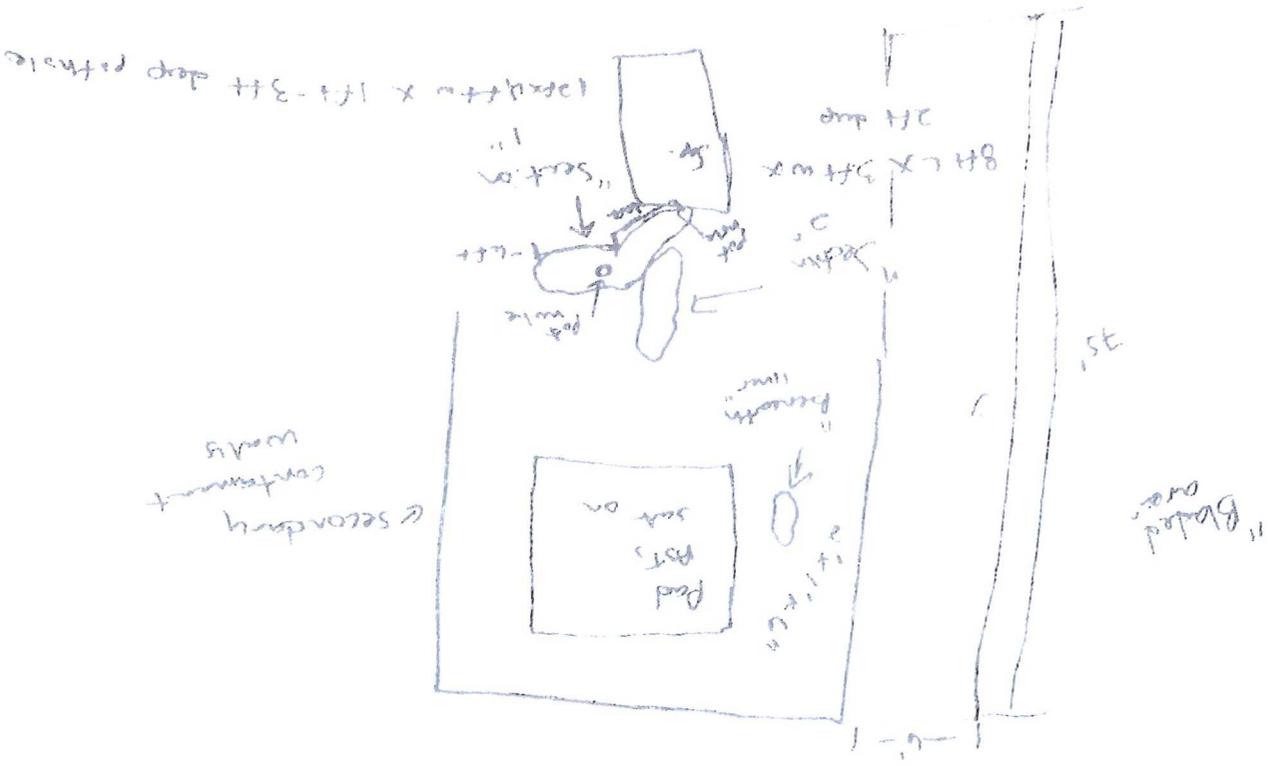
East of ladder ~ 4' x 3' x 1 foot to 3 feet deep

S of ladder ~ 5' x 4' x 1' to 2' deep

Inside containment ~ 6' long x 4' wide x 2" to 3' deep

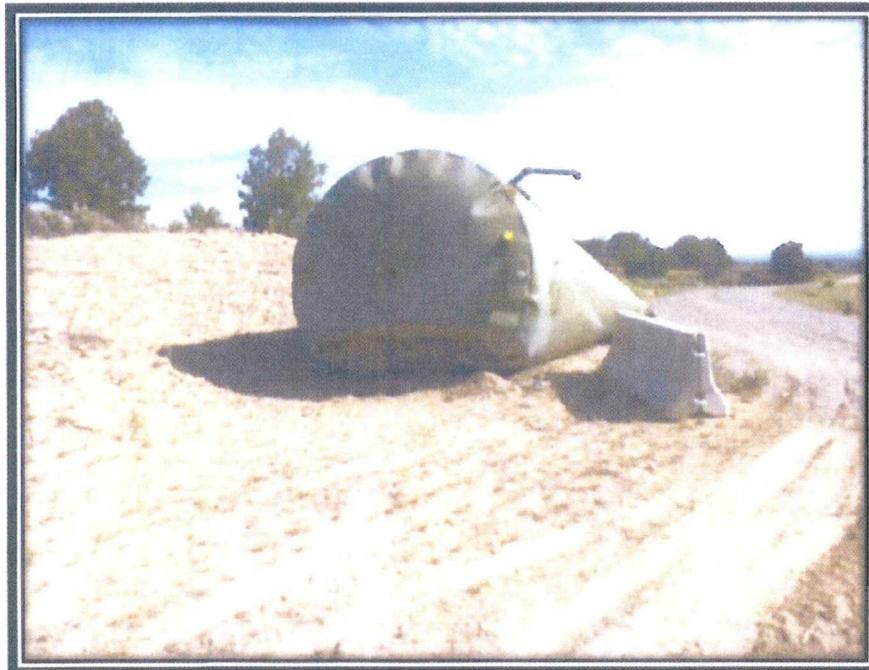
Picture 2: View of Tank Struck by Lightning

When the operator arrived at the Lybrook A12 facility on July 28 it appeared that there had been a lightning strike because the produced water tank was blown out of the containment and roughly 100 feet north of the containment. A vac truck was dispatched to the site the next day to recover liquid in the containment. The area of greatest impact was also bladed to turn the soil and ensure that impacted soil could volatilize clean. Additionally, Encana is working to repair the secondary containment that was blown out of shape due to the lightning.

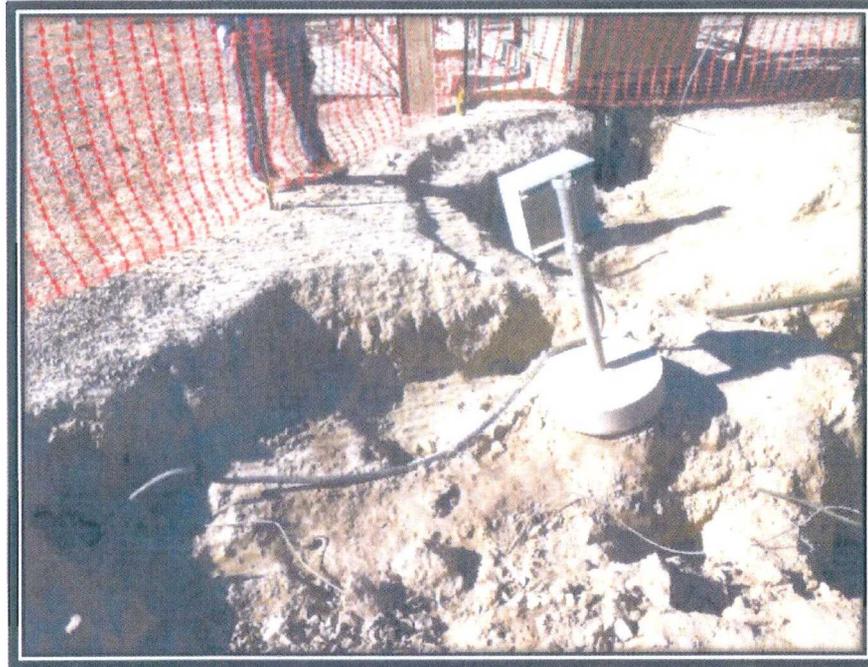
twelve (12) feet by four (4) feet by one (1) foot to three (3) feet bgs. *Section 2* measured approximately eight (8) feet by three (3) feet by two (2) feet bgs. The area under the liner (*Under Liner*) was also excavated to the extents of approximately two (2) feet by one (1) foot by six (6) inches bgs. One (1) five (5) point composite sample was collected from *Section 1*, *Section 2*, *under the liner*, and along the western edge of the location (*Bladed Area*) due to splatter from the tank and the manifold located on top of the tanks when they broke apart with New Mexico Oil Conservation Division (NMOCD), Mr. Cory Smith, and Bureau of Land Management (BLM) representative, Mr. Abiodun "Emanuel" Adeloje, as witnesses; see *Field Notes* and *Site Map*. The samples were screened in the field for organic vapors using a PID. All four samples returned results of 0.0 ppm OV. The samples were placed into individual laboratory provided four (4) ounce jars, capped headspace free, and transported on ice under strict chain of custody to Envirotech's Analytical Laboratory to be analyzed for TPH (DRO/GRO/ORO) using USEPA Method 8015D, benzene and total BTEX using USEPA Method 8260B, and chlorides using USEPA Method 300.0. The samples returned results below the regulatory standards all constituents analyzed; see enclosed *Analytical Results* and *Summary of Analytical Results*. Envirotech, Inc. recommends *No Further Action* in regards to this incident.

Picture 3: View of *Section 1*

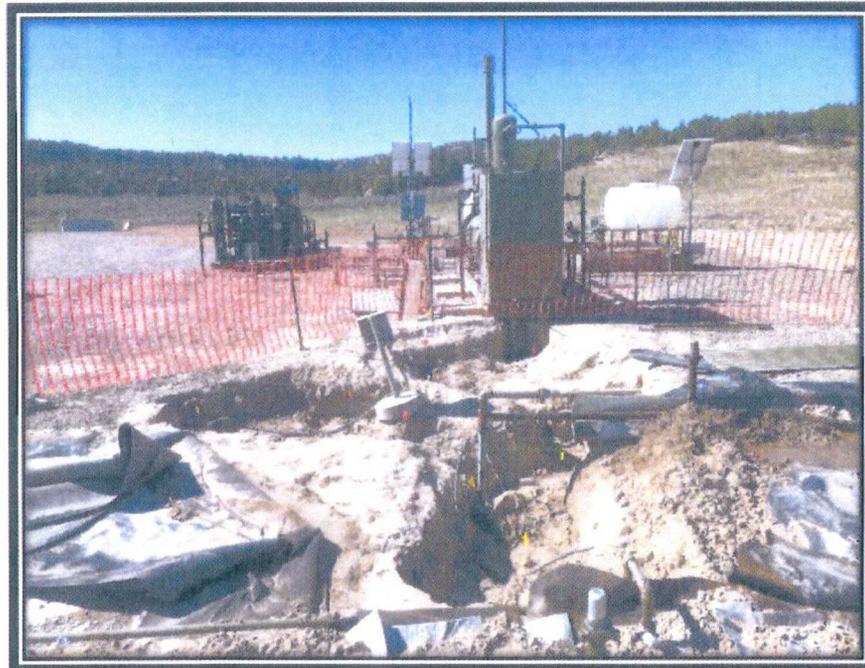
Picture 4: View of Sampling Locations (Orange Flags) in *Section 1*

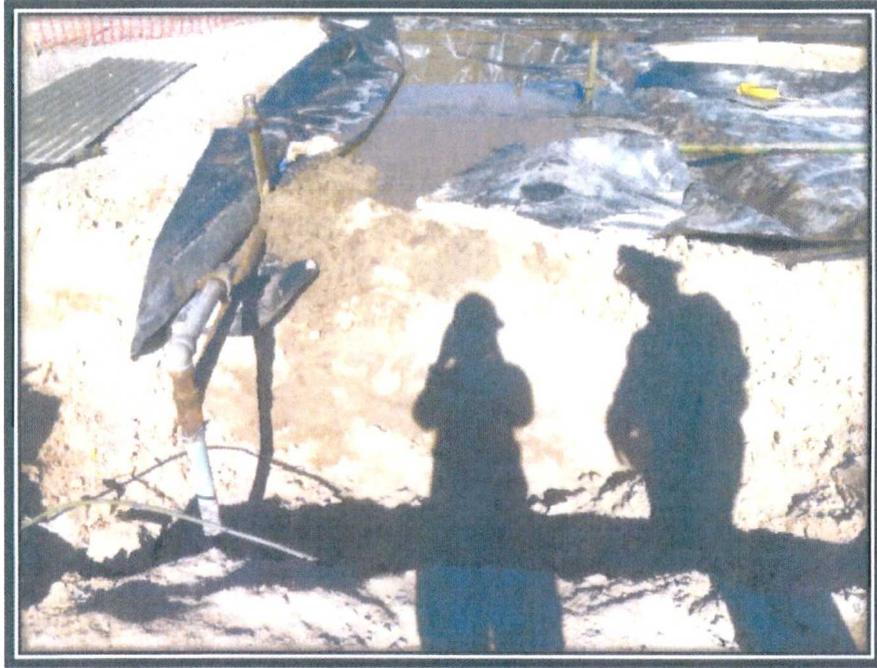
Picture 5: View of *Section 2*

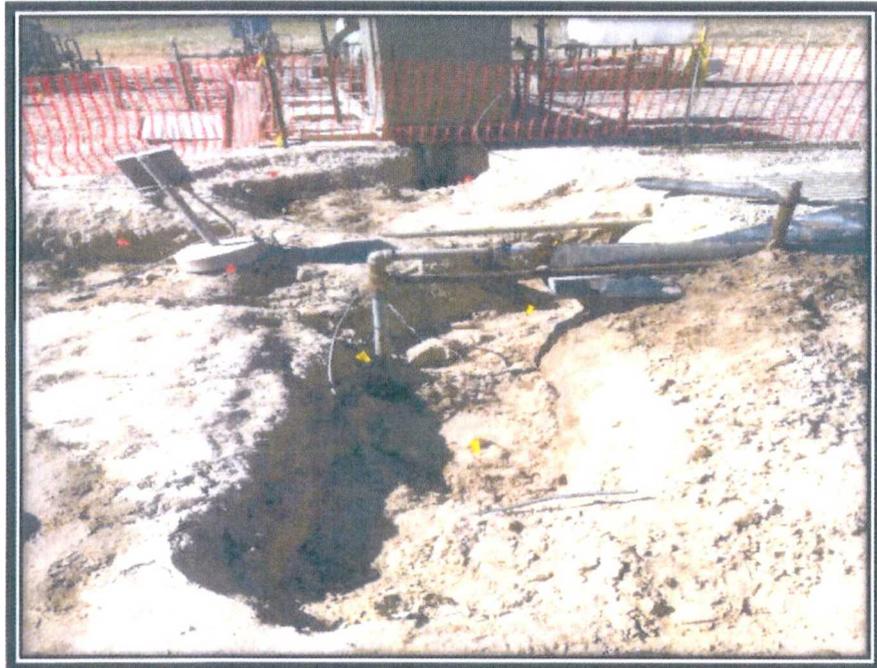
Picture 6: View of Sampling Locations (Yellow Flags) in *Section 2*

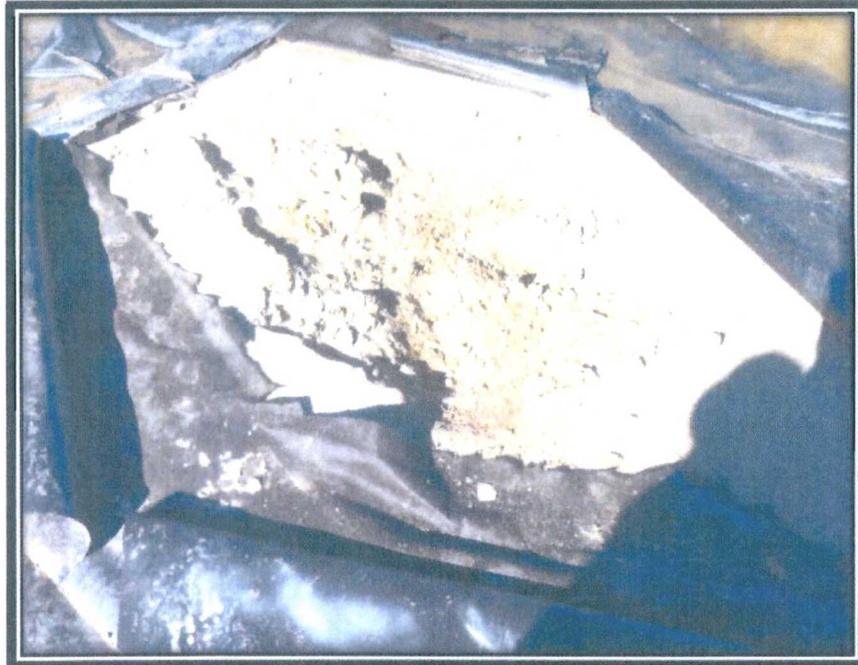
Picture 7: View of *Under Liner* Excavation

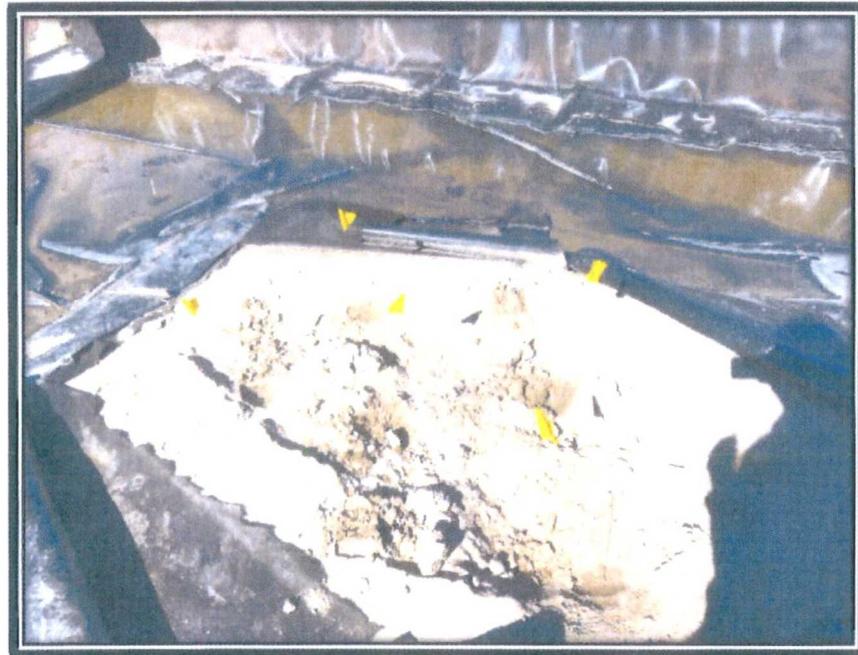
Picture 8: View of Sampling Locations (Yellow Flags) in *Under Liner*

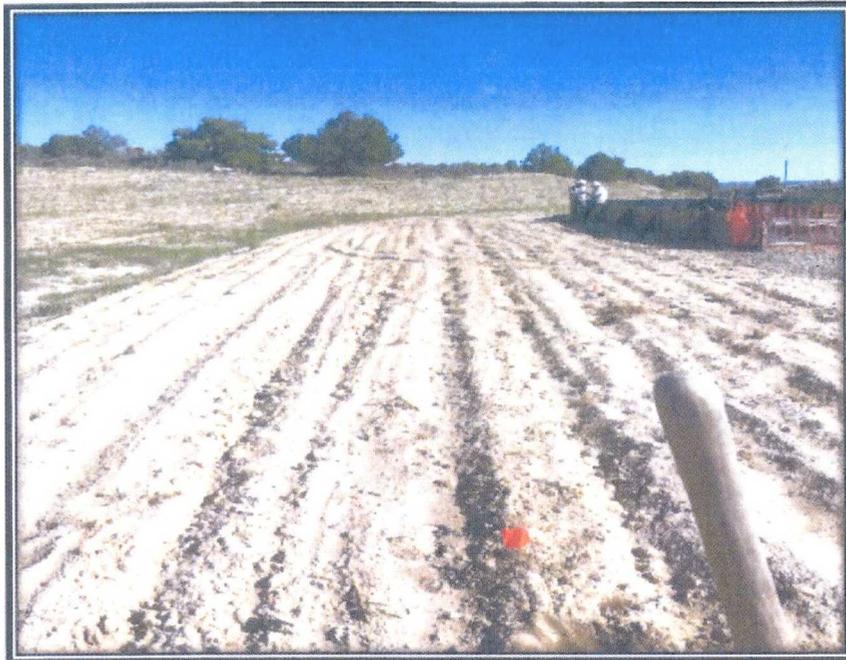
Picture 9: View of *Bladed Area* and Sampling Locations (View 1)

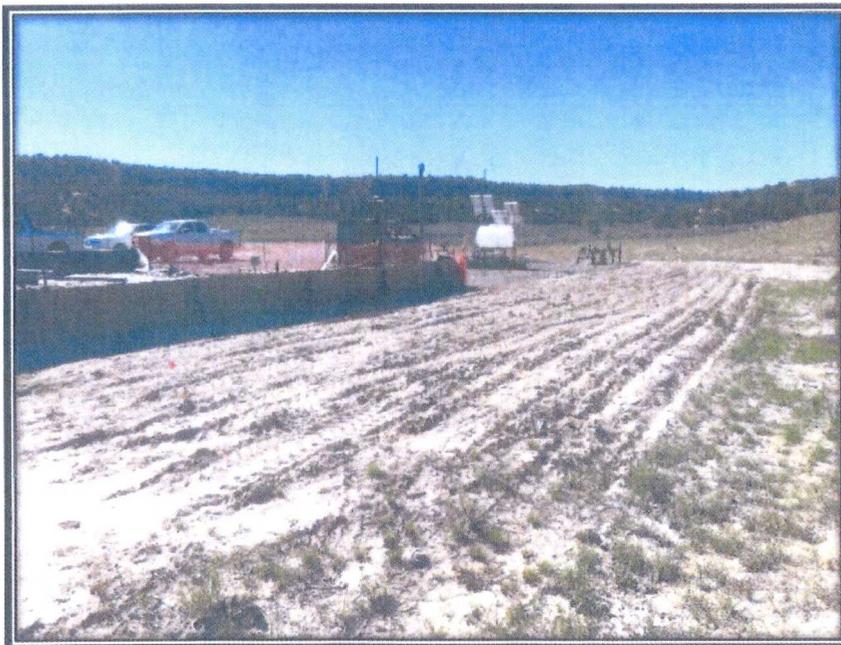
Picture 10: View of *Bladed Area* and Sampling Locations (View 2)
