Release Notification and Corrective Action

SUBJECT: JICARILLA CHACON D#1

Energen Resources Chacon Jicarilla D # 1 Clean-up

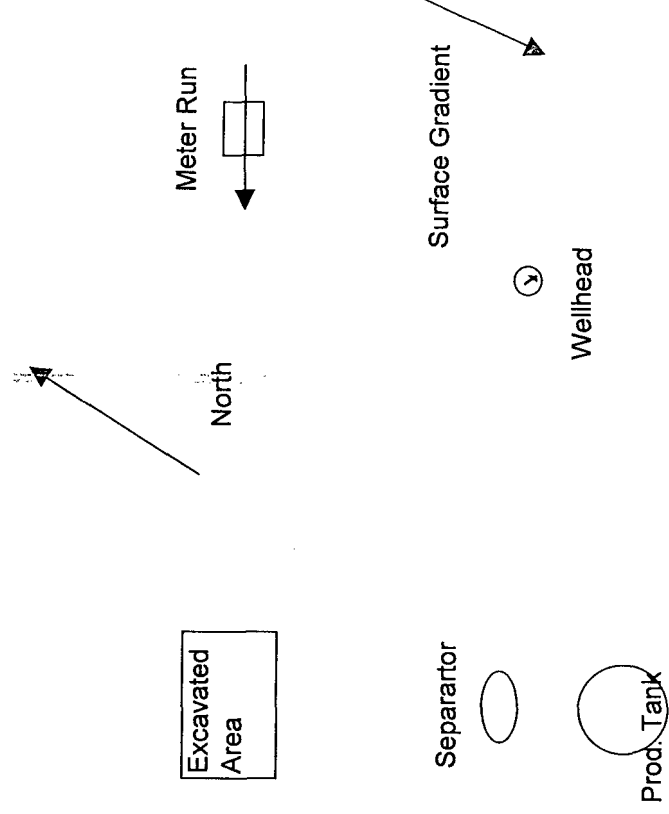
Site Diagram:

Final Size: 20' X 20' X 1' deep

Comments:
Soil was excavated to 1-ft in depth. Bedrock encountered at 1-ft below surface.
