**PIT REMEDIATION AND CLOSURE REPORT**

Operator: Merrion Oil & Gas Telephone: (505) 327-9801

Facility Or: Salazar G34 No. 2  
Well Name

# Merrion Oil & Gas Salazar G 34-2 Site Schematic

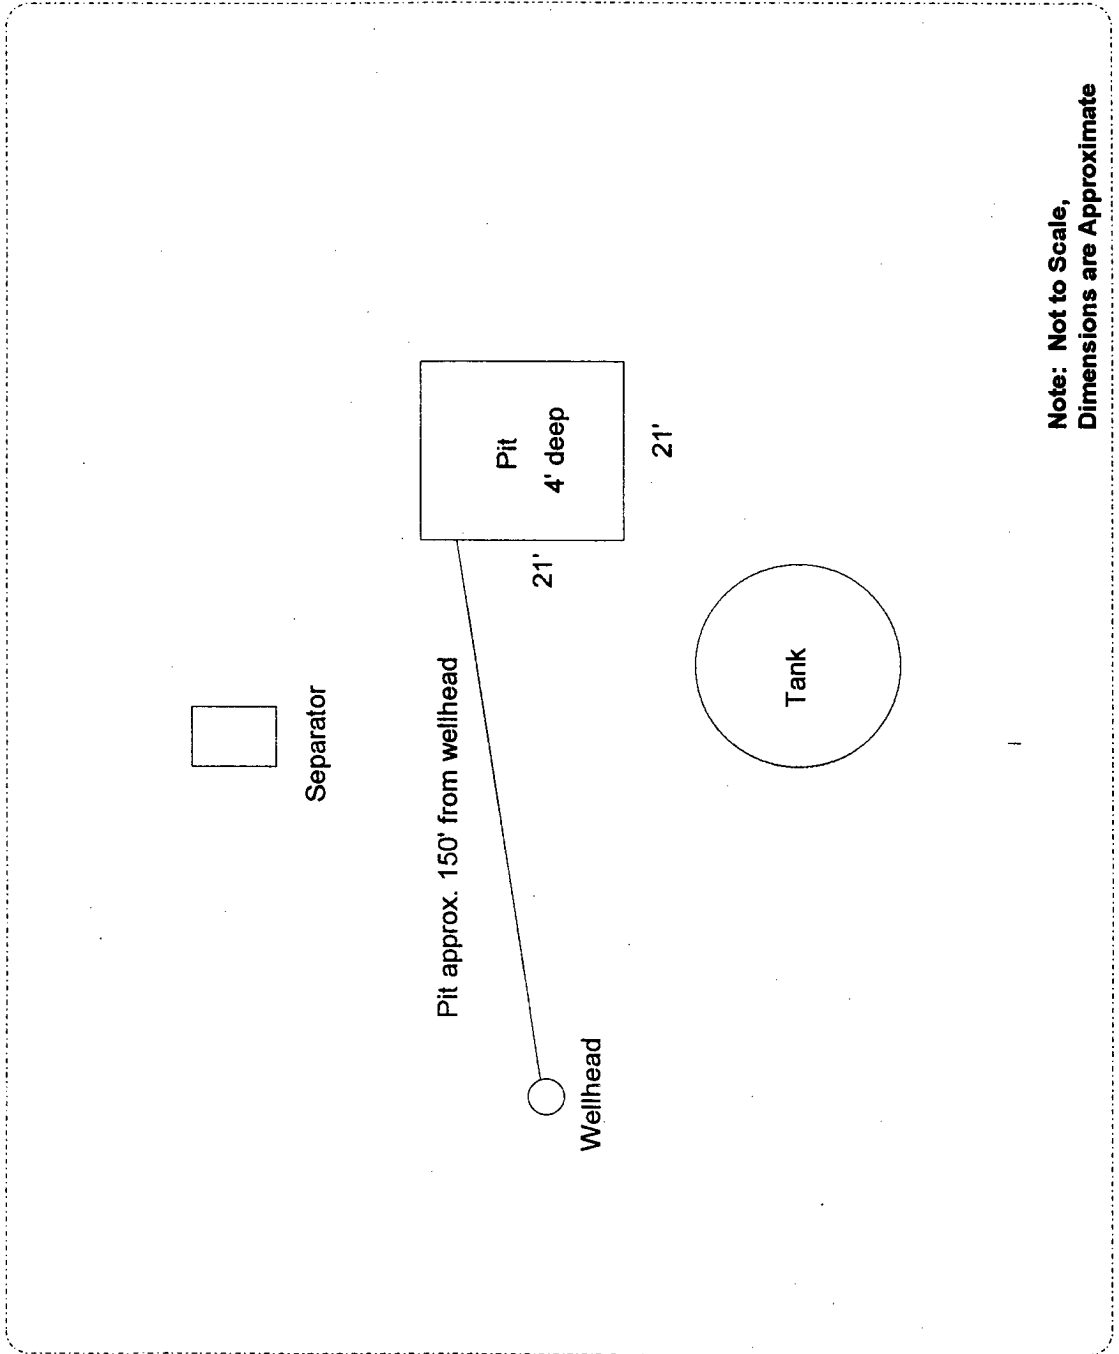
Pit Location: Pit dimensions: length 21', width 21', depth 4'  
(Attach diagram)

General Description of Remedial Action: Took composite soil sample, read 61 ppm on OVM. Took final composite soil sample for TPH analysis. Installed new 40 bbl. fiberglass pit with liner.

Sample location Composite walls and bottom
