# BURLINGTON RESOURCES

Re: San Juan 27-4 Unit #59 (30-039-20369) Bradenhead

# SAN JUAN 27-4 UNIT 59

## WellView - Schematic

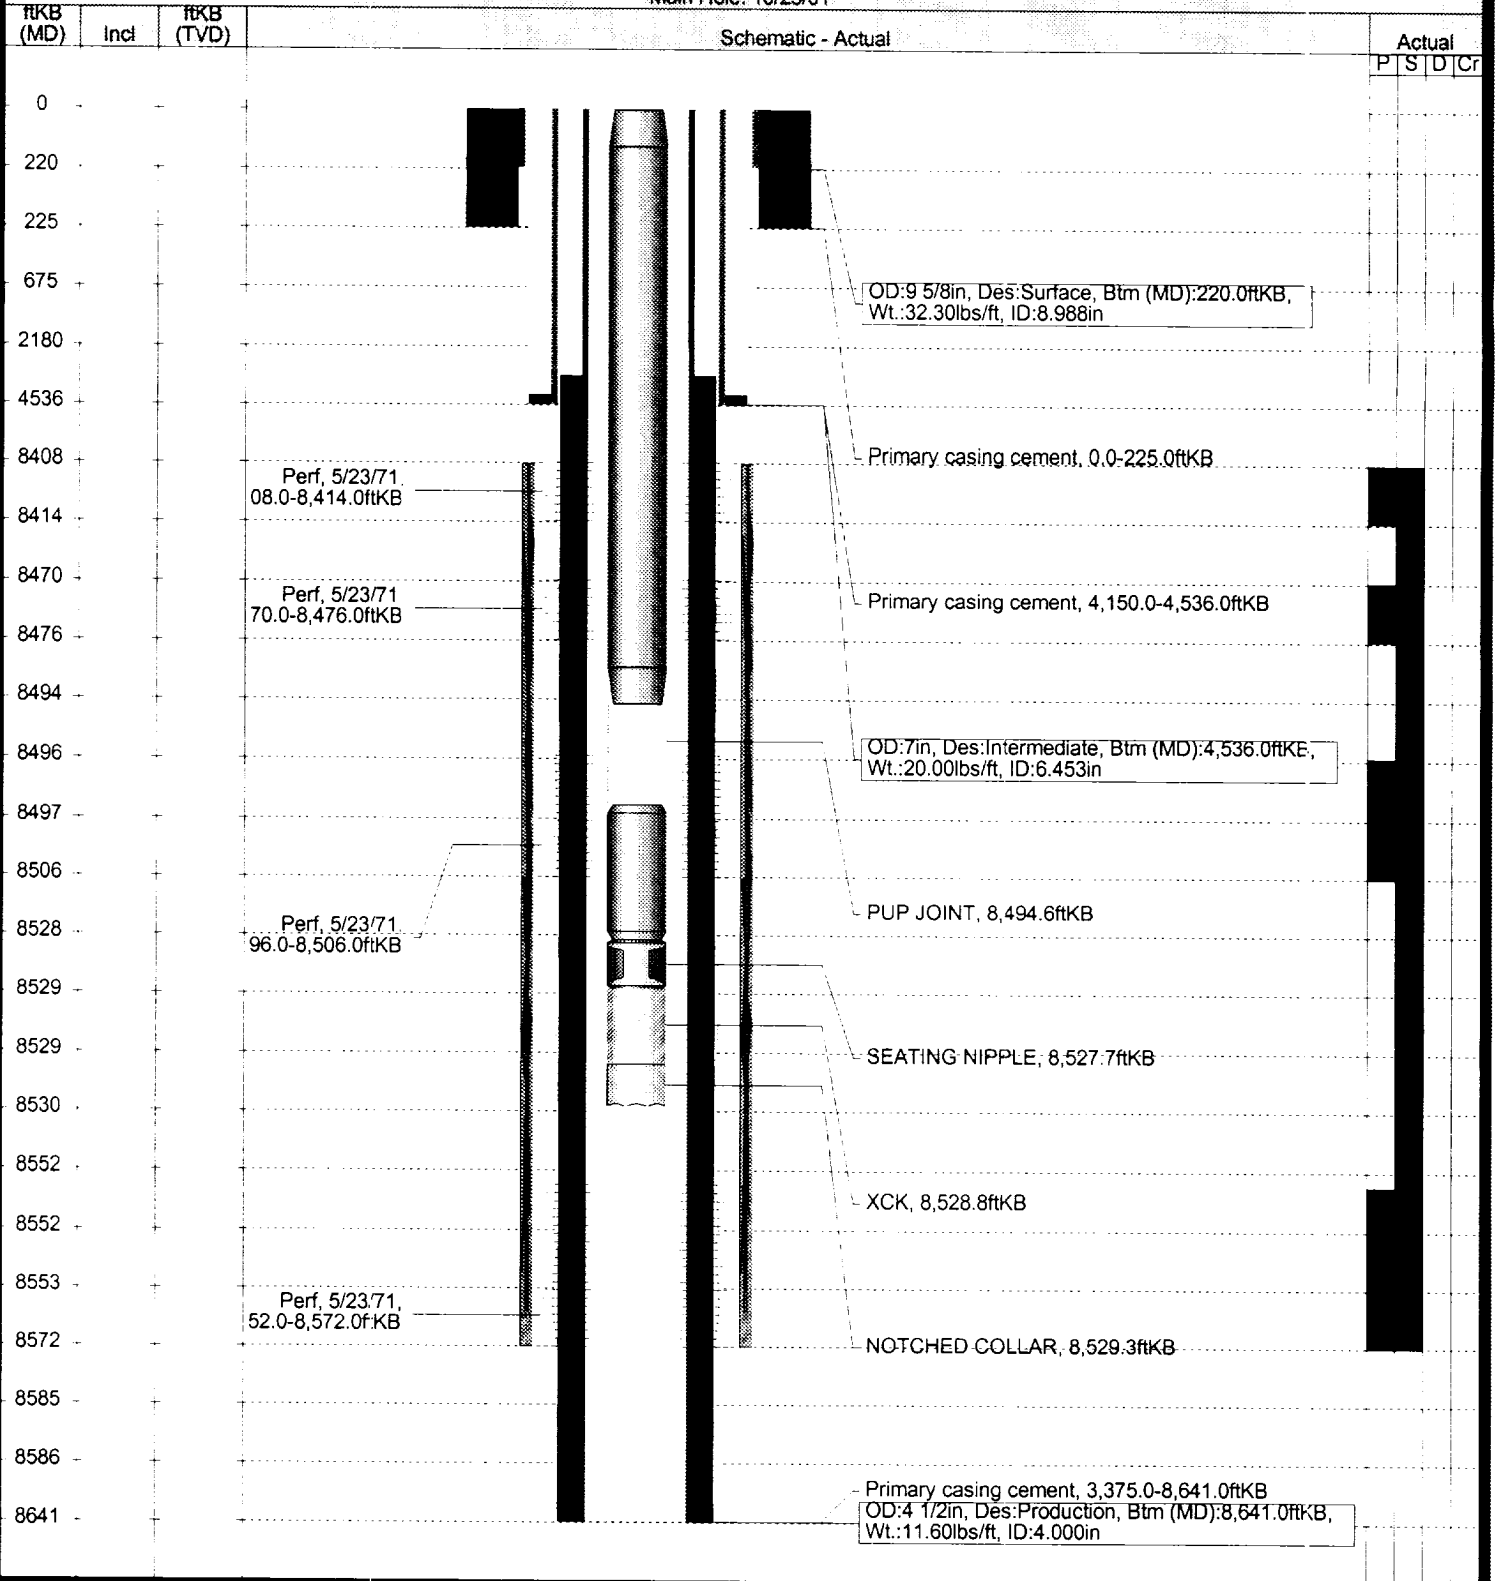
Main Hole: 10/25/01

The attached wellbore schematic shows that the top of primary casing cement (3375') is well above the bottom of the 7" intermediate casing string (4536'). A copy of the temperature survey log is attached to show the top of cement. Since the top of cement is 1161 feet above the end of the intermediate casing string, a hydraulic seal should exist. This is confirmed by the bradenhead test because there is zero pressure at the Bradenhead. Therefore, the formation is protected and this well is in compliance with Rule 108.

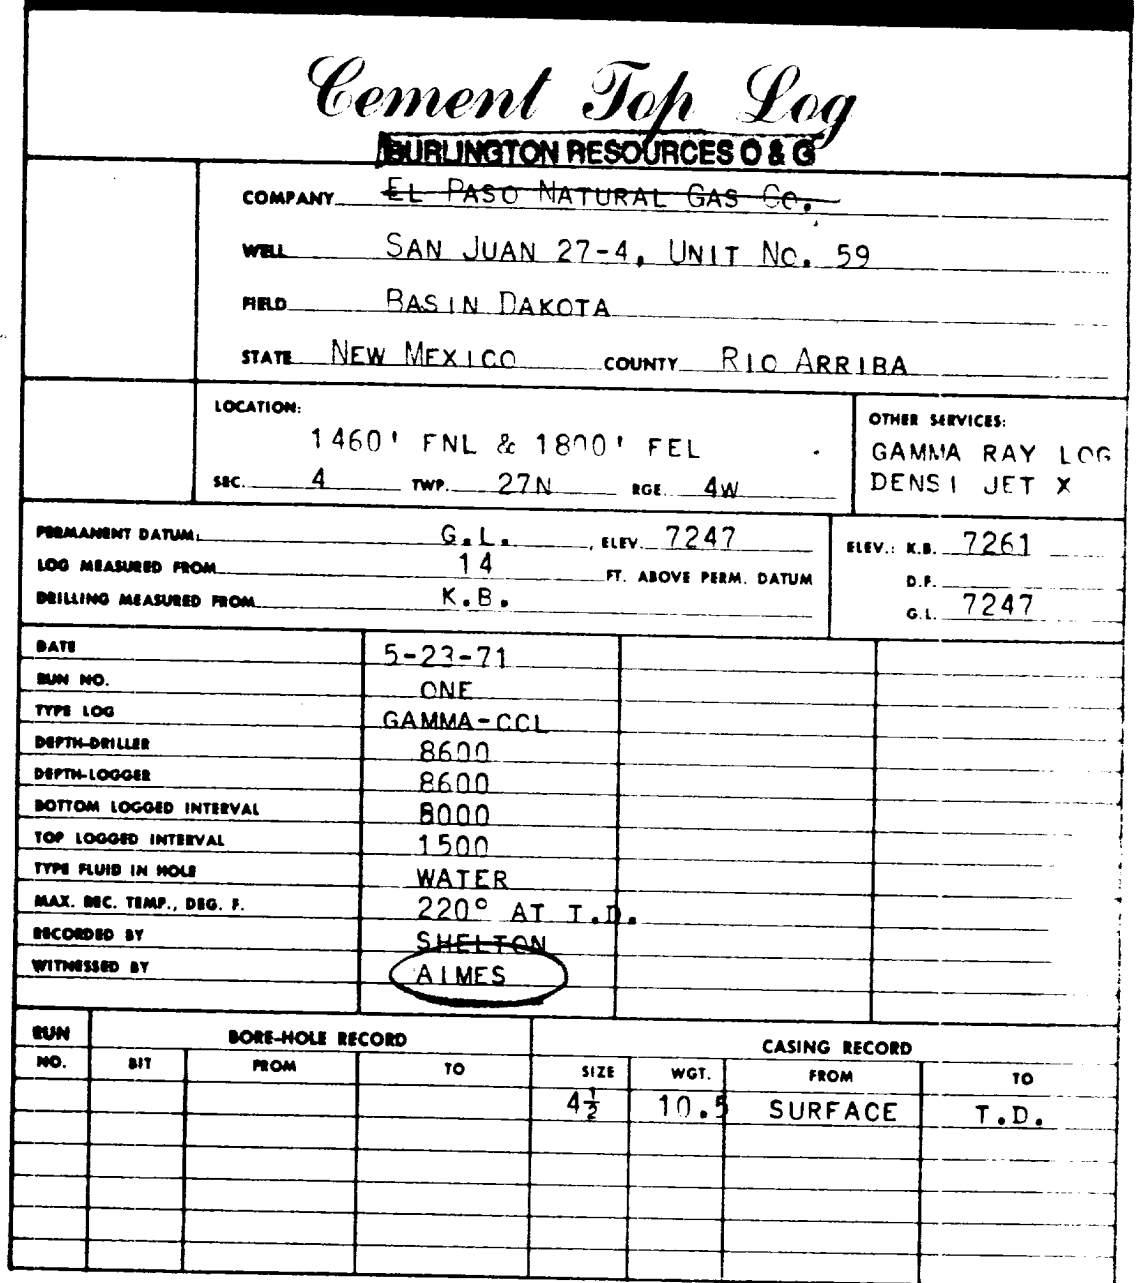
INDICATED Cement  
TOP
