BIM	
Sundry Notice	es and Reports on We	lls	
1. Type of Well GAS		DV-12-PM-2:28. FARMINGTON, NN & .	Lease Number SF-079493A If Indian, All. or Tribe Name

Tubing Repair Procedure

San Juan 27-5 No. 144 DPNO 44060A Basin Dakota Field 1650' FSL & 1840' FWL. Section 35, T-27-N, R-5-W Rio Arriba county, NM

San Juan 27-5 Unit No. 1.

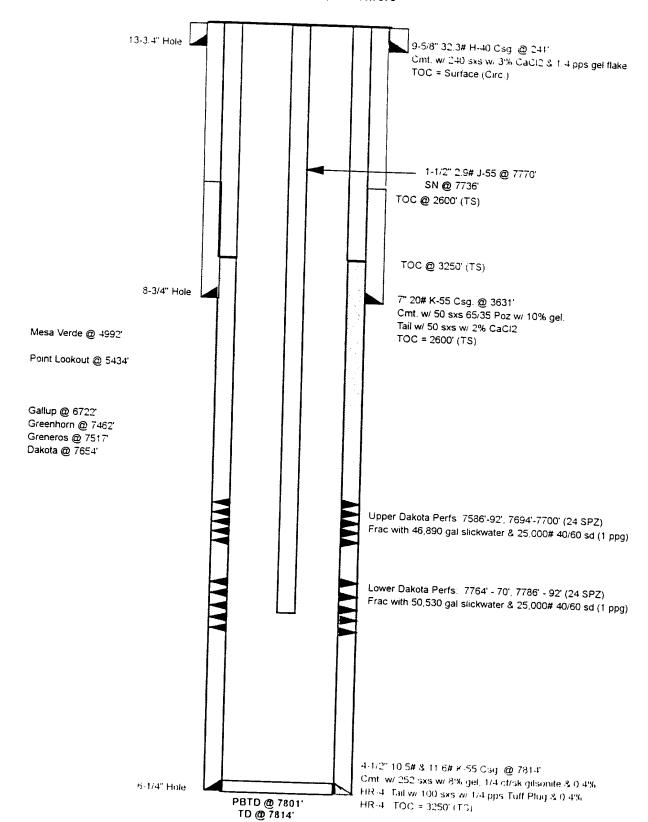
Project Summary: The San Juan 27-5 No. 144 is a Dakota producer drilled in 1972. This well has loaded up and appears to have scale in the tubing (slickline can not get through). It is possible that the loading problem may be caused by a hole in the casing so we will perform a MIT while on this well. I propose to pull the tubing, replace any bad joints, clean the well out and install plunger lift equipment in order to return the well to production.

5/95 - Ran : lickline, ran 1-1/2" gauge ring to 7380', 1-1/4" blind box to 7710' (very tight).

Well currently logged off.

- 3. Pick up 1-1/2" tubing and RIH to tag PBTD. Tally out of hole with 1-1/2" tubing. Visually inspect the tubing and replace any joints that are corroded or scaled up.

- RIH with a bit and casing scraper (or mill) and clean out to PBTD with air. POOH and RIH with RBP and set at 7500'. Load casing and test to 750 psi. Unload well with air and release RBP,

- If a casing leak is found then stand back the 1-1/2" tubing and pick up a 2-3/8" workstring. Dump 5. 2 sxs of sand on the RBP. Isolate the holes with a packer and establish a pump-in rate and pressure. Notify the Operations Engineer to obtain a squeeze procedure. Squeeze the casing leak according to the prescribed procedure. WOC and drill out cement. Test casing to 750 psi and resqueeze as necessary. Retrieve RBP and lay down workstring.

- RIH with expendable check, 1 jt., SN and 1-1/2" production tubing. Land tubing at approximately 6. 7770'. ND BOP, NU wellhead. Pump off check and blow well in.
