#### PIT REMEDIATION AND CLOSURE REPORT

FINAL PIT CLOSURE SAMPLING REPORT

## BONNEVILLE FUELS CORPORATION SCOTT "E" FEDERAL #13

SCOTT "E" FEDERAL . # 13

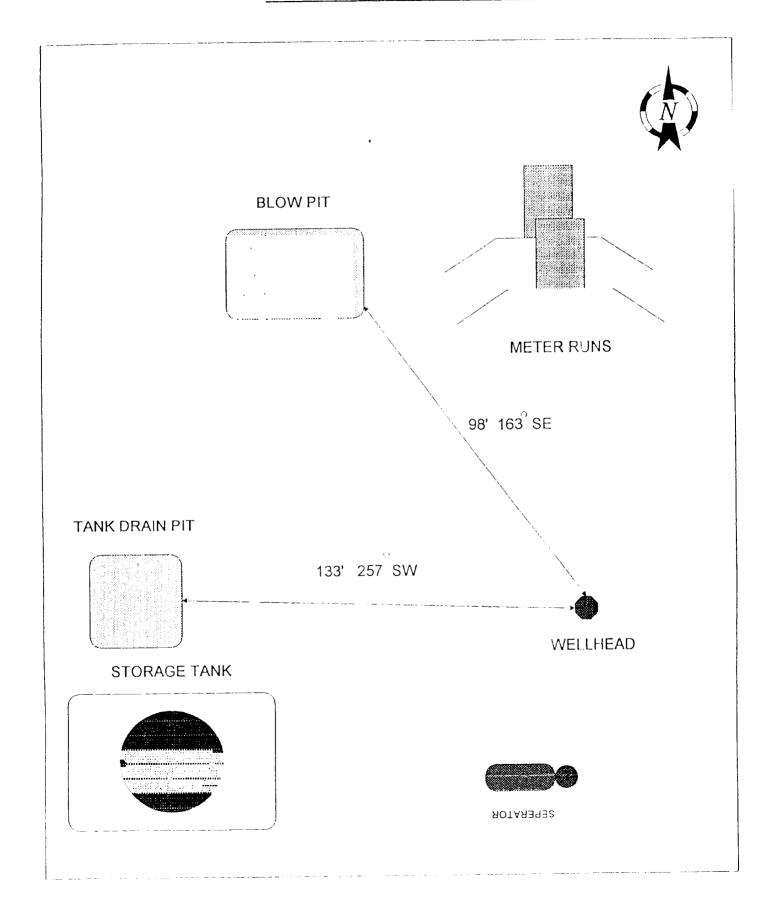
Telephone: (505) 632-9876 Operator: BONNEVILLE FUELS CORPORATION Address: 310 NORTH FIRST STREET, BLOOMFIELD, NM 87413 Facility Or: SCOTT "E" FEDERAL #13 Well Name T 27 Location: Unit or Qtr/Qtr Sec SW SIDE VIEW TPII Depth 2130 ppm Surface 2 ft. ppm 4 N. 1340 ppm 2130 ppm ppm 6 ft. 8 N. 628 ppm 10 ft. ppm ppm 12 ft. 1340 ppm 14 N. ppm 16 ft. ppm 18 N. ppm ppm 20 ft. 628 ppm N. ppm ppm N. ppm ft. TOP VIEW 15 ft. North Side 171 ppm 171 ppm East Side 244 ppm 139 ppm South Side West Side 196 ppm W)196ppm 244 ppm (E 15 ft. North (S)139 ppm

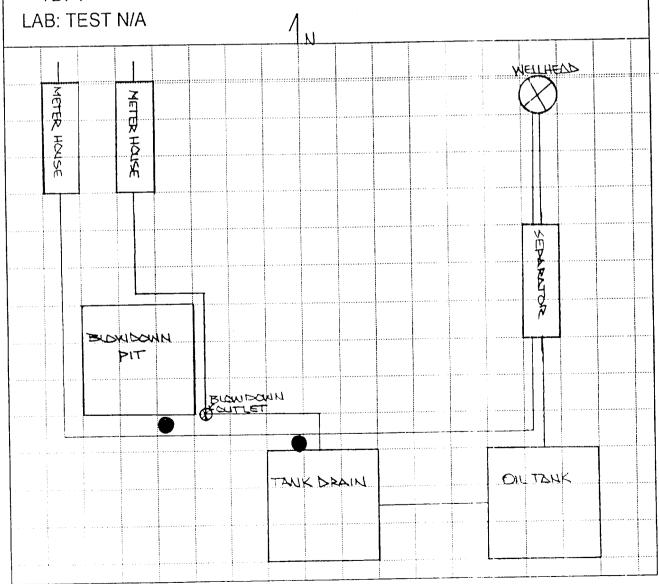
Two pit assessed:Blowdown/Tank Drain

Blowdown Composite: 5'- 10' (PID: 72.5 Units)

Blowdown Grab: 14' (PID: 1800 Units)

Tank Drain Composite: 4' (PID: 6.4 Units)
