Bonneville Fuels Corporation

May 5, 1997

re: Fullerton Federal #11:

Production Casing Leak to the Braden Head

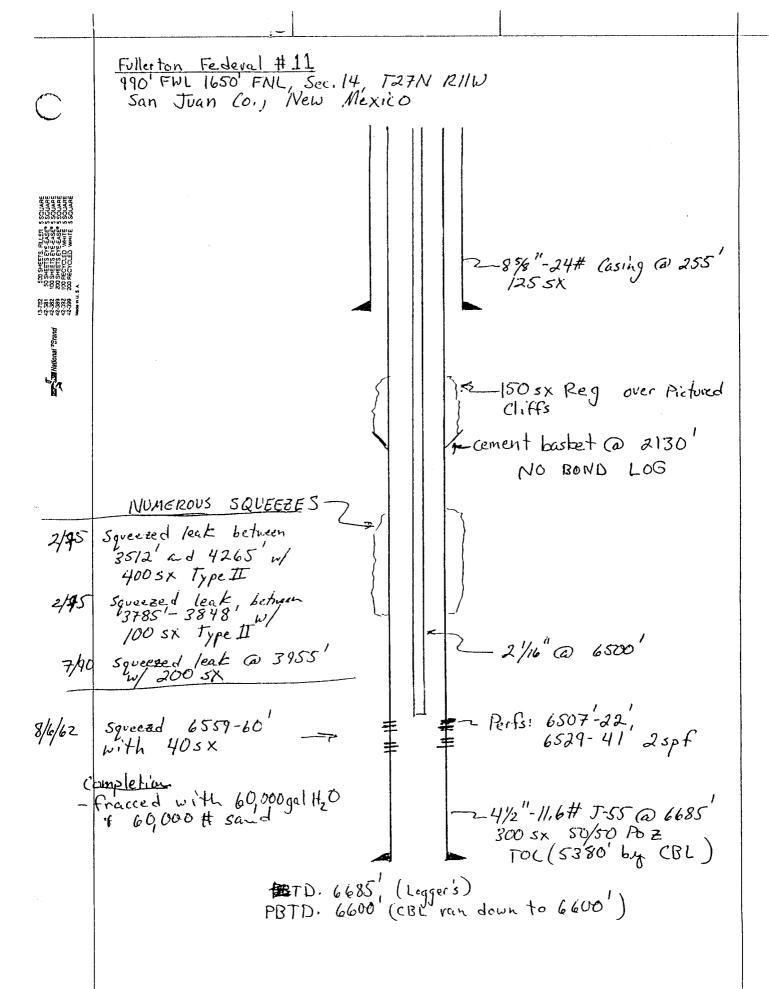
Attachment: Well Bore Schematic

The well was drilled, cased, and cemented in 1962. The 2nd stage (150 sx. reg. cement @ 2130') TOC on the casing at this well is estimated at approx. 1350'~(+4,900'~MSL). No bond or temperature surveys were run. A 4-1/2" production casing leak is suspected between this estimated TOC and the surface.

An AFE, a workover plan to locate and cement off the suspected casing leak, and a Sundry Notice for this remedial work is being generated today. As soon as these documents are prepared and a work plan is approved BFC will dispatch A. Merrill to repair the well. This work will require a rig and start of work is contingent on rig availability. The surface diversion/venting work is being undertaken, and will be completed, today. The venting and tankage site will be approx. 100' east of the wellhead (+125' from the separator) and NO SMOKING signage will be posted.
