## UNITED STATES DEPARTMENT OF THE INTERIOR BUREAU OF LAND MANAGEMENT

8.	Well Name & Number
3. Address & Phone No. of Operator			McClanahan A #2
PO Box 4289, Farmington, NM 87	499 (505) 326-9700	9.	<b>API Well No.</b> 30-045-13069

## **TUBING REPAIR PROCEDURE**

McClanahan A #2 DPNO: 32125A 1190' FSL, 1060' FWL M, Sec. 23, T23N, R10W, SJC, NM

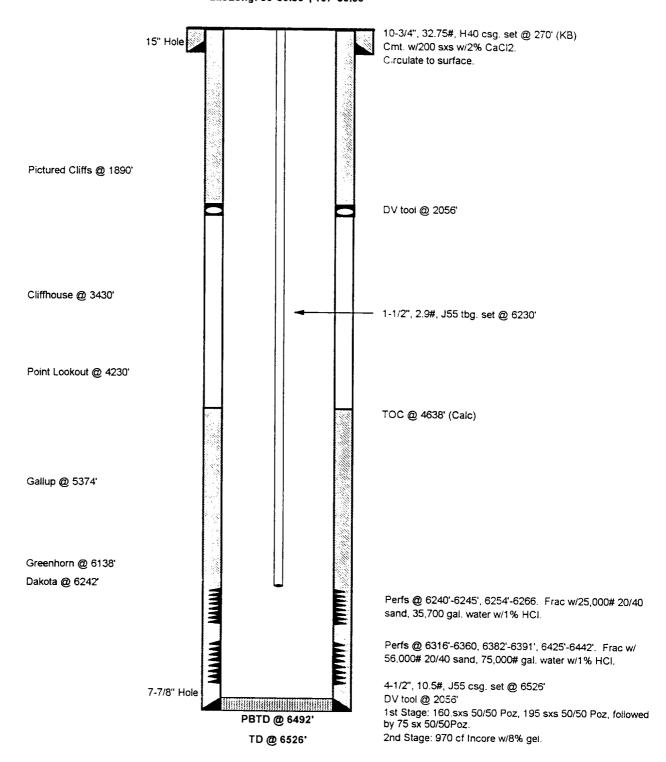
## McCLANAHAN A #2

Current -- 3/10/97
