Well File
Howell B #3
S/W 3-30N-7W

MEMORANDUM

Subject: Howell B #3
Adjacent Well Data

Attached is the data concerning the wells adjacent to the Howell B #3. The data includes a schematic showing casing depths, cement tops, cemented intervals, and formation tops.

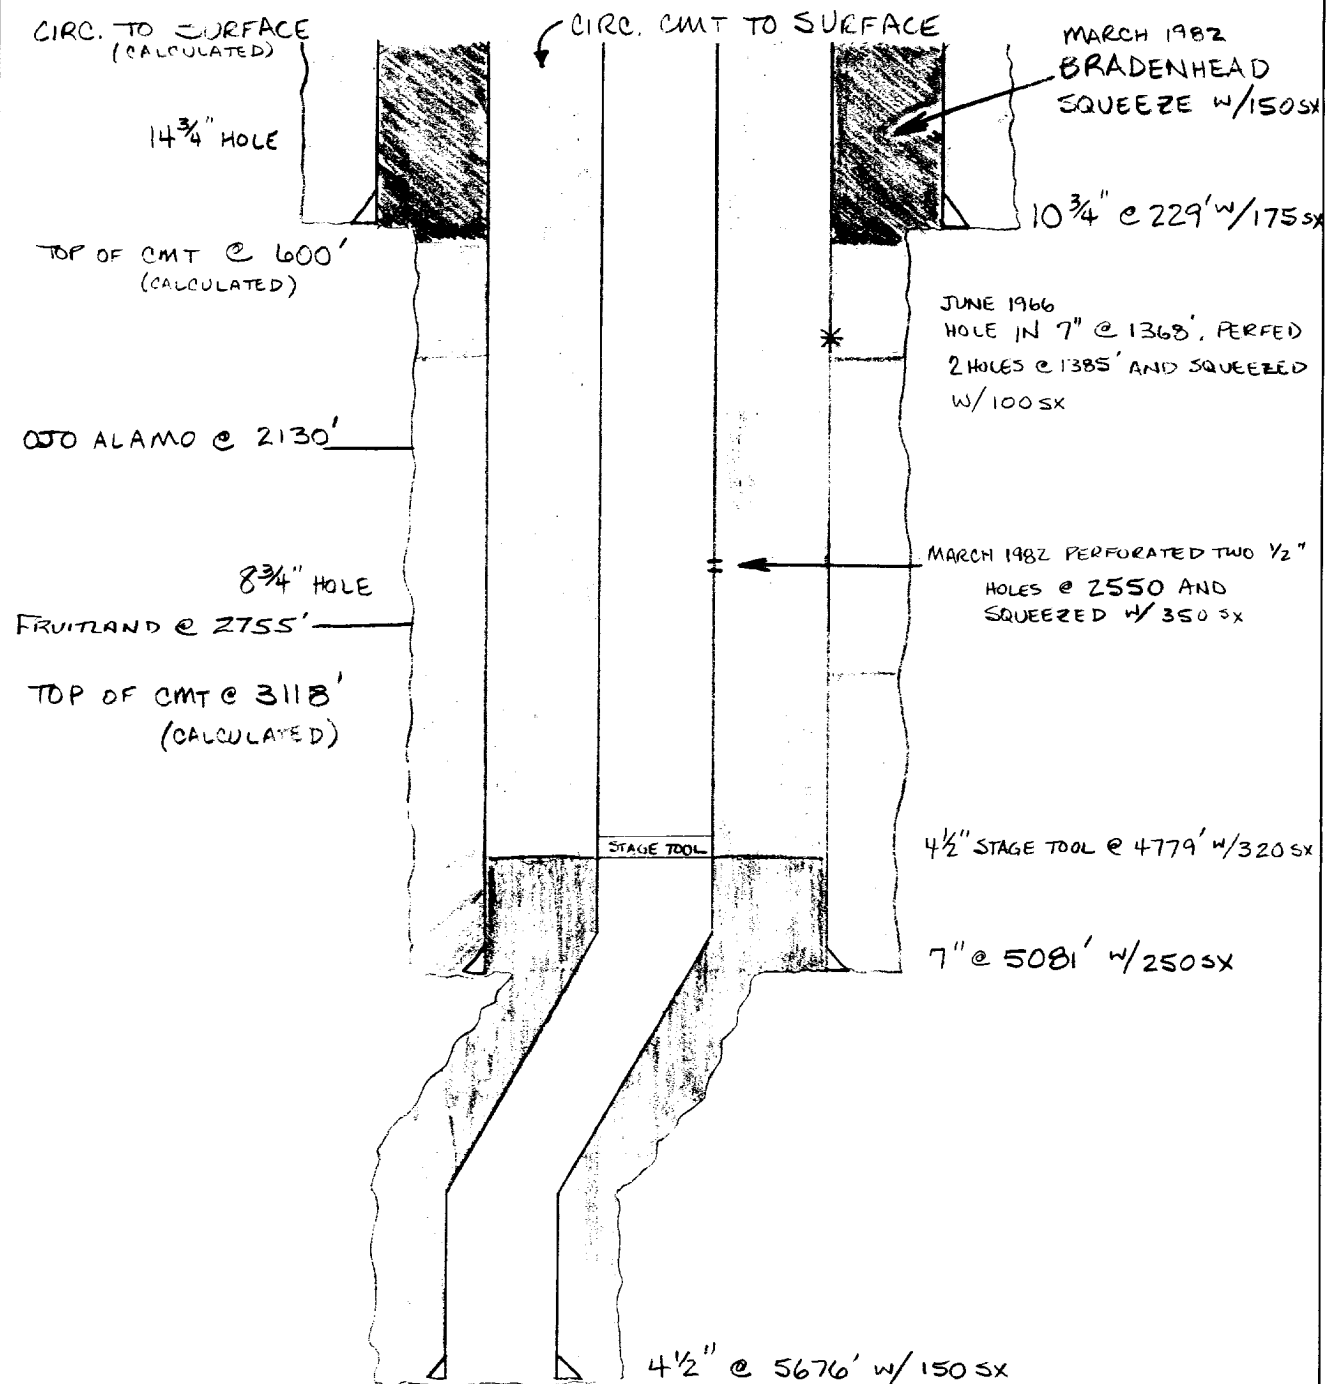
NORTHEAST BLANCO UNIT # 19
NE SEC 9 - T30N - R7W

This well was drilled and open-hole completed in September, 1954. In June 1966 the 2 3/8" tubing was pulled, but efforts to clean out the open hole section failed. The open hole and a casing failure at 1368' in 7" casing were squeezed. The well was whipstocked with a knuckle joint and 4 1/2" casing cemented in two stages. In March, 1982 the 2 3/8" tubing was pulled and the 4 1/2" casing was tested to 2000 psi, held okay. Two squeeze holes were shot in the 4 1/2" casing at 2550' and were squeezed with 350 sks. The annulus between the 10 3/4" and 7" casing was bradenhead squeezed with 150 sks. The casing was tested to 1000 psi, held okay. The tubing was then rerun. It is very unlikely that this well has a casing leak.

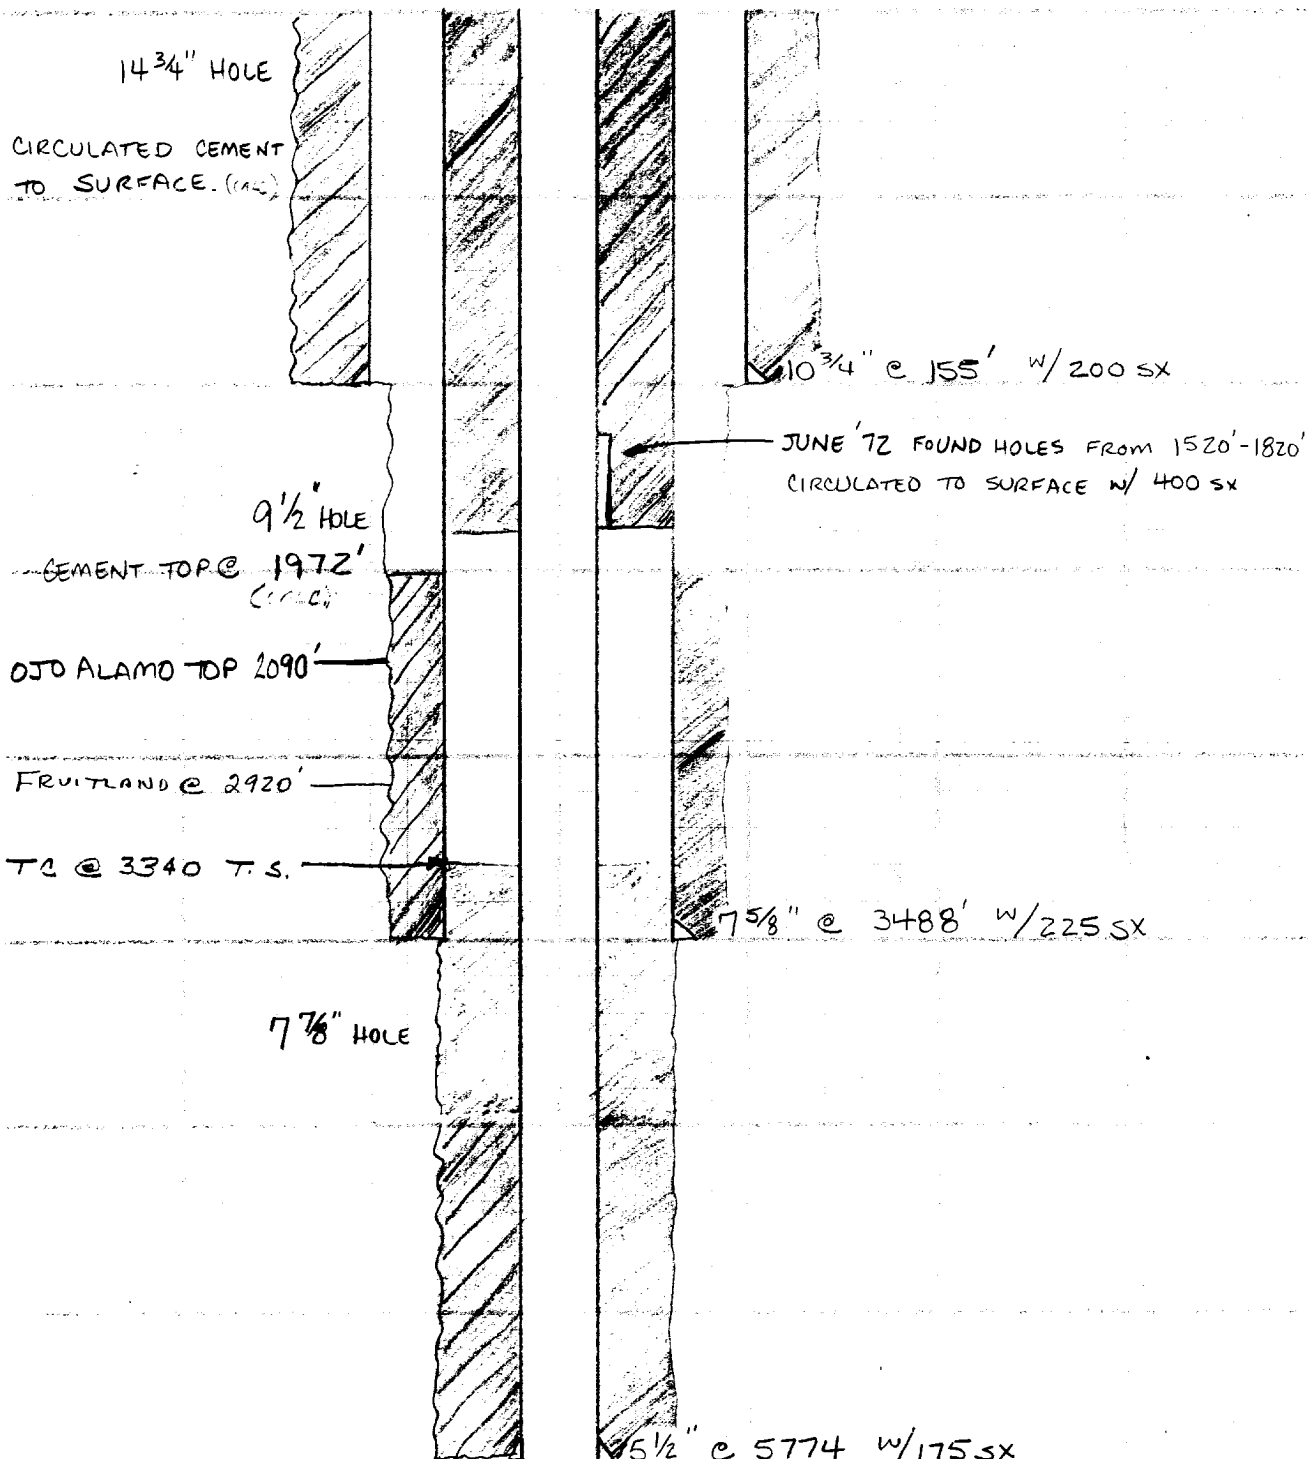
NORTHEAST BLANCO UNIT #101
 NE SEC 10 - T30N - R7W
 (FORMERLY HOWELL #1-BX)

This well, formerly the Howell B #1X, was spudded in August, 1957, and completed in October, 1957. In June 1972, holes were found in the 5 1/2" casing from 1520' to 1820' and were squeezed with 400 sks. Cement was circulated between the 7 5/8" and 5 1/2" casing. The casing was pressure tested to 1000 psi, held okay, and 2 3/8" tubing was rerun. During the past eleven years, the casing may have developed another leak. However, it is unlikely, considering the squeeze cementing, that the well is leaking gas to a shallow formation unless it is communicating with the plugged Howell B #1.

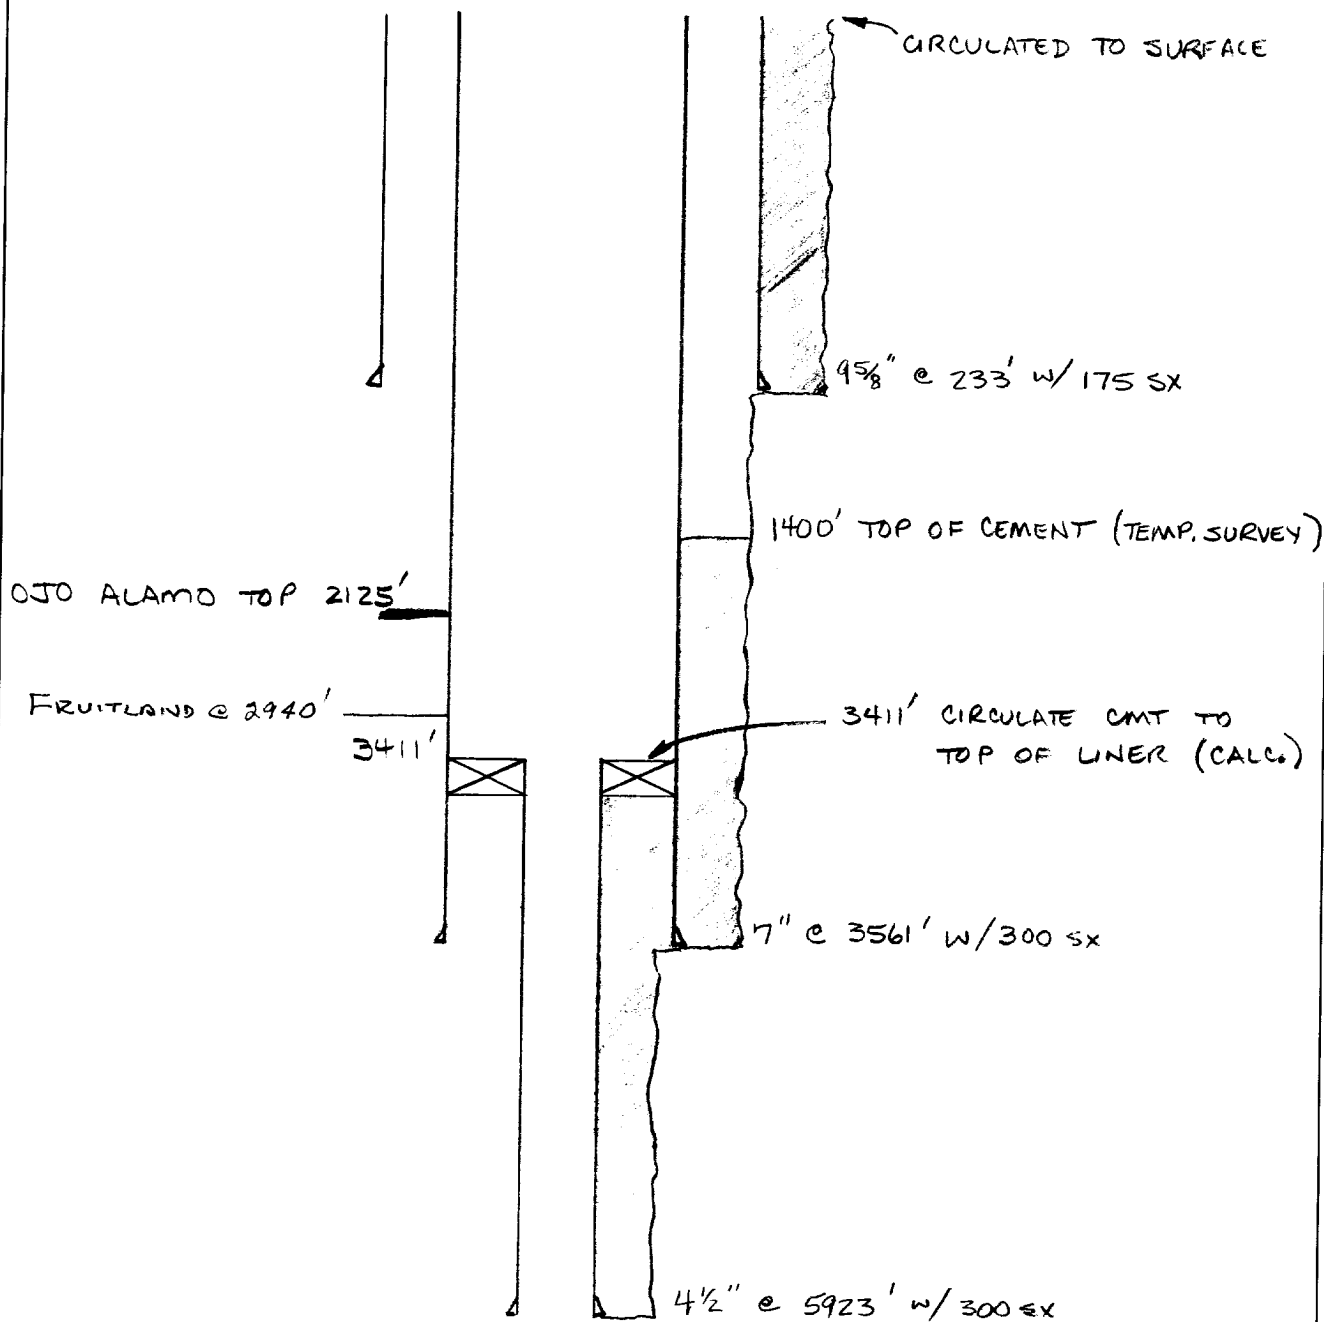
NORTHEAST BLANCO UNIT # 8A
NW SEC 10 - T30N - R7W

This well was drilled in 1978. The corrosive Ojo Alamo water is covered with cement according to temperature survey. The well does not have cathodic protection.

The tubing has not been pulled and the casing tested since completion.

It is unlikely this well is leaking gas; however, gas could be migrating in the 7" x 8 3/4" annulus if the 7" casing has failed.

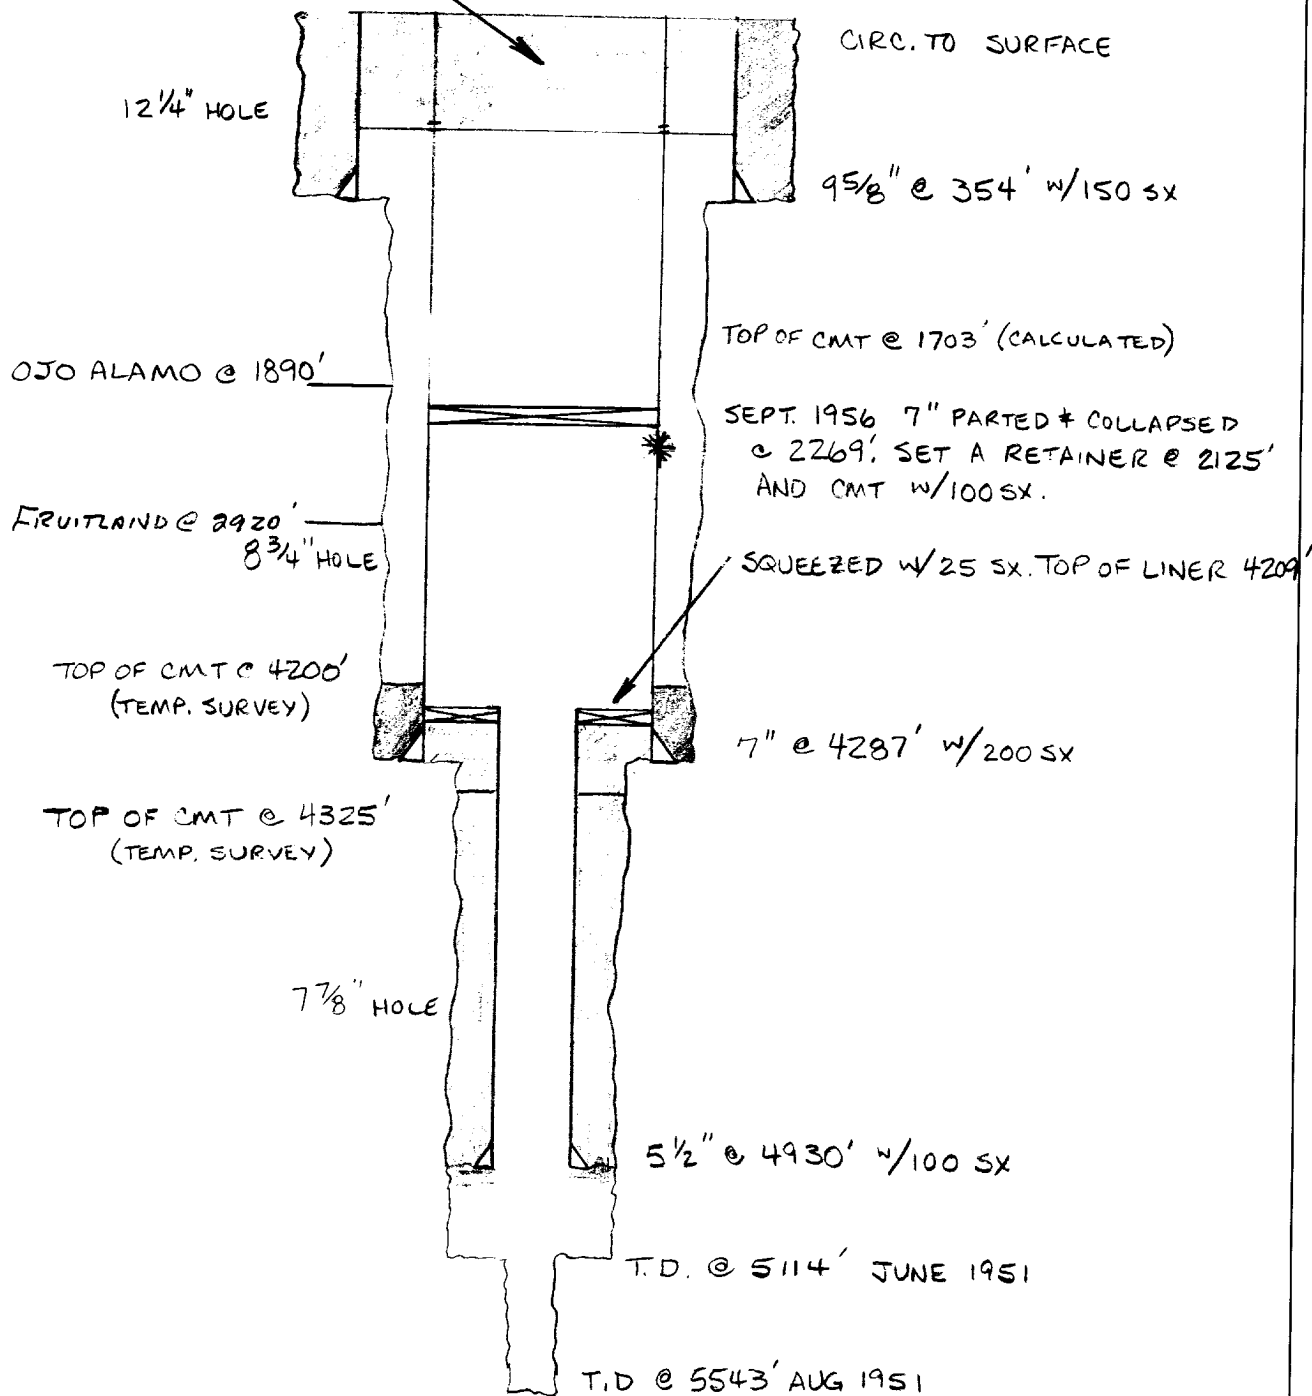
HOWELL B #1 NE SEC 10 - T30N - R7W

This well was drilled in 1951. The 7" casing collapsed and parted at 2259'. A retainer was set at 2125' and the well was squeezed with 100 sks. The well was temporarily abandoned until 1958 when the 7" casing was perforated at 200' and cement circulated to surface. The well was abandoned.

It may be assumed that the 100 sks. of cement pumped through the retainer at 2125' dropped to the open hole section from 4931' to 5523' and was lost into the fractured Point Lookout. This would allow Cliff House and Fruitland gas to migrate to shallow formations and into the lake.

This well does not have the Fruitland covered with cement.

AUG 1958 PERFORATED 7"
 @ 200' AND CIRC. CMT.
 WELL ABANDONED

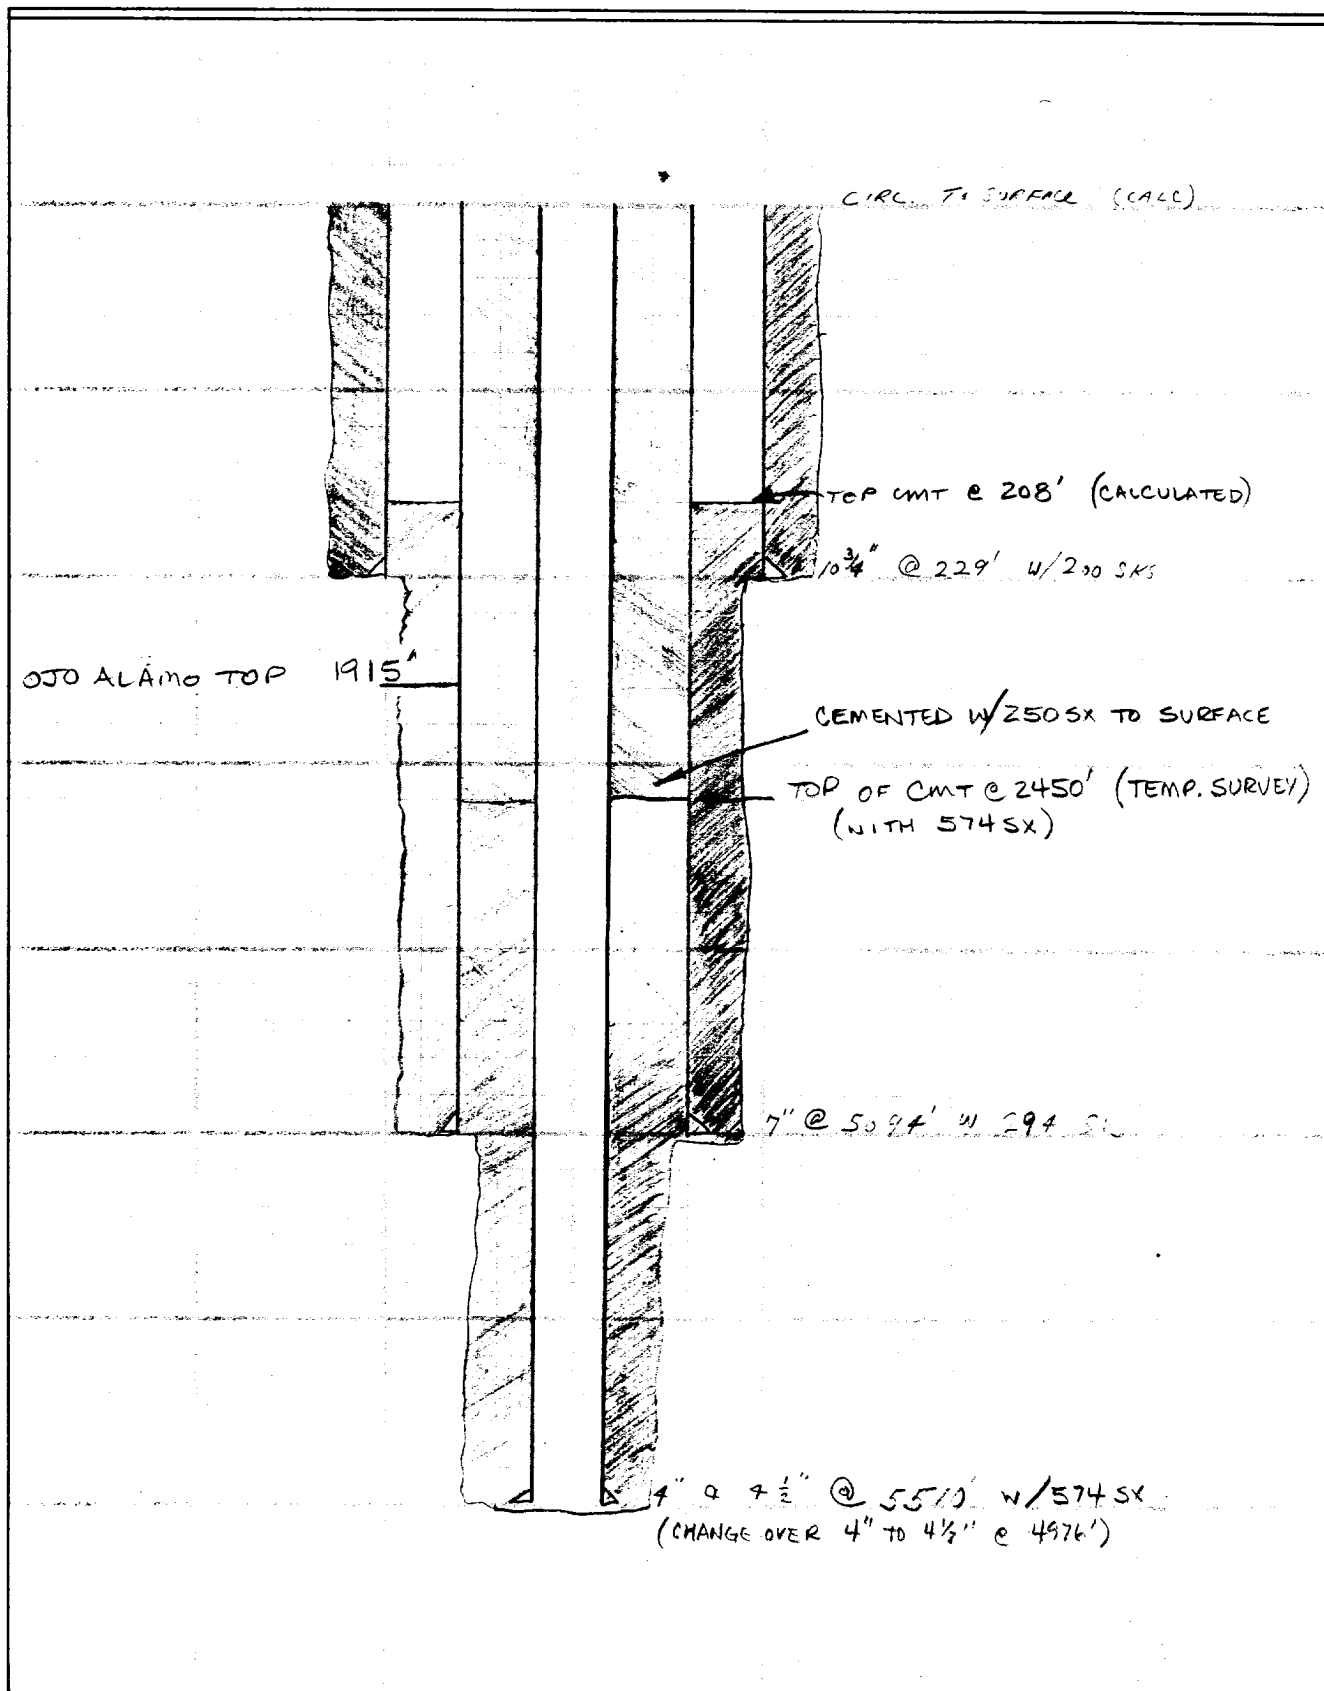
NORTHERN BLANCO UNIT # 16
 NE SEC. 16, T 30 N, R 7 W

This well was drilled and completed in July, 1954. In May, 1962, the tubing was pulled and the well was cleaned out to 5525'. A long string of 4" and 4 1/2" casing was set at 5510' with the change over at 4976'. A temperature survey showed the top of cement at 2450'. The 4 1/2" and 7" casing annulus was then cemented and circulated to surface. The casing was tested to 1500 psi and held okay. The well has not been entered since that time and appears to have good cement coverage.

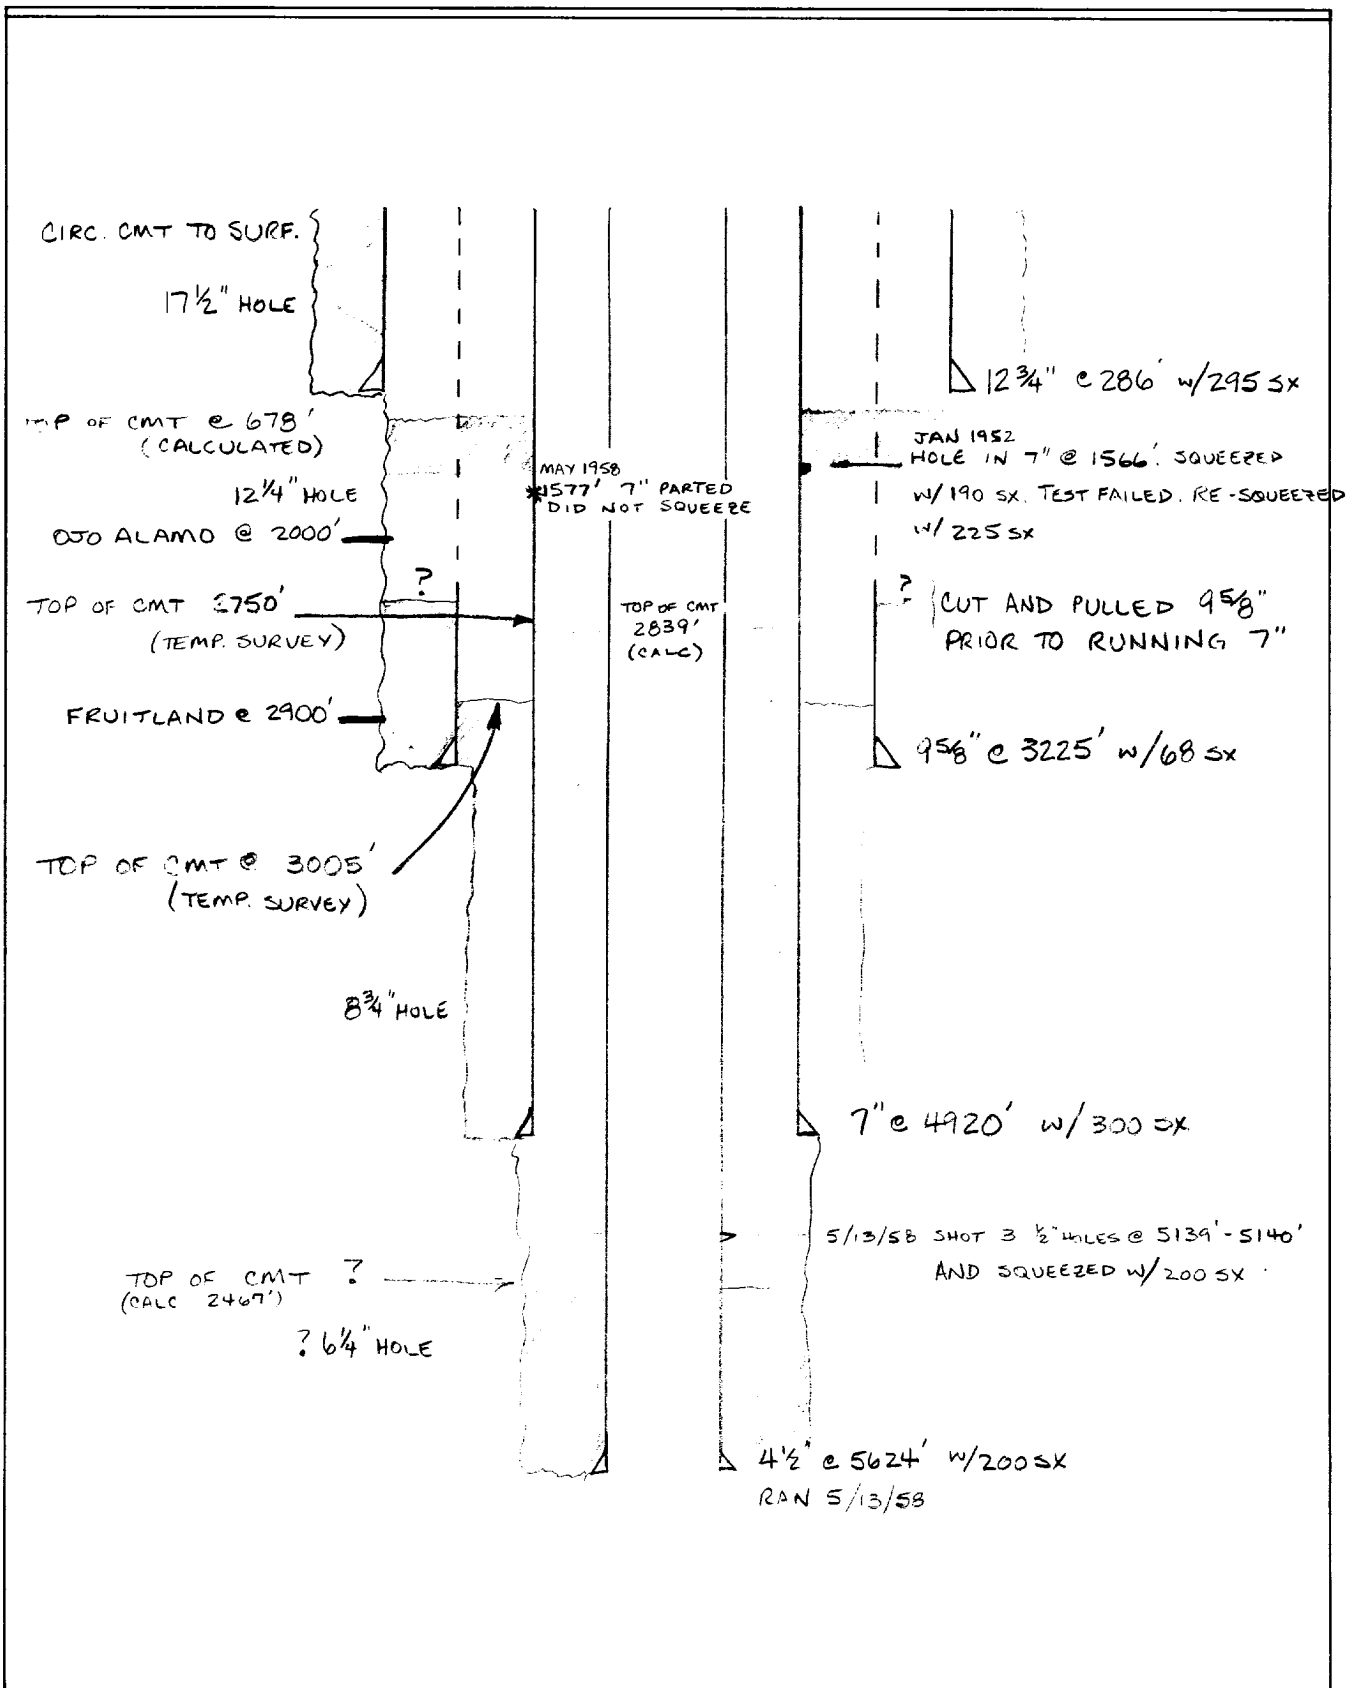
NORTHEAST BLANCO UNIT # 102
SW SEC 3 - T 30 N - R 7 W

This well, formerly the Howell #2B, was spudded in November, 1951, and completed in March, 1953. In May, 1958, the open hole was found to be caved in through the Menefee zone and the 7" casing parted at 1577'. A full string of 4 1/2" casing was set at 5624'. The initial cement job did not stop gas flow behind the casing and two days later was squeezed. Since May, 1958, the tubing has not been pulled nor the casing tested with a packer. During the past 25 years, it is likely that a casing leak may have developed. However, the condition of this well is such that if a casing leak has developed, migration of gas to shallow zone would not be likely.

The Ojo Alamo is not covered with cement nor does the well have cathodic protection.

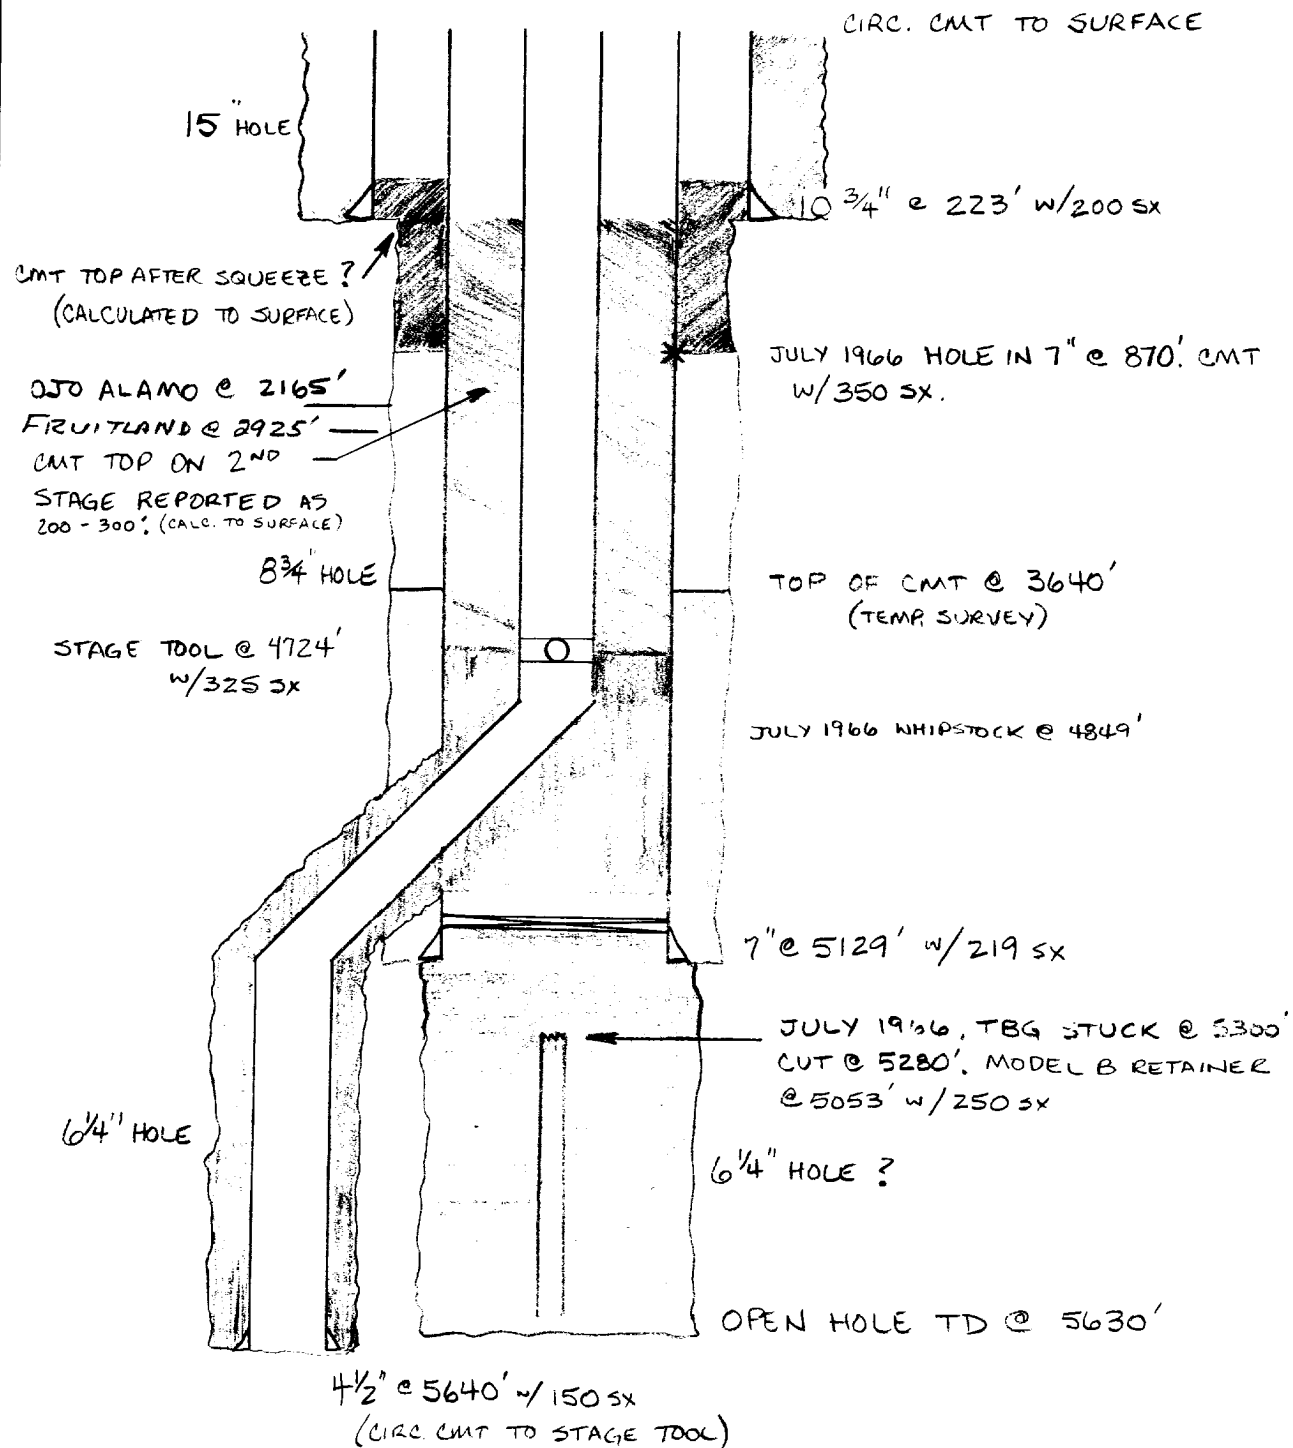
NORTHEAST BLANCO UNIT #15
SW SEC 2 - T30N - R7W

This well was drilled and completed in May and June 1954. In July, 1966, the tubing was found to be stuck at 5300'. The tubing was cut at 5280' and the 7" was found corroded from 800' to 2440' with a hole at 870'. The casing was squeezed and the hole whipstocked at 4849'. A full string of 4 1/2" casing was set at 5640' and cemented in two stages. The Mesa Verde was completed in two stages and 178 joints of 2 3/8" tubing was run. Since 1966 the well has not been entered and may have developed a casing leak. However, it is not likely that a leak would migrate to a shallow formation.

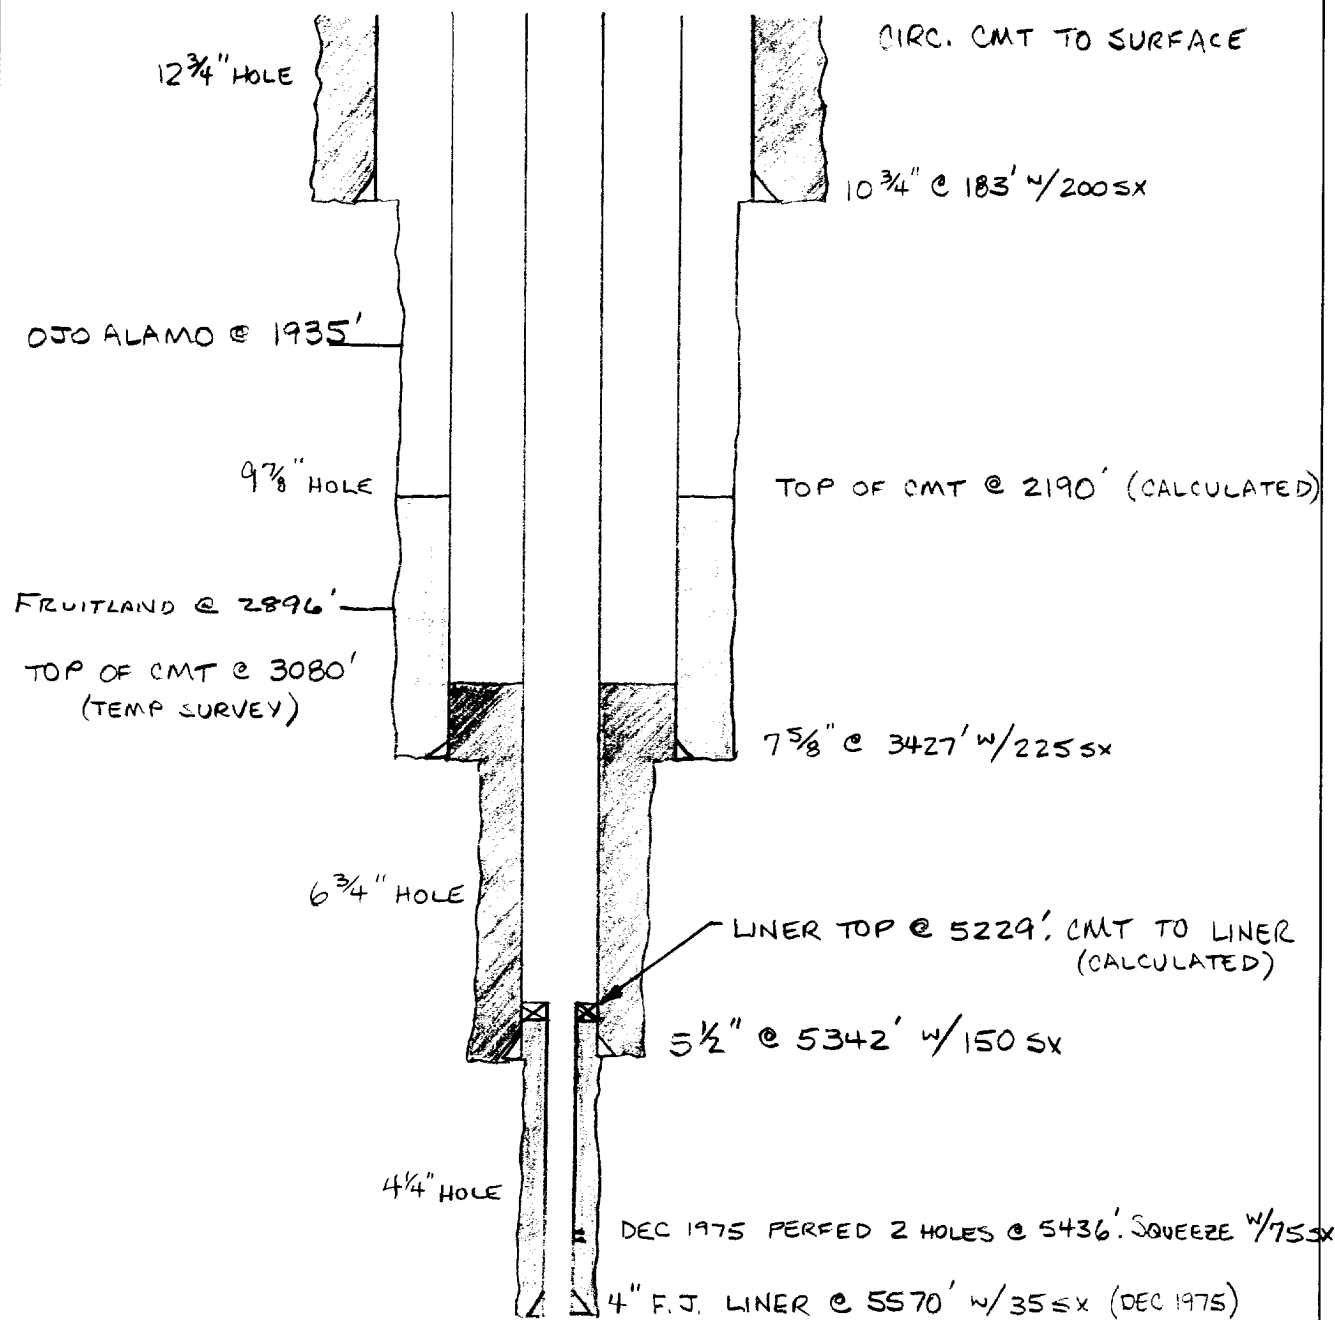
NORTHEAST BLANCO UNIT #28
SE SEC 34 - T31N - R7W

This well was drilled and completed in October, 1955. In December, 1955, the tubing was pulled and the 5 1/2" casing was tested to 1200 psi, held okay. New hole was drilled to 5571' and a 4" flush joint liner was run from 5229' to 5570'. The liner was cemented with 35 sks. and then, two days later, squeezed through a perforation at 5436' with 75 sks. The Point Lookout and Cliff House were completed and 2 3/8" tubing run. Since that time, the well has not been entered and may have developed a casing failure. The Ojo Alamo is not covered.

This well would have to develop leaks in both the 5 1/2" and 7" casing strings to allow gas to escape to a shallow formation. This may be possible since the Ojo Alamo is not covered with cement nor does the well have cathodic protection.

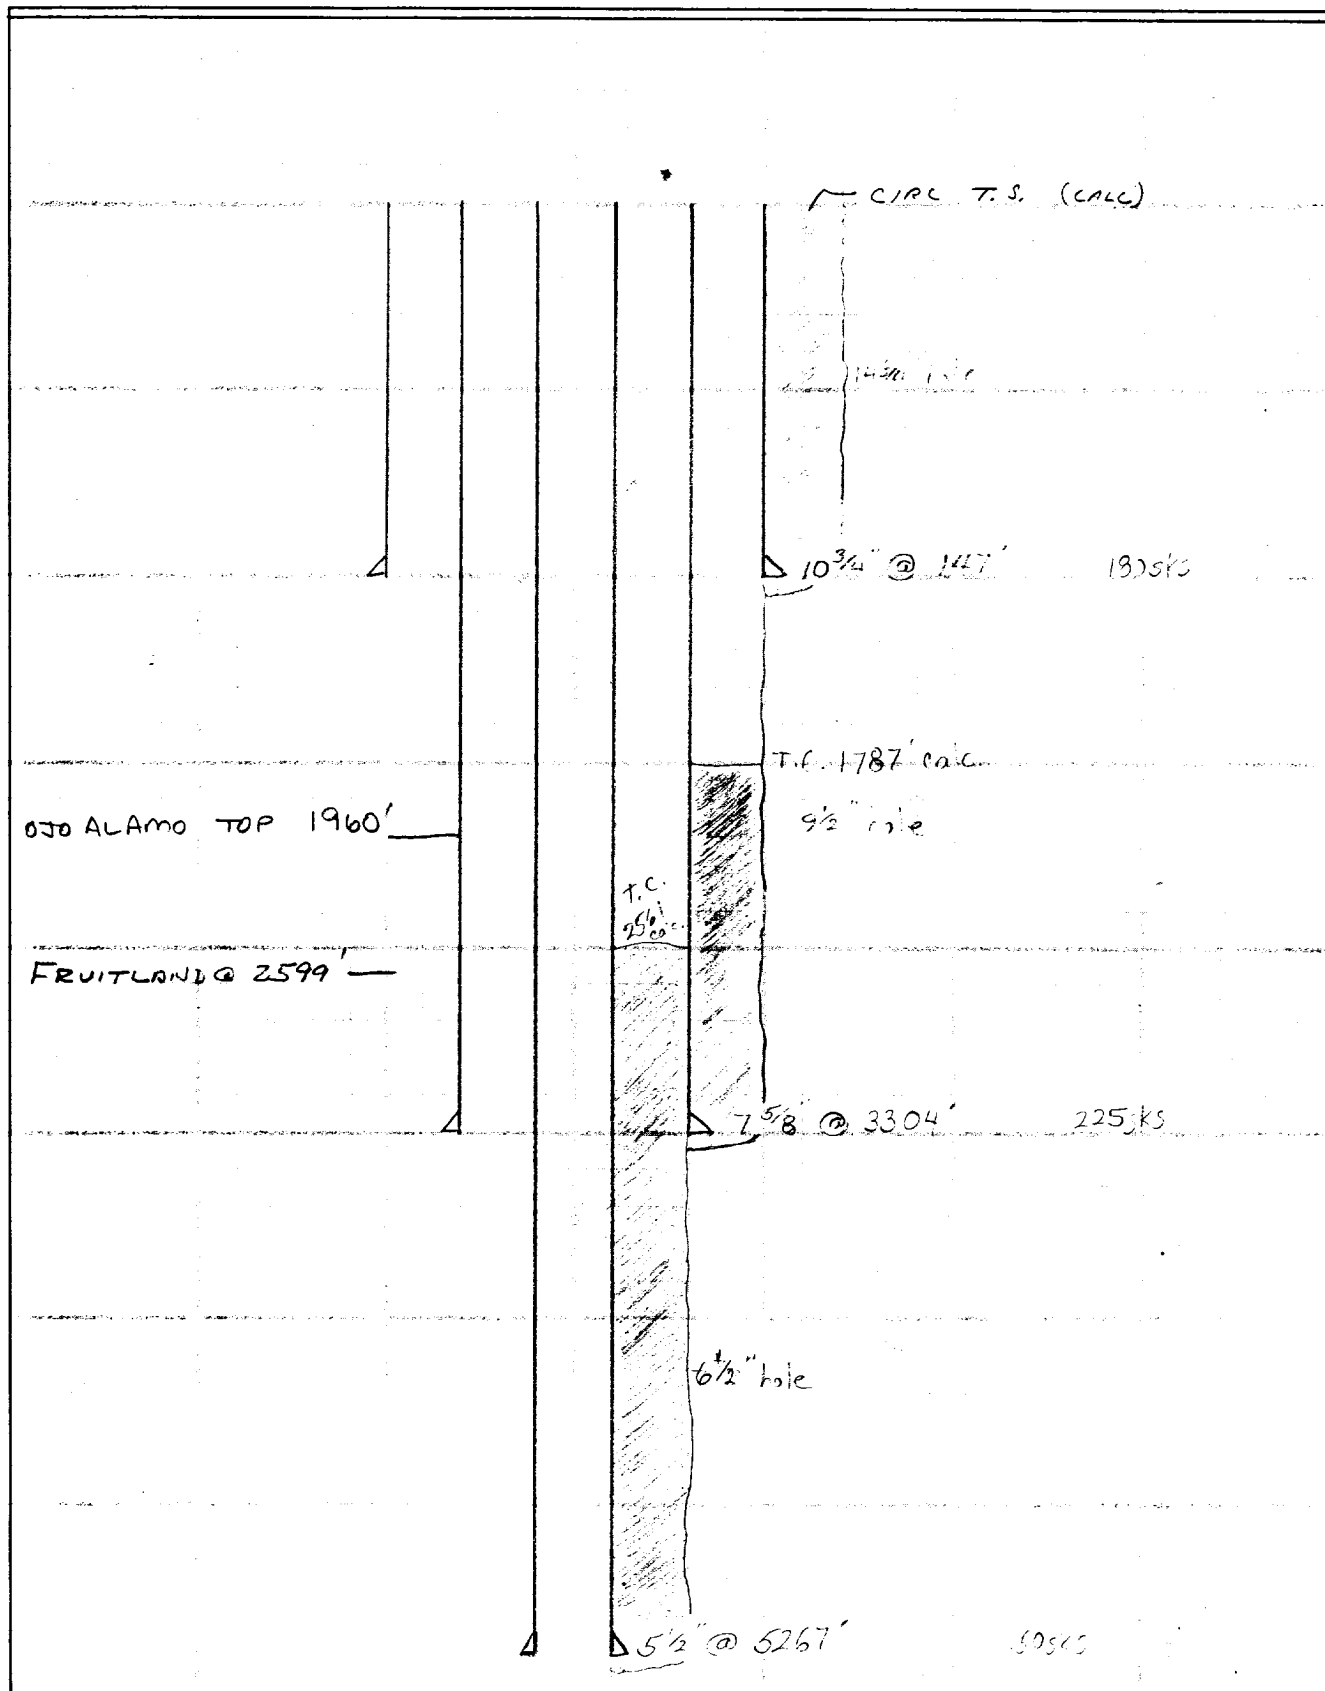
NE Block Unit #27
NE B T-30-N R-7-VI

This well was drilled in 1955 and has not been re-entered since. The calculated top of cement indicates coverage of the Ojo Alamo water. Cathodic protection is not installed on the well.

There is no record of testing the 5 1/2" x 7 5/8" annulus.

This well could be leaking and/or allowing gas migration to a shallow formation where it might eventually break out into the lake in the SE/4 of Section 3.

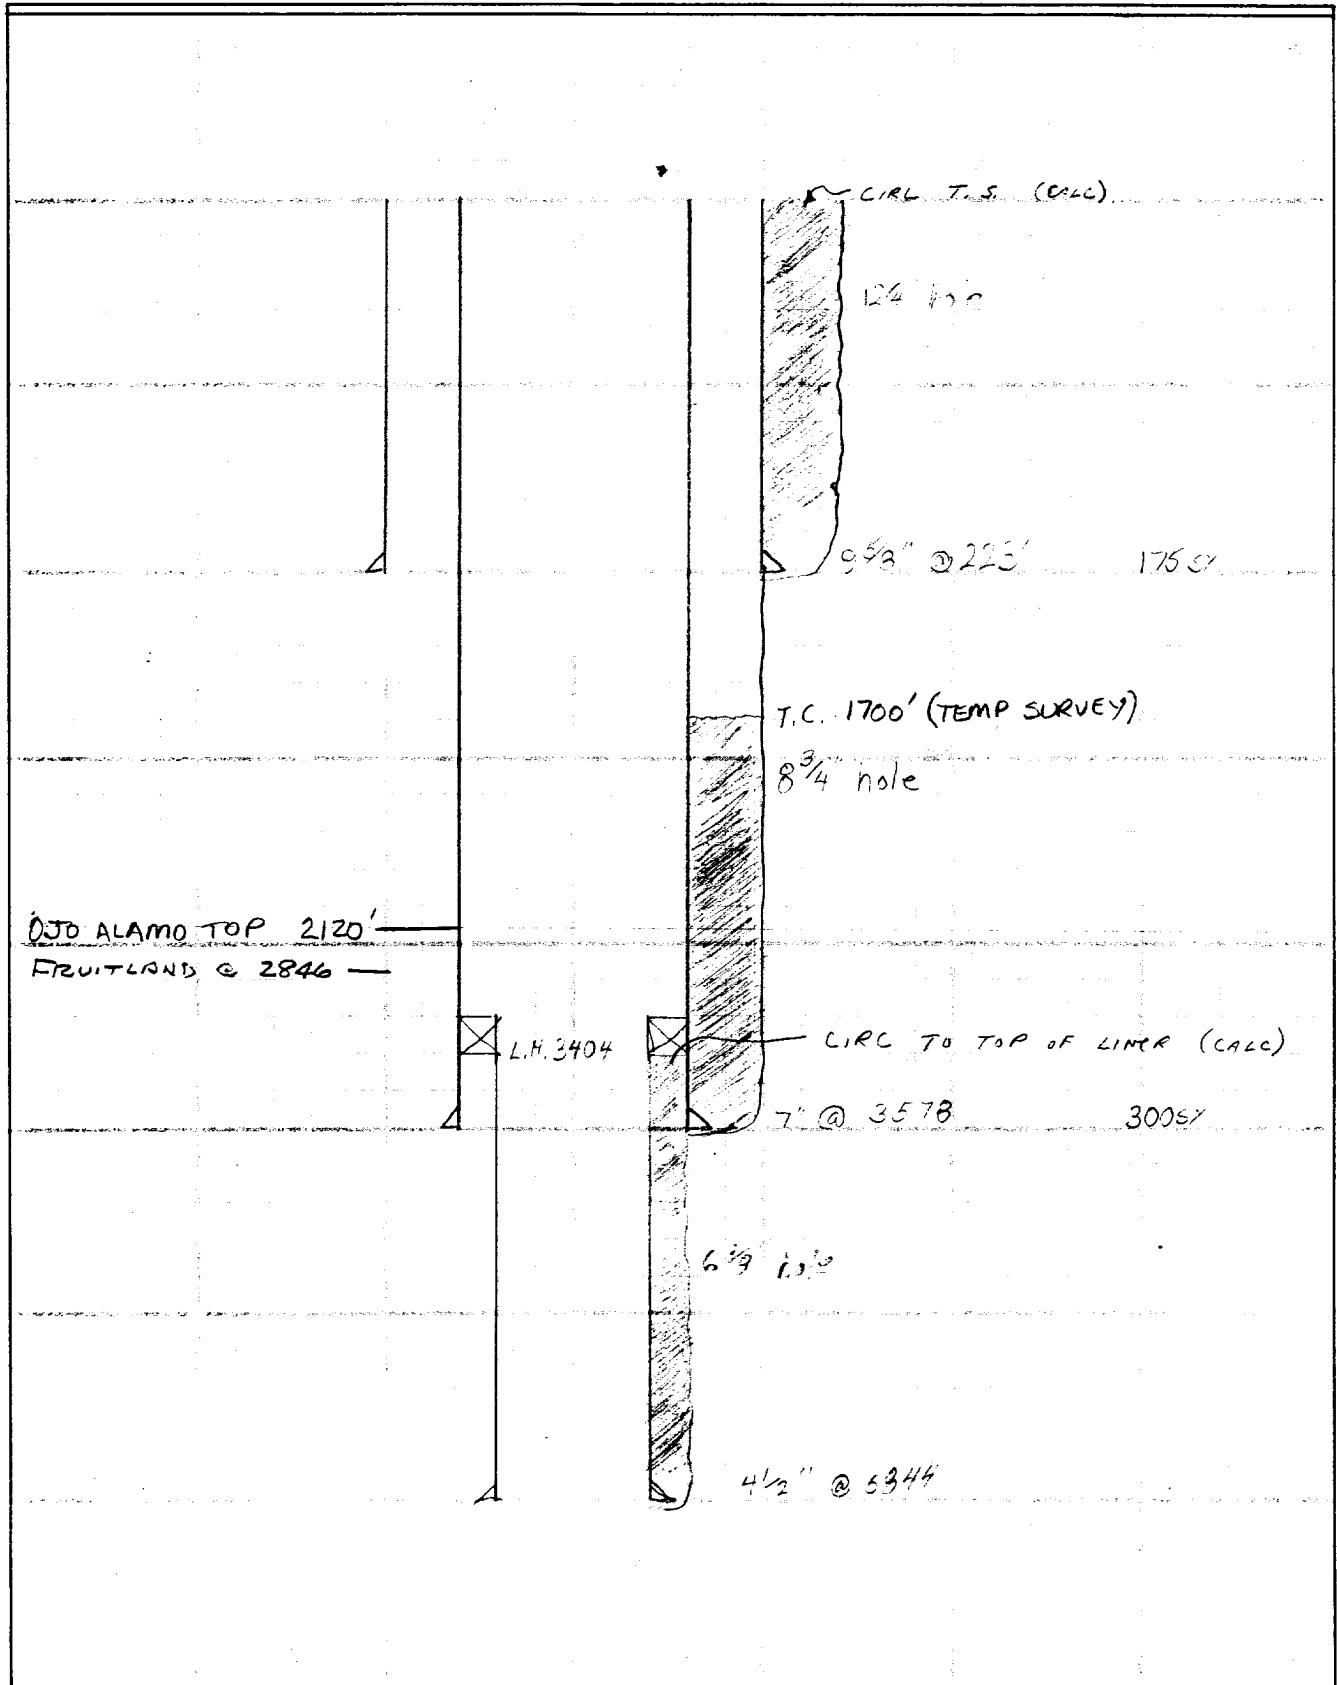
NE Blance Unit # 16A
 SF 3 T-30-1-11

This well was drilled in 1978. The corrosive Ojo Alamo water is covered with cement according to temperature survey. The well does not have cathodic protection.

The tubing has not been pulled and the casing tested since completion.

It is unlikely this well is leaking gas; however, gas could be migrating in the 7" x 8 3/4" annulus if the 7" casing has failed.
