Well File
Howell B #3
S/W 3-30N-7W

MEMORANDUM

Subject: Howell B #3
Adjacent Well Data

Attached is the data concerning the wells adjacent to the Howell B #3. The data includes a schematic showing casing depths, cement tops, cemented intervals, and formation tops.

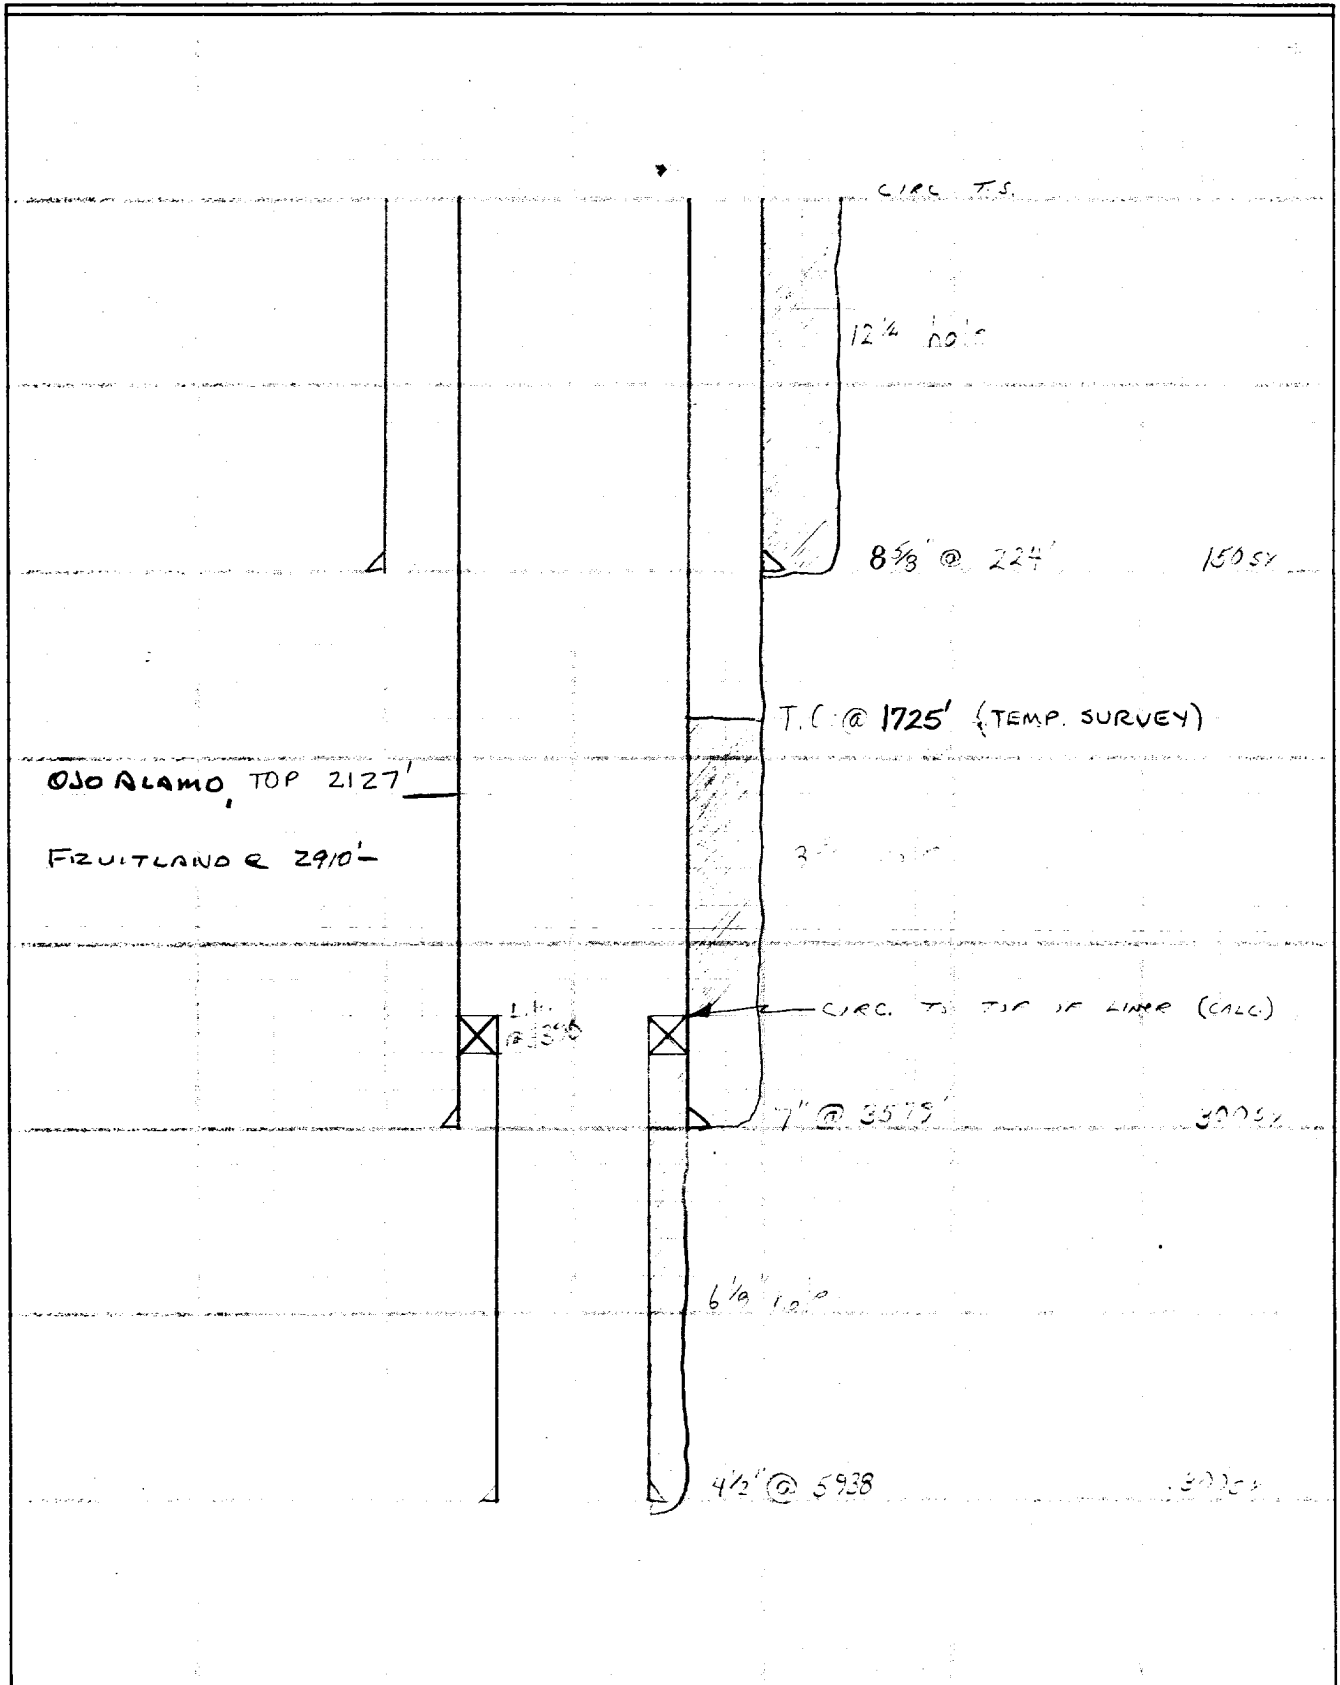
NE Blanco Unit #024
 NW 3 T-20-N R-7-W

This well was drilled in 1978. The corrosive Ojo Alamo water is covered with cement according to temperature survey. The well does not have cathodic protection.

The tubing has not been pulled and the casing tested since completion.

It is unlikely this well is leaking gas; however, gas could be migrating in the 7" x 8 3/4" annulus if the 7" casing has failed.

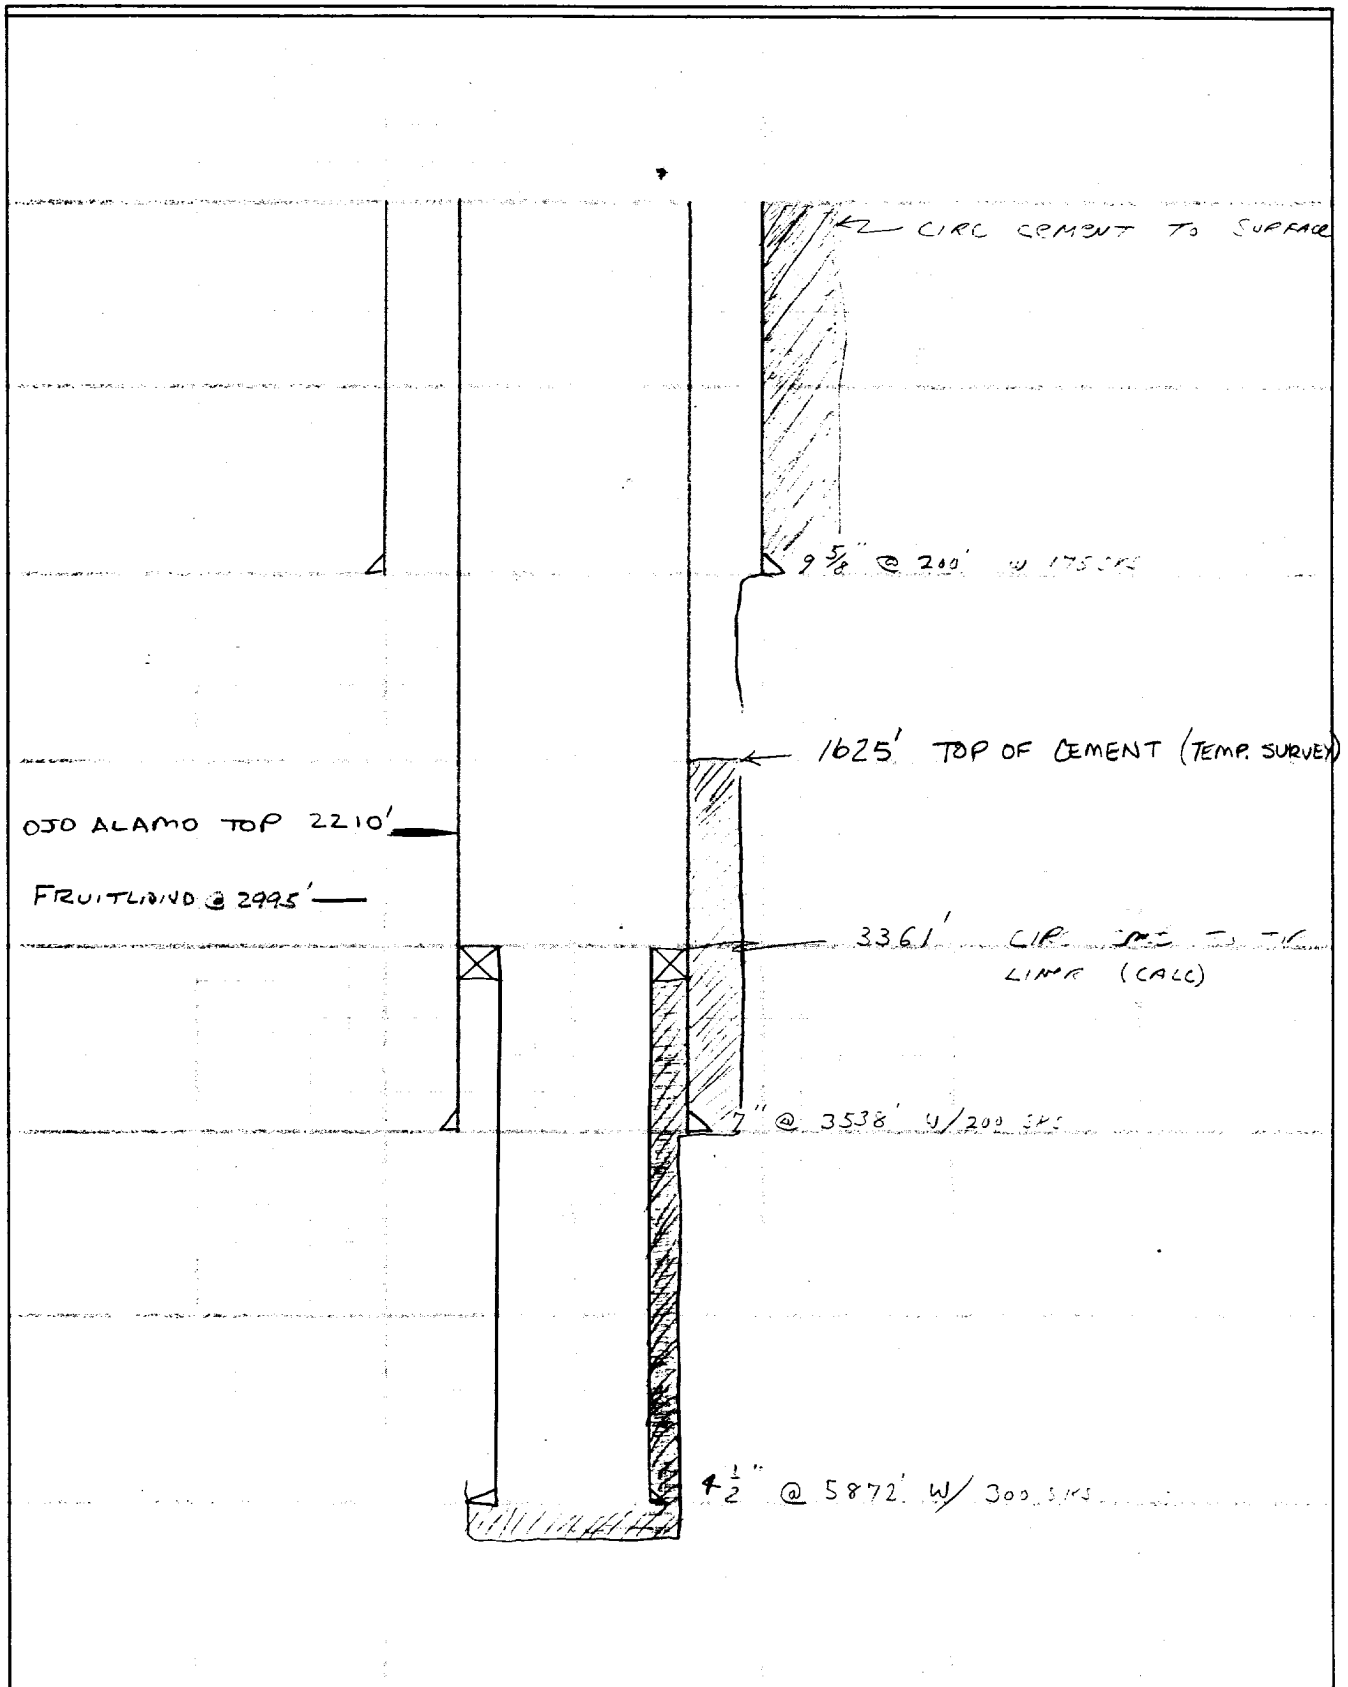
NORTHEAST BLANCO UNIT #17A
 NW SEC 9 - T 30 N - R 7 W

This well was drilled in 1978. The corrosive water of the Ojo Alamo are covered with cement. The well does not have cathodic protection. The tubing has not been pulled and the casing tested since completion. It is unlikely this well is leaking gas but gas could be migrating in the 7" x 8 3/4" annulus if the 7" casing has failed.

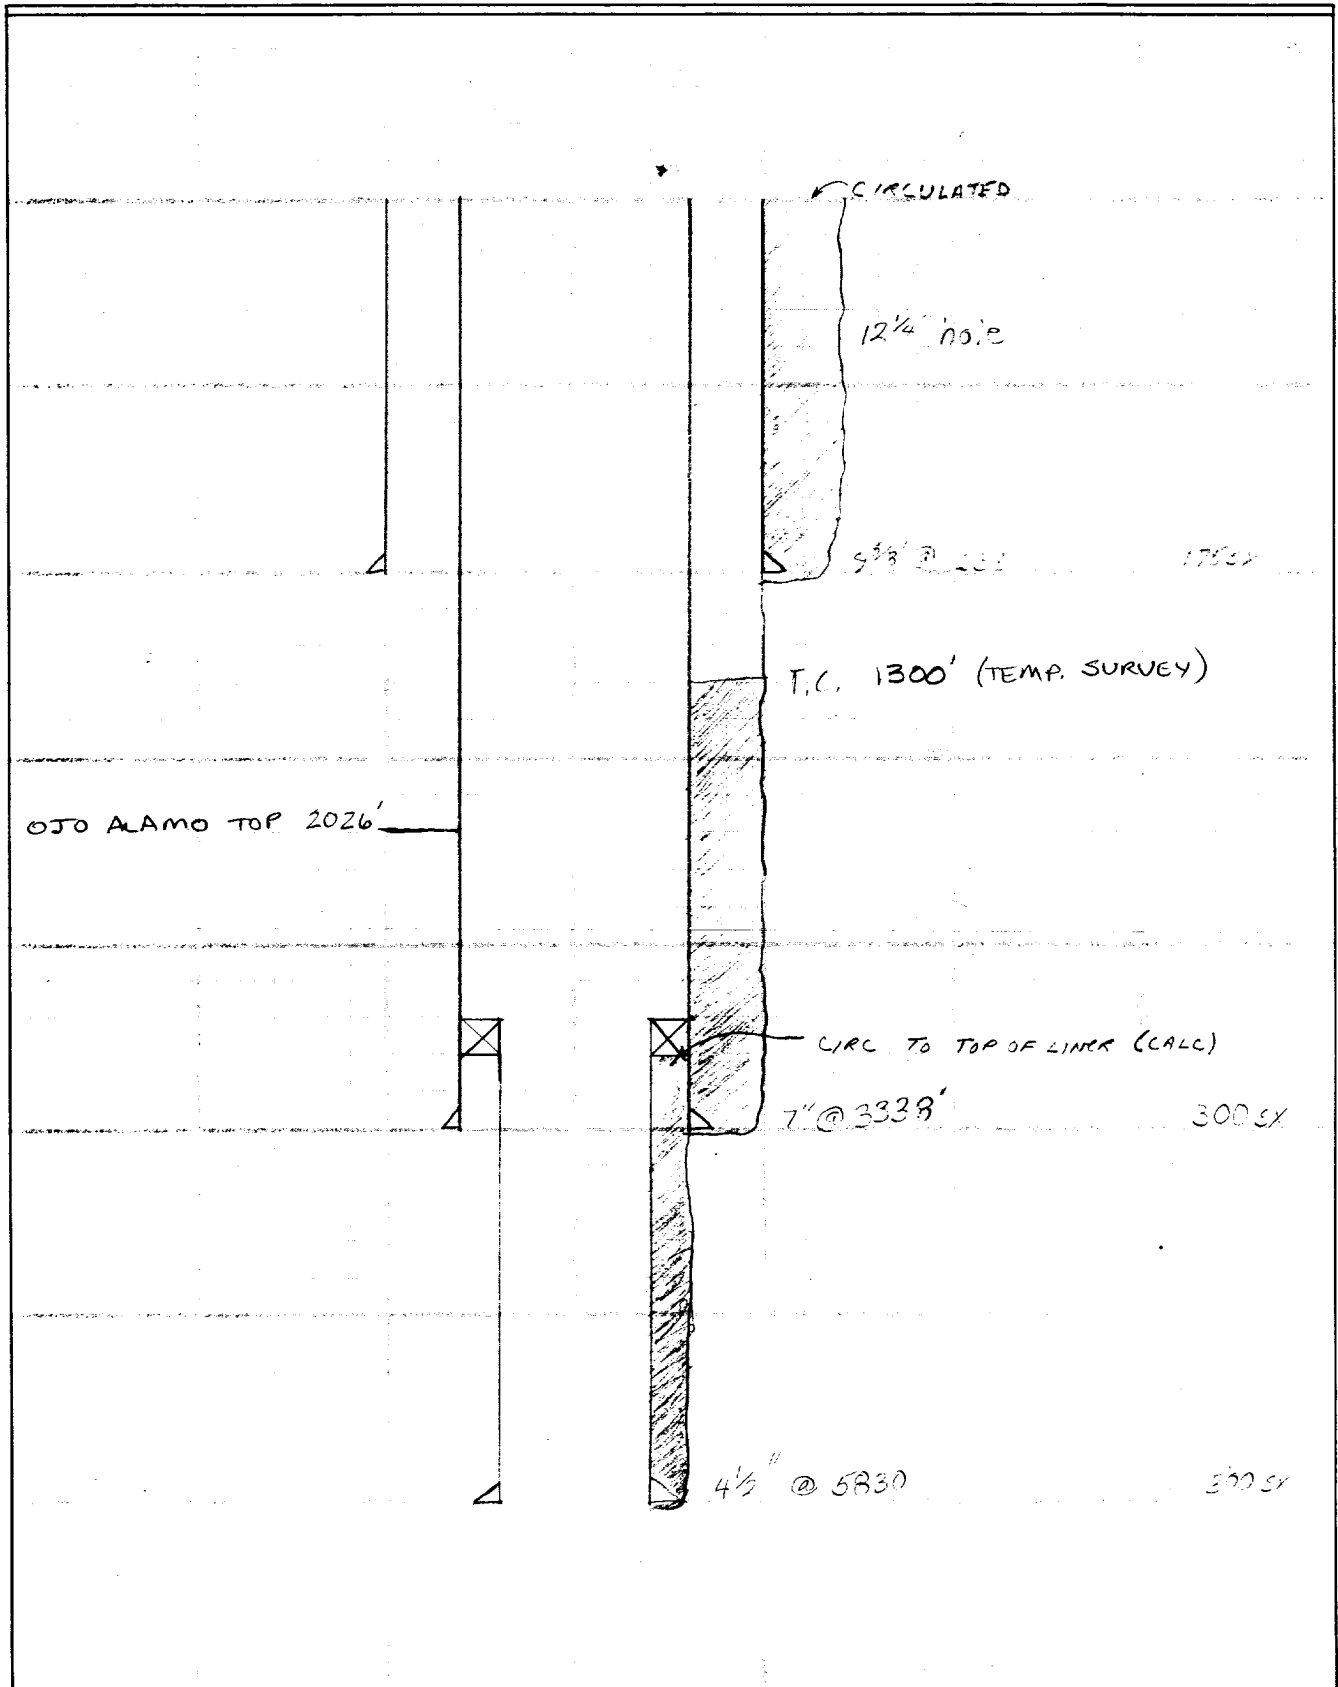
NE Bluffs Unit #44F
SE 4 T-30-N R-7-W

This well was drilled in 1978. The corrosive Ojo Alamo is covered by cement according to temperature survey. The well does not have cathodic protection.

The tubing has not been pulled and the casing tested since completion.

It is unlikely this well is leaking gas; however, gas could be migrating in the 7" x 8 3/4" annulus if the 7" casing has failed.

This well is in close proximity to the gas leak in the lake in the SE/4 of Section 4.
