Sundry Notices and Reports on Wells

WORKOVER PROCEDURE

Repair Tubing

Quinn #4

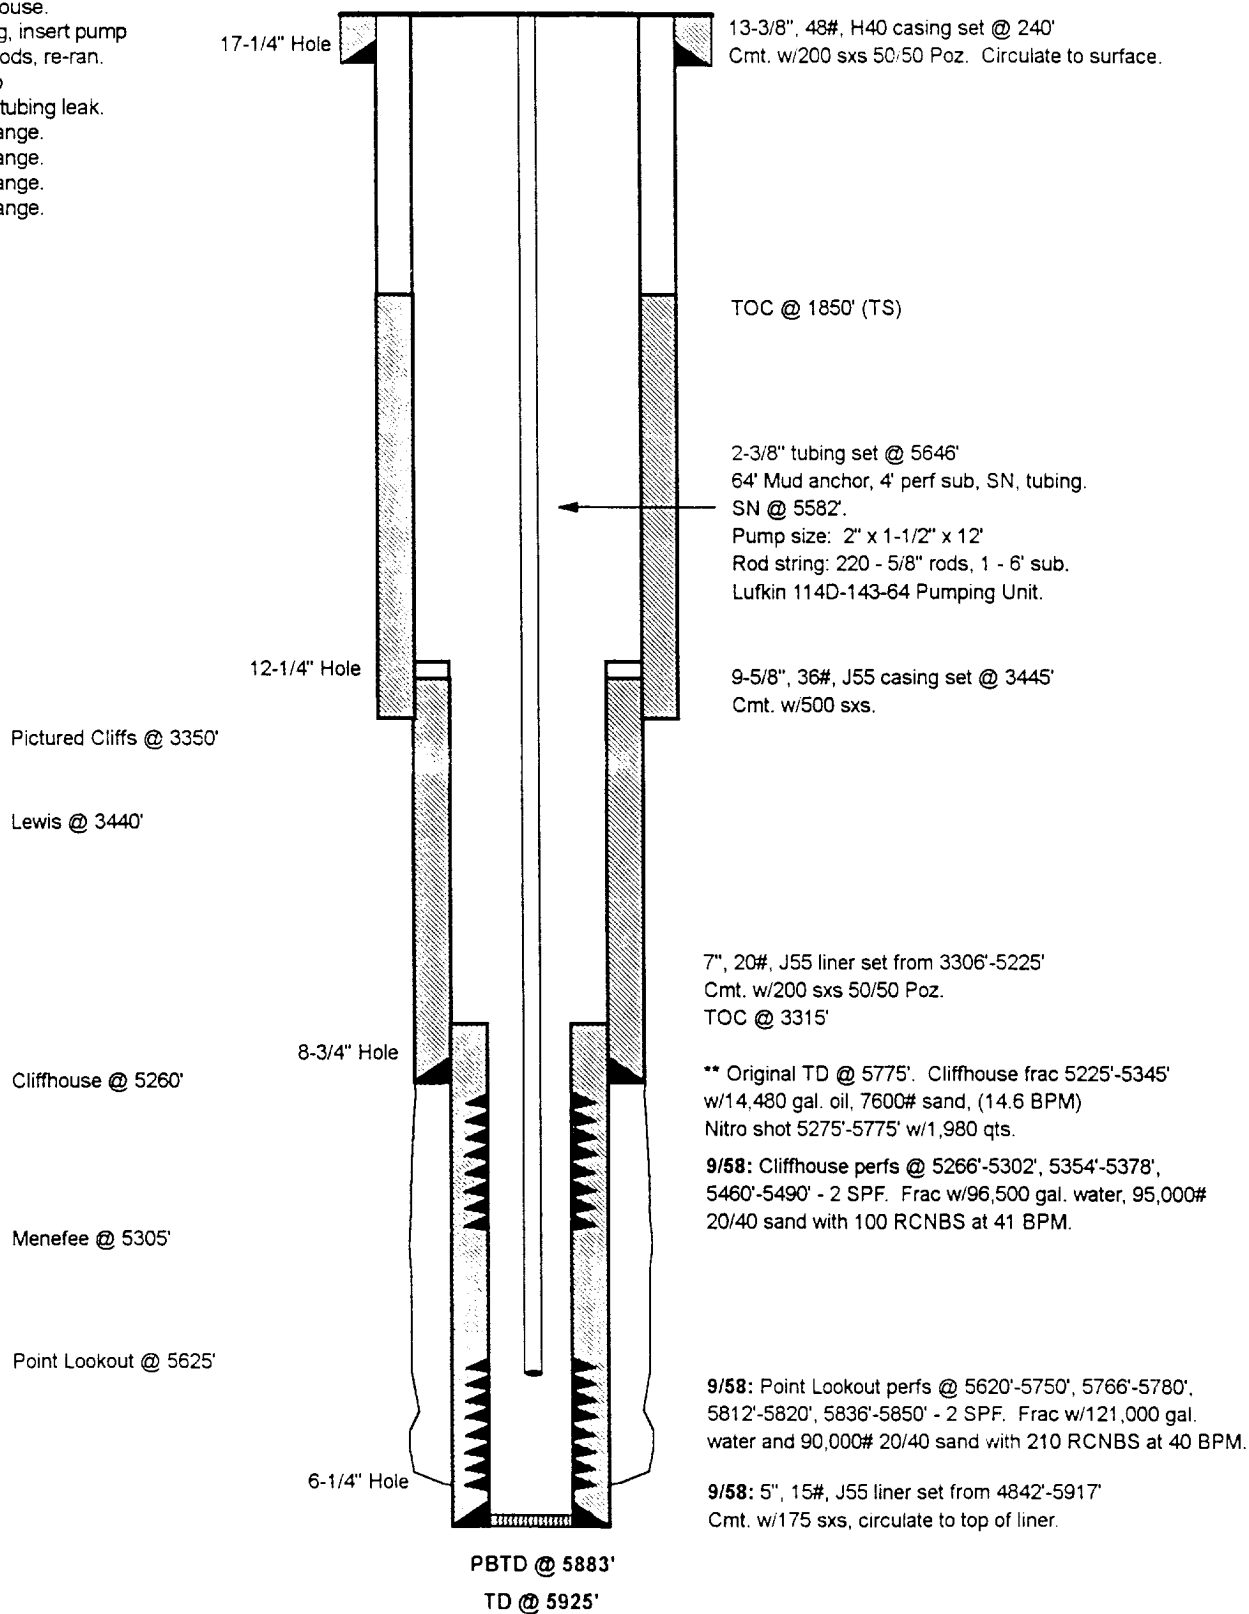
Quinn #4

Current -- 1/24/97

Spud: 9/10/54
 Completed : 12/29/54
 Elevation: 6493' (KB)
 6483' (GL)
 Logs: Radioactivity, TS
 9/21/58: Deepened well to 5925', ran 5" liner. Perf and frac Pt. Lookout and Cliffhouse.
 7/12/75: Trip tubing, insert pump
 4/13/77: Stripped rods, re-ran.
 3/29/79: Trip pump
 5/11/79: Repaired tubing leak.
 9/27/79: Pump change.
 4/6/80: Pump change.
 3/26/81: Pump change.
 2/20/91: Pump change.
